THE MAJOR CAUSE OF EARTHQUAKE DISASTERS : SHEAR BANDINGS

**THE MAJOR CAUSE OF
EARTHQUAKE DISASTERS:
SHEAR BANDINGS**

Institute of Mitigation for Earthquake
Shear Banding Disasters

Capturing Shear Bandings

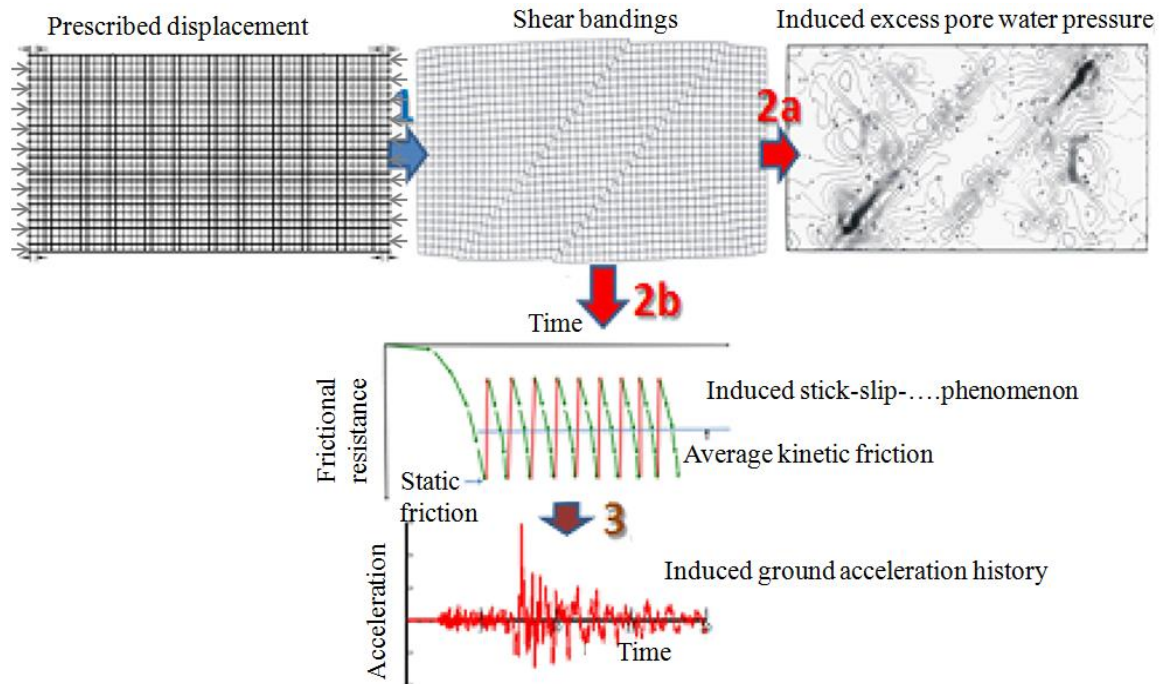
Figure 1.7. A flow chart for the ground vibration and the highly concentrated pore water pressure to be induced by shear banding

Figure 1.7 is shown more clearly vivid that the ground vibrations and the highly concentrated phenomenon of excess pore water pressure are caused by shear bandings in a tectonic earthquake. Where shear banding energy is found to be greater than 90% of the total tectonic earthquake’s energy; and ground vibration energy is only less than 10% of the total tectonic earthquake’s energy. This is the major reason for most of the earthquake disasters to happen in the shear banding zones.

- Legend :
- 1. Local shear banding is induced in a tectonic plate by lateral compression.
 - 2a. Highly concentrated excess pore water pressure is induced in the shear band.
 - 2b. When shear banding occurs, **stick-slip**-...phenomenon appears repeatedly.
 - 3. Acceleration time history for the ground vibration is induced by **stick-slip**-...phenomenon.

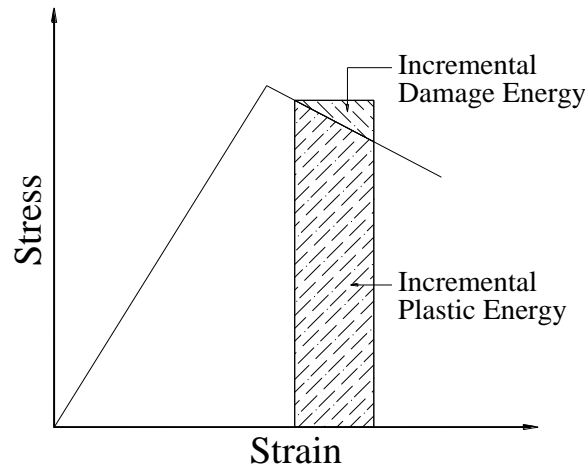
Figure 1.8. Schematic diagram of the incremental damage energy and the incremental plastic energy

strain softening range. The incremental plastic energy of an element for a particular load step is equal to the shaded area below the stress-strain curve shown in Figure 1.8 times the volume of the element. And the incremental damage energy of an element for a particular load step is equal to the shaded area above the stress-strain curve shown in Figure 1.8 times the volume of the element.

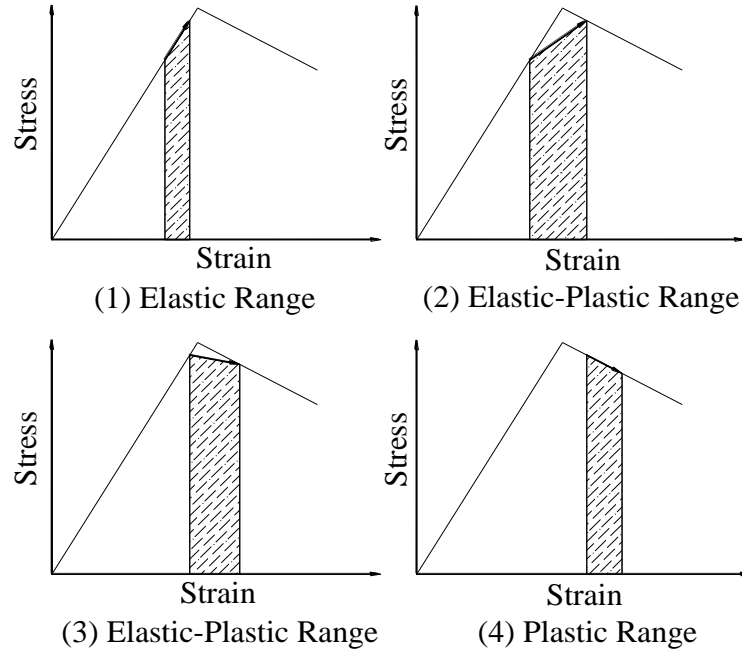
Figure 1.10. Four possible conditions in a loading step when averaging scheme is used to form the stress-strain matrix

However, as explained in Figure 1.10, there is only one minimum total incremental potential energy. This is so because the average of the stress-strain matrix for the existing stresses ($\underline{\sigma}$) and the existing stresses

plus the stress increments ($\underline{\sigma} + d\underline{\sigma}$) is used to form the global stiffness matrix. As shown in Figure 1.10, only one of the four conditions will be used; hence only one minimum total incremental potential energy will exist.

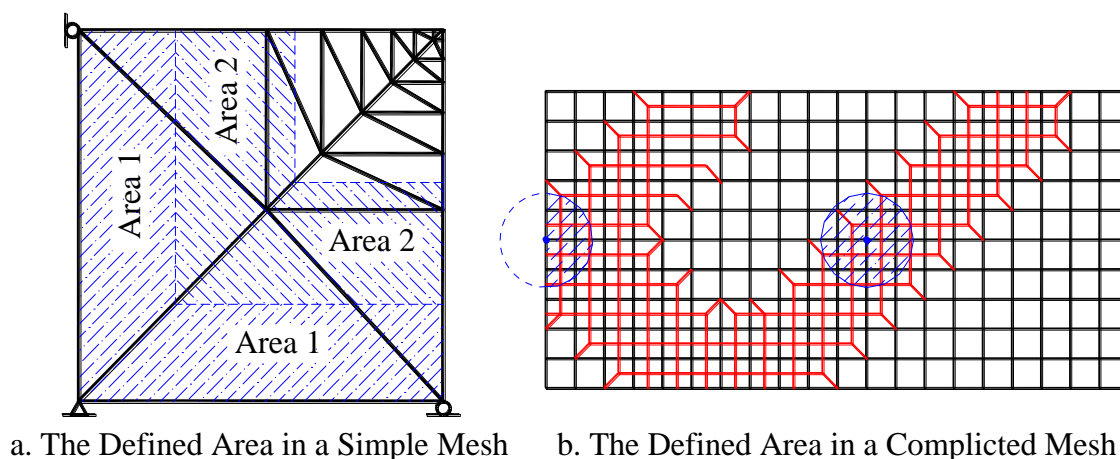
Figure 1.16. Definition of the area used in the determination of the degree of freedom density

Degree of Freedom Density (DOFD). The degree of freedom density is equal to the ratio of the total degrees of freedom, within a defined area, divided by that area. For a simple problem as that shown in Figure 1.16.a, the areas 1, 2, etc., can be used as defined areas in determining the degree of freedom density. For any other sophisticated problems as that shown in Figure 1.16.b, a moving circle or a moving square with a constant area can be used as the defined area. By placing the center of the moving circle or the moving square on the top of each nodal point, the total number of degrees of freedom covered by the moving circle or the moving square can be determined and the degree of freedom density can be obtained. If the nodal point is near the boundaries of the mesh, only the area within the mesh, which is covered by the moving circle or the moving square has to be used.

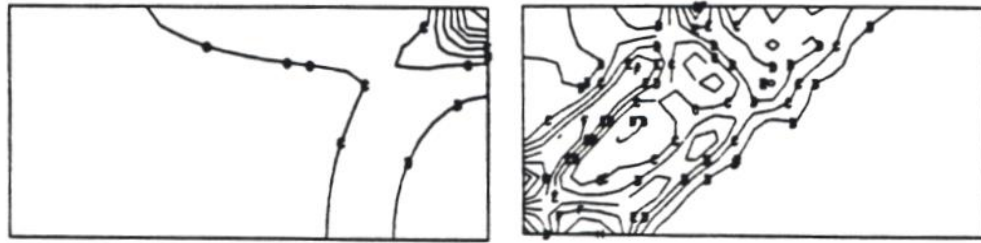
Figure 1.33. Strain energy density contours ($H/2G=-0.05$, and 3 substeps used)

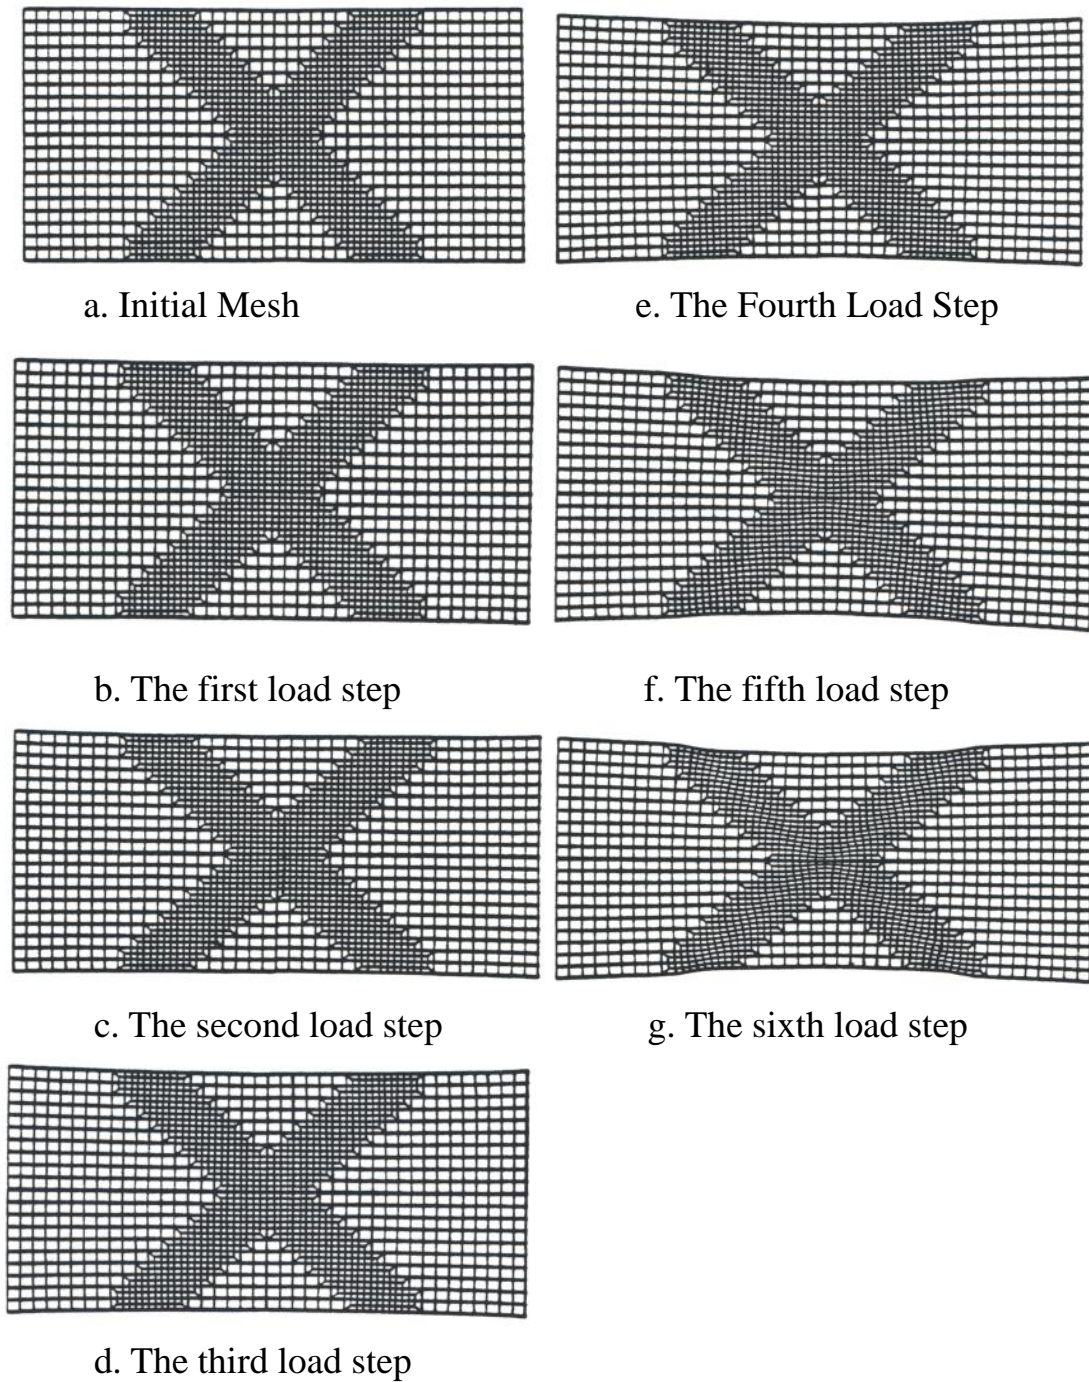
Figure 1.44. The X pattern of localization of deformation in the unconfined tension simulation ($H/2G = 0.0$, number of substeps = 3)

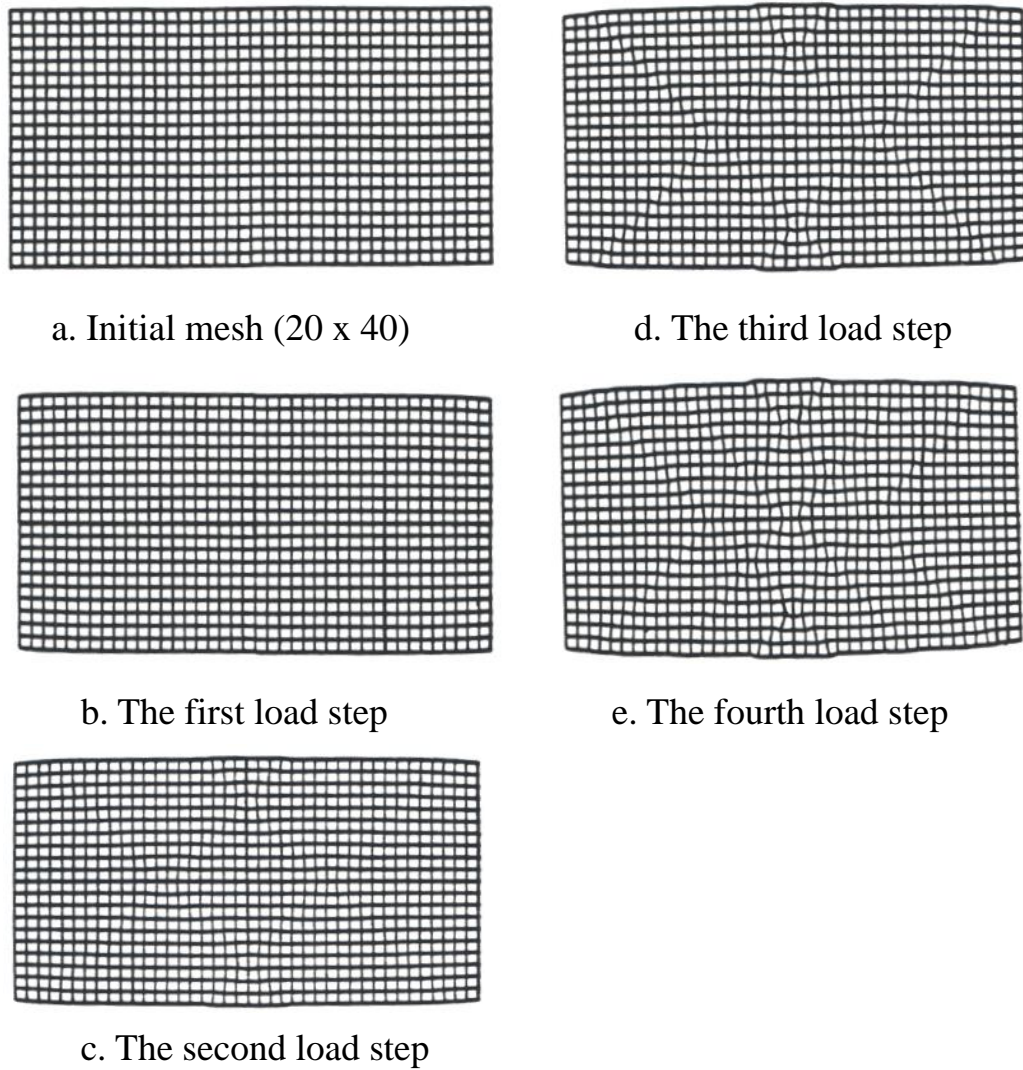
Figure 1.51. The 3I pattern of localization of deformation in the unconfined compression simulation ($H/2G = -0.05$, number of substeps = 5)

The fifth experiment produced a pattern of localizations called 3I pattern. The number of loading substeps used for this pattern is five. From Figure 1.51 it is seen that the 3I pattern is formed by two sets of three I-shape shear bands. It is to be noted that 3I pattern is formed gradually.

From Figure 1.51.d it is seen that a 2I pattern is formed first in the third load step. Then the 3I pattern is formed in the fourth load step (see Figure 1.50.e). Totally there are sixteen blocks in the plate formed by the 3I pattern. The angle of the shear bands with respect to the horizontal is found to be 45.1 degrees in Figure 1.51.e.

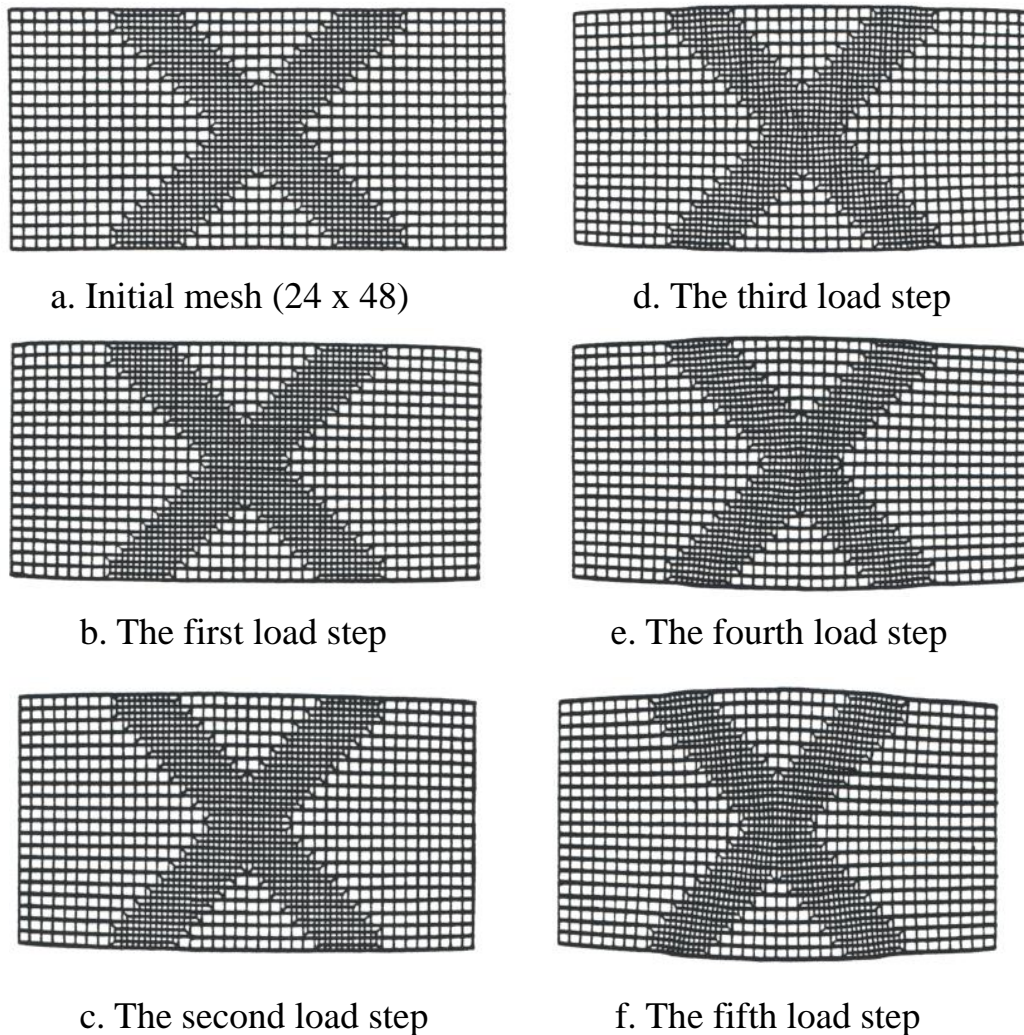
Figure 1.56. The X pattern of localization of deformation in the unconfined compression simulation ($H/2G = 0.0$, number of substeps = 3)

results from the 20 x 40 refined mesh show that the selective refinement of a mesh does not improve the formation of the localization. It is to be pointed out that localizations do not further propagate to form other types of shear bands. The angle of the shear bands with respect to the horizontal is found to be 45.9 degrees in Figure 1.53.f, 45.2 degrees in Figure 1.54.f, 45.4 degrees in Figure 1.55.f, and 45.9 degrees in Figure 1.56.f.

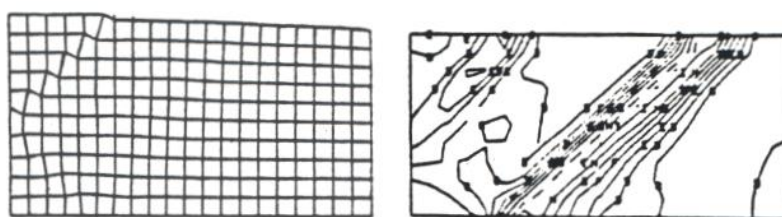
a. Unrefined mesh

b. Refinement along path observed in Figure 5.9.a

c. Refinement along path observed in Figure 5.9.b

Figure 1.66. Influence of selective refinement along shear band path
(10 substeps used)

Influence of Mesh Details. Two nearly identical meshes are compared in Figure 1.66. The mesh in Figure 1.66.a has two rows of half-size elements at the outer edge of the plate and two columns of half-size elements near the point 'D' in Figure 1.66.a. The mesh in Figure 1.66.b has two rows and two columns of half-size elements near the centerlines of the plate. It was generally observed that shear bands propagated from a source point--'D' in Figure 1.66.a and 'A' in Figure 1.66.b--located at the plate boundary. Segments cd and ab are fully developed in Figures 1.66.a and 1.66.b respectively. Therefore with the same amount of prescribed deformation, the mesh with half-size elements near the centerlines of the plate exhibits more detrimental behavior (i.e. more deformation in a region). The strain energy density contours suggest that the presence of the half-size elements retards the development of localization. Above results reveal again that coarse elements tend to exhibit more 'brittle' behavior than small elements. This provides a clue for the small elements to have a tendency to retard the development of localization.

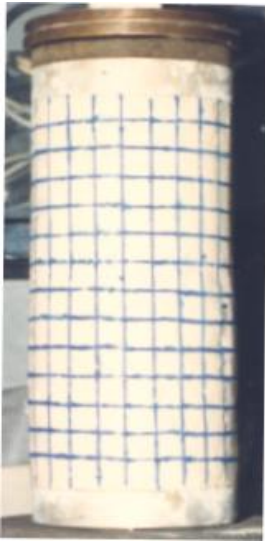
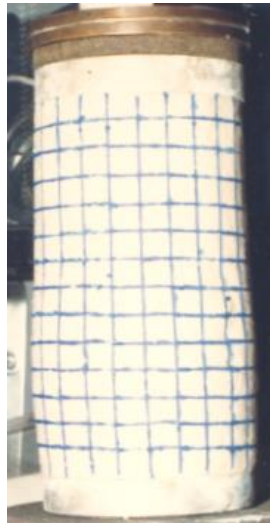
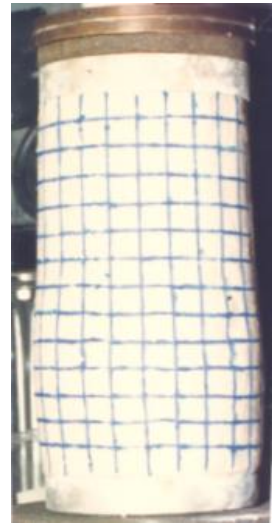
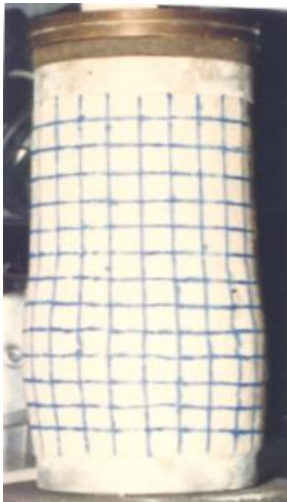
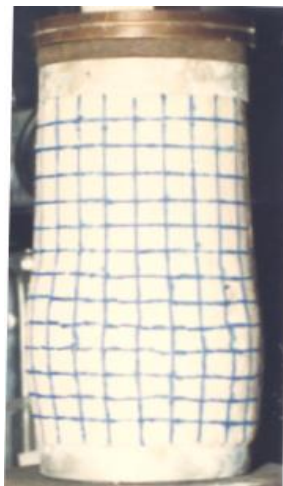
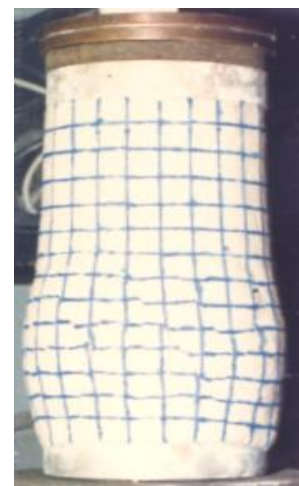
Figure 1.74. Performance of the unconfined compression test under axis-symmetry conditions

Performance of a Test under Axis-symmetric Conditions. To evaluate the hardening parameter (H) and initial size of yield surface (\mathcal{K}), a unconfined compression test under axis-symmetric conditions was performed as shown in Figure 1.74. From Figure 1.74 it is seen that the sample keeps on bulging at one end with an increase in vertical displacement. The same figure also exhibits two sets of shear bands when the stress is far beyond the peak stress. This means that shear bands are easier to be captured and observed in plane strain conditions than in axis-symmetric conditions, as also noted by Rudnicki and Rice (1975), and Rice (1977).

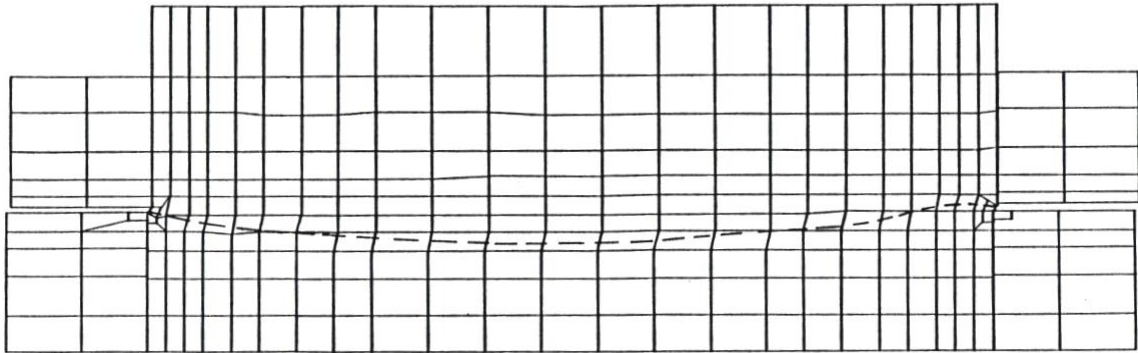
Figure 1.92. Numerical simulation of direct shear test
(Size of gape = 0.025 inch, doubled normal stress
and shear strength of the interface elements)

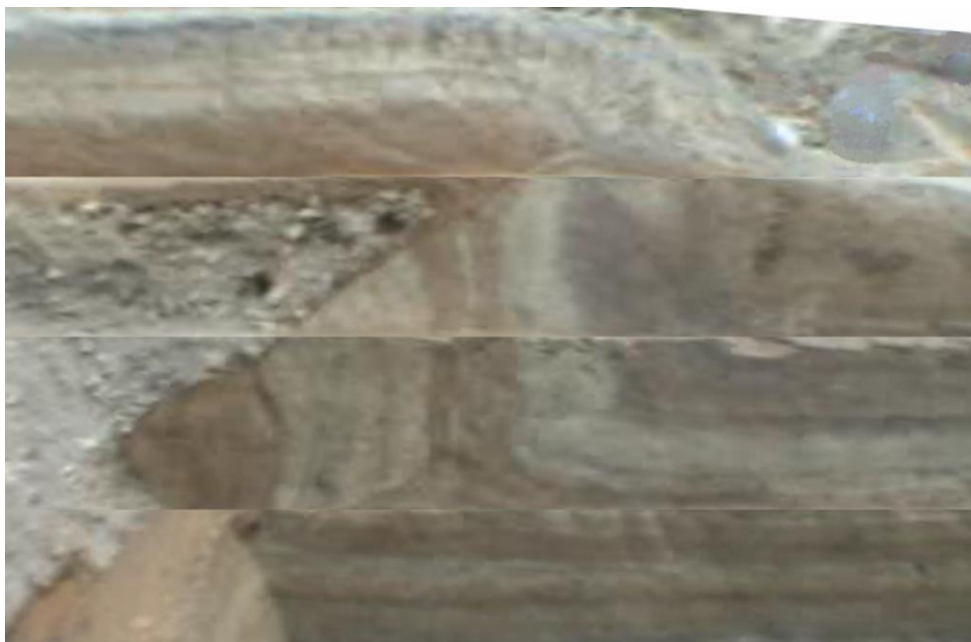
Figure 2.2. Shear bands appearing in Zhushan of Taiwan during the 921 Jiji earthquake

Because there are several different tectonic plates on earth, each tectonic plate floating on the hot magma has a tendency to move, so under the situation of mutual interaction between the tectonic plates, lateral compression or lateral extension phenomena may exist. Once the shear strain goes deep into the plastic range, Drucker (1950), Hill (1962), Mandel (1960), Rudnicki and Rice (1975), Rice (1976), and Valanis (1989) consider that localization of deformations will appear due to the loss of ellipticity, and further induce shear bands as shown in Figure 2.2.

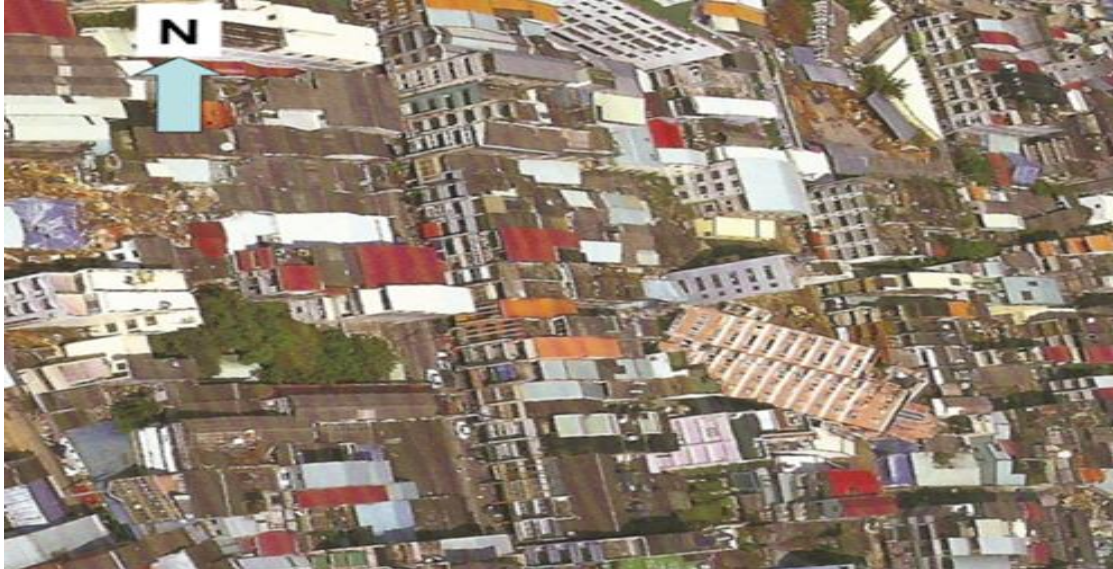
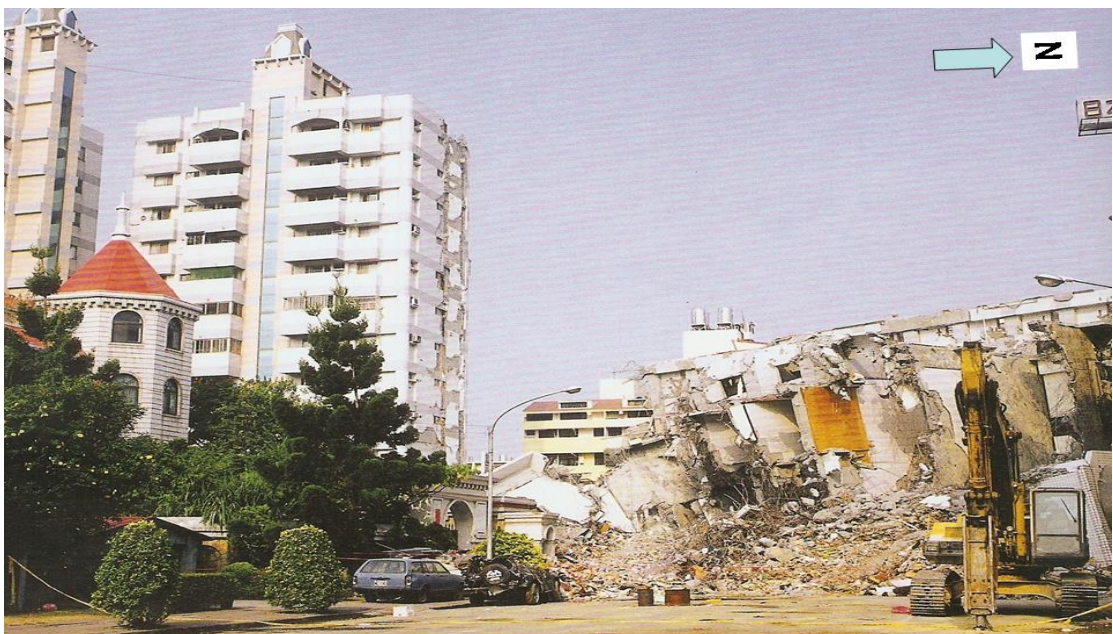
(a) The Dongshih-Dynasty building

(b) The Xiangyang-Yongzhao building

Figure 2.5 Buildings with local collapse in the 921 Jiji earthquake
(Wu, 2010)

In view of the above, in a tectonic earthquake, shear banding only exists locally, while seismic vibration exists throughout the entire plate. During the 921 Jiji earthquake, a tectonic earthquake, when the Dongshih-Dynasty building and the Xiangyang-Yongzhao building were collapsed, all other buildings that were in closely proximity to these two collapsed buildings remained stable (details in Figure 2.5); so it was revealed that the collapse to buildings in a tectonic earthquake only occurred locally. Wu (2010) used satellite imagery and a displacement velocity vector distribution map to show that the collapse to these two buildings is closely related to the local shear bandings. However, during the amendments to seismic design specifications of buildings, the reason for these collapsed buildings considered is limited to their insufficient resistance to the horizontal seismic vibration, thereby only amending the horizontal seismic vibration resistance of the upper structural components including columns, beams, slabs and shear walls, etc.

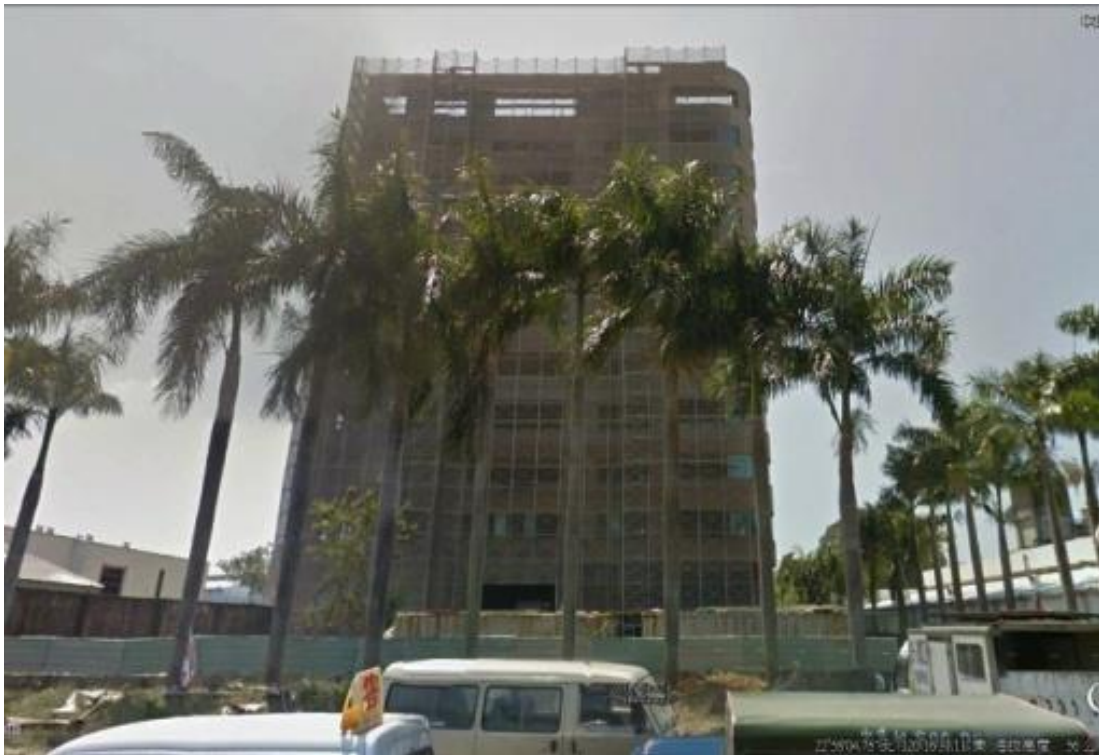
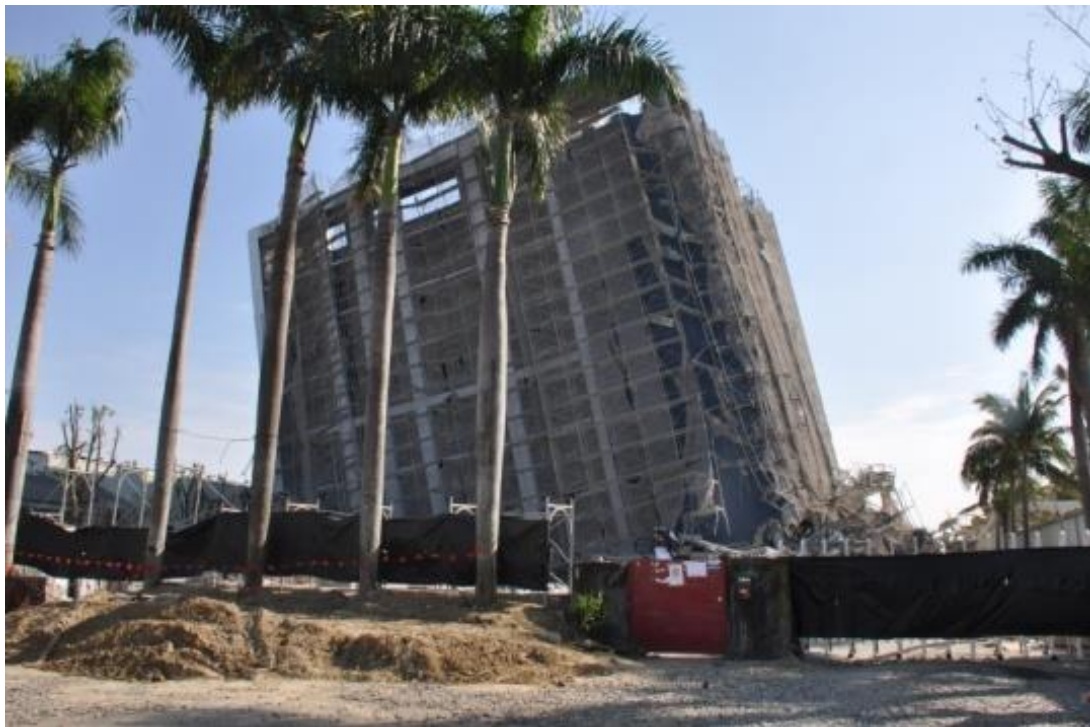
(a) Before the tilting damage (Google Earth, 2016)

(b) After the tilting damage

Figure 2.6 Tilting damage on a re-designed and altered building in the Meinong earthquake

After 1999, the horizontal seismic vibration resistance provided in the seismic design specification of buildings has been greatly enhanced based on the magnitude of $M_L = 7.3$ in the 921 Jiji earthquake. However, Figure 2.6 shows that the building subjected to alteration work in accordance with the latest seismic design specification of buildings still appears to be seriously damaged during the 0206 Meinong earthquake in 2016 with a magnitude of $M_L = 6.4$; and other old buildings in close proximity to this building remained stable during the same earthquake.

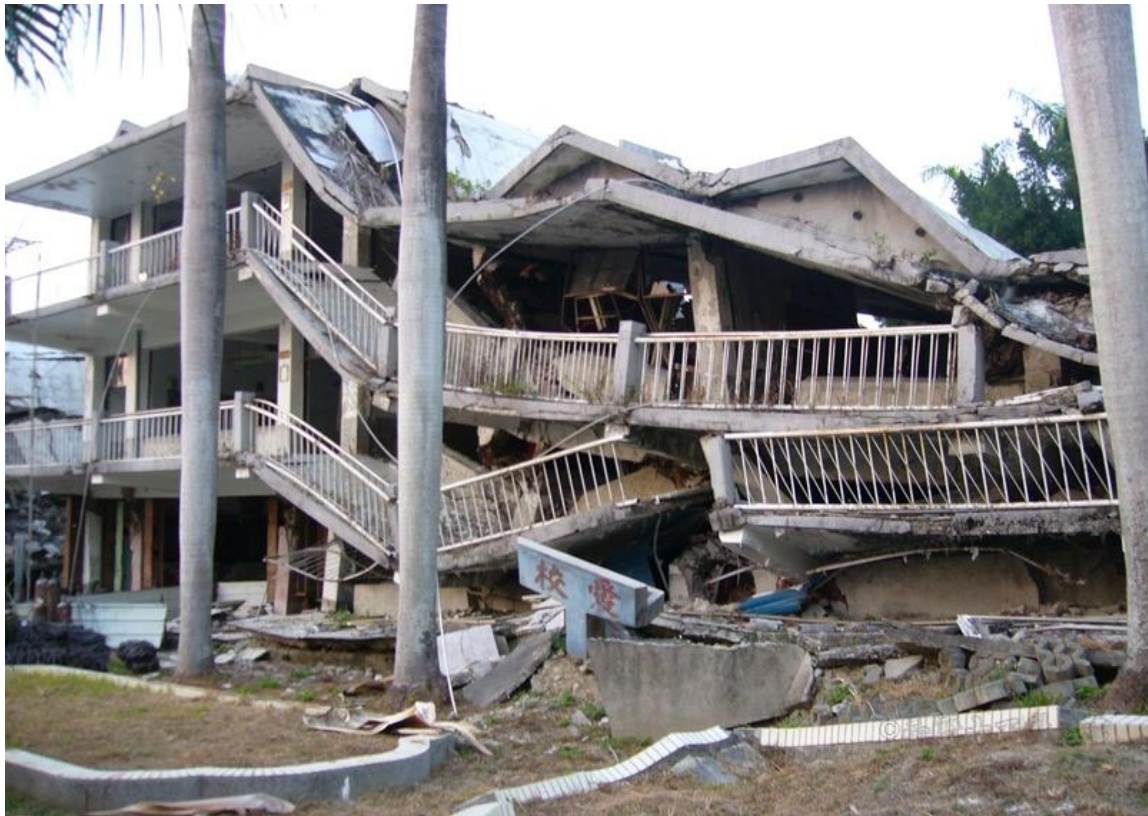
Figure 2.7 Local collapse of Kuangfu Junior High School Building in the 921 Jiji earthquake

(b) Rear view (Peggy, 2013)

(c) Schematic diagrams of construction process and local collapse mechanism in a tectonic earthquake

Under shear banding, when the hanging wall is uplifted and the footwall has yet to be lifted (details in Figure 2.7), no matter how the upper structural components, such as columns, beams, slabs, and shear walls undergo seismic isolation, seismic mitigation, or seismic reinforcement, the damage due to tilting of all buildings cannot be avoided.

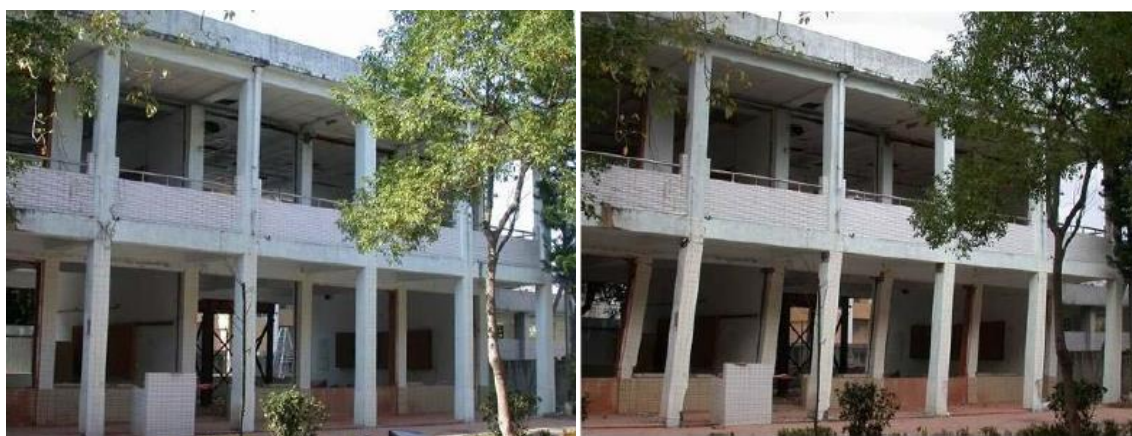
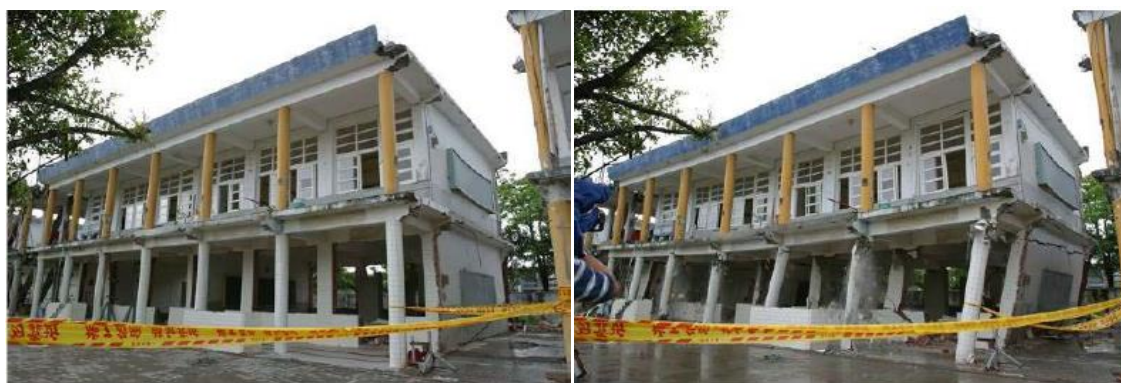
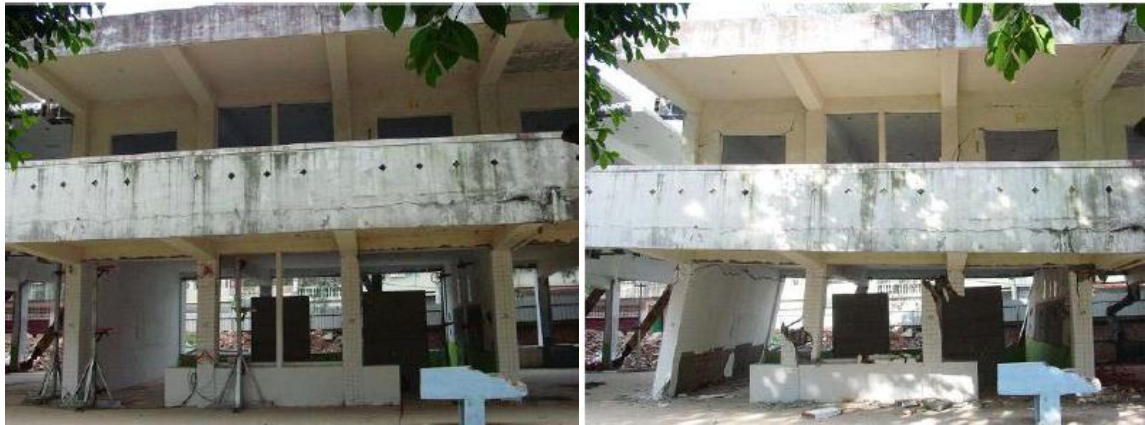
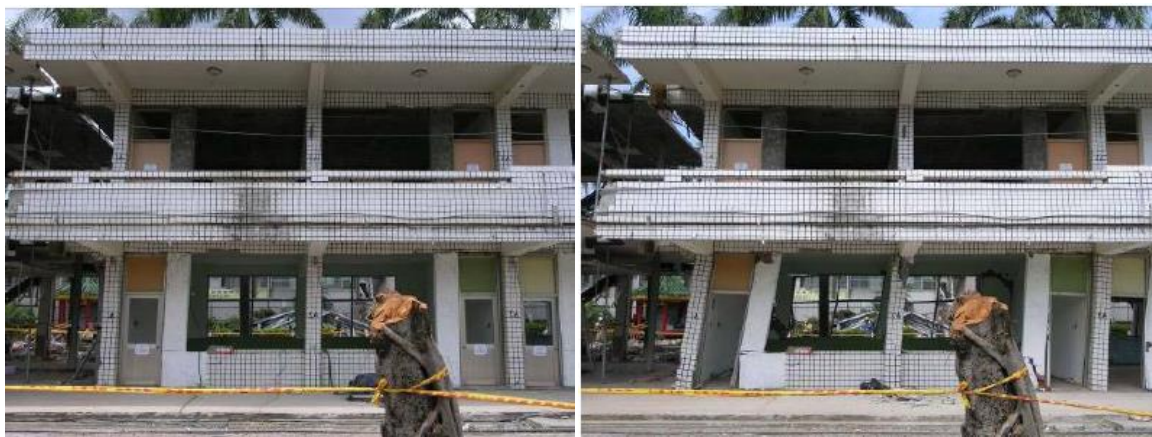
Lateral Pushover Test. The National Center for Research on Earthquake Engineering has also conducted lateral pushover test for actual structures, focusing on the old buildings of four schools, Sincheng Junior High School in Hualien, Kouhu Elementary School in Yunlin, Ruipu Elementary School in Taoyuan, and Guanmiao Elementary School in Tainan. The displacement diagrams of actual structures obtained from the tests are shown in Figure 2.15.

(a) Sincheng Junior High School in Hualien

(b) Kouhu Elementary School in Yunlin

(c) Ruipu Elementary School in Taoyuan

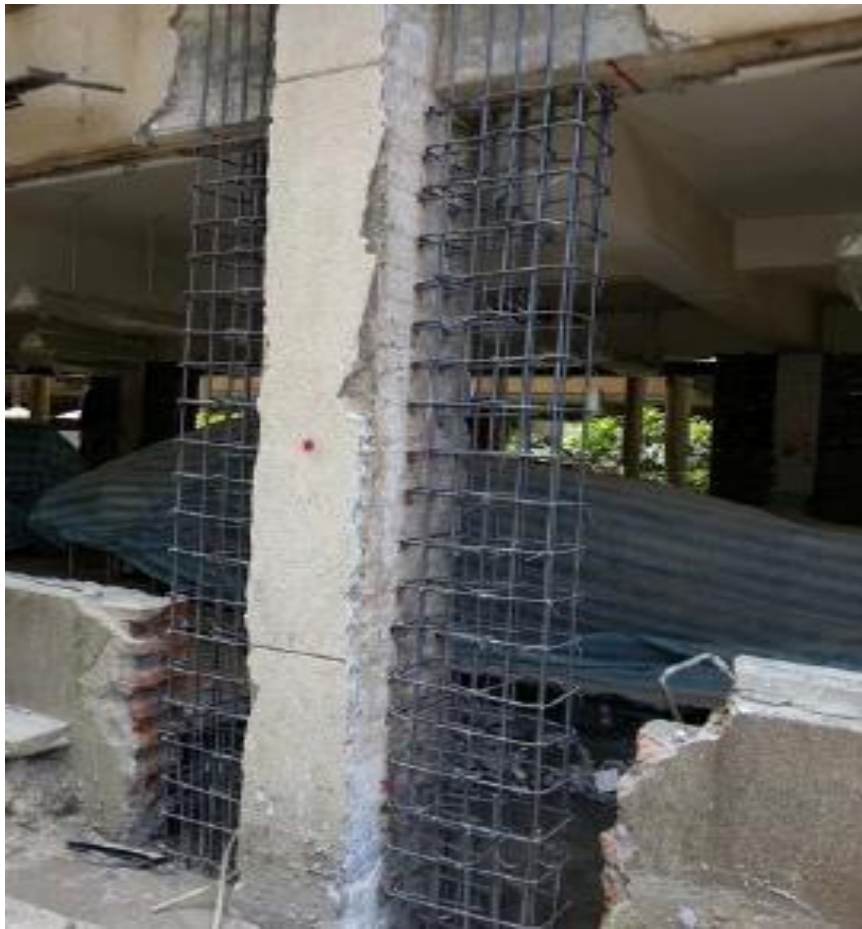
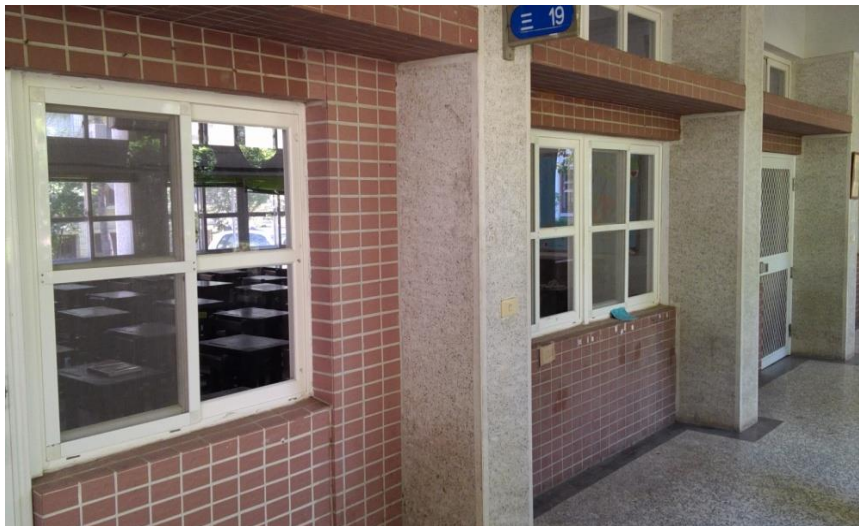
(a) Rebar assembly (Ting-Wei Hsu, 2011)

(b) After completion

Figure 2.19. Practical application of the RC wing wall reinforcement method

The detailed design diagram of the RC wing wall reinforcement method is shown in Figure 2.18. The RC wing wall reinforcement method adds a RC wing wall in the weak direction of the structure. Its purpose is to enhance the overall structural strength. Figure 2.19 shows the practical application of this method.

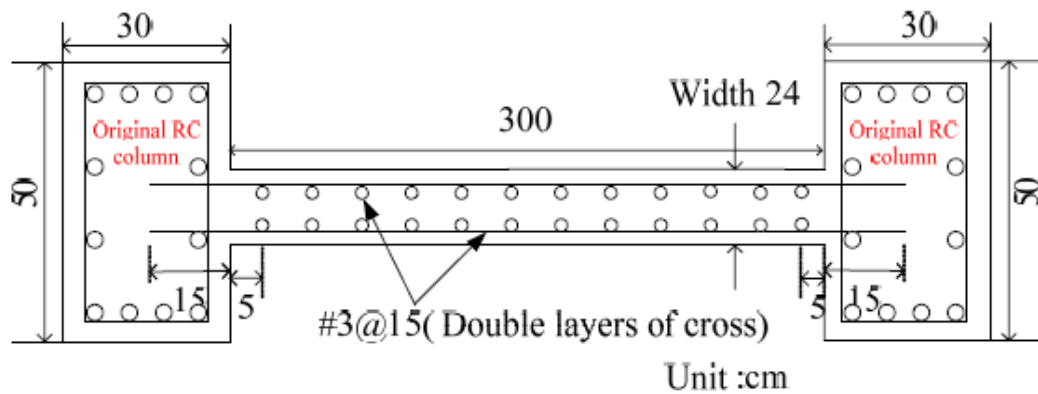
The detailed design diagram of the shear wall reinforcement method is shown in Figure 2.20. The shear wall reinforcement method can improve the strength of the overall structure resisting the horizontal force of earthquake; at the same time, it can eliminate the damage to soft and weak layers, reducing the structural torsion effect caused by the plane eccentricity. Figure 2.21 shows the practical application of the shear wall reinforcement method.

Figure 2.20. The RC shear wall reinforcement method (Chung, 2009)

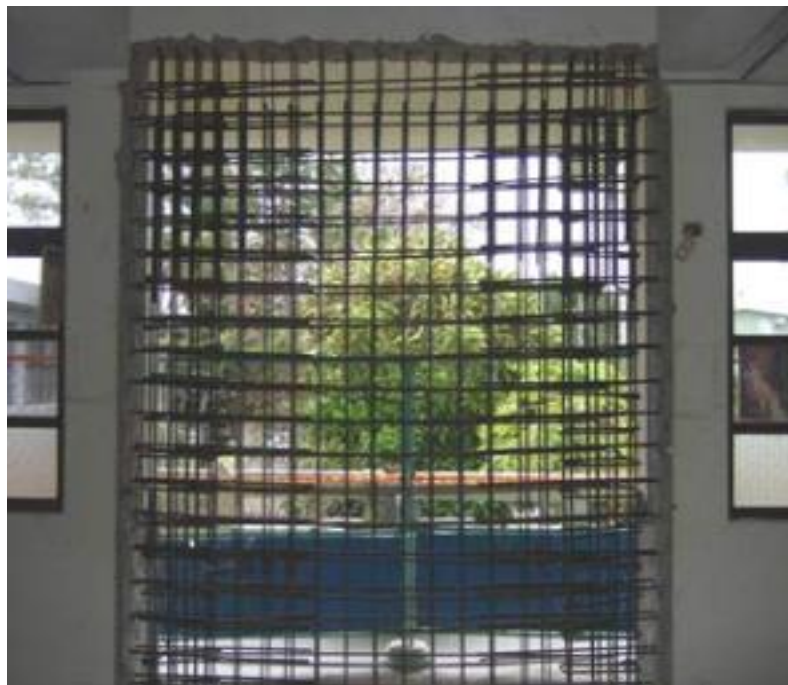
(a) Rebar assembly

(b) After completion

Figure 2.21. Practical application of the shear wall reinforcement method

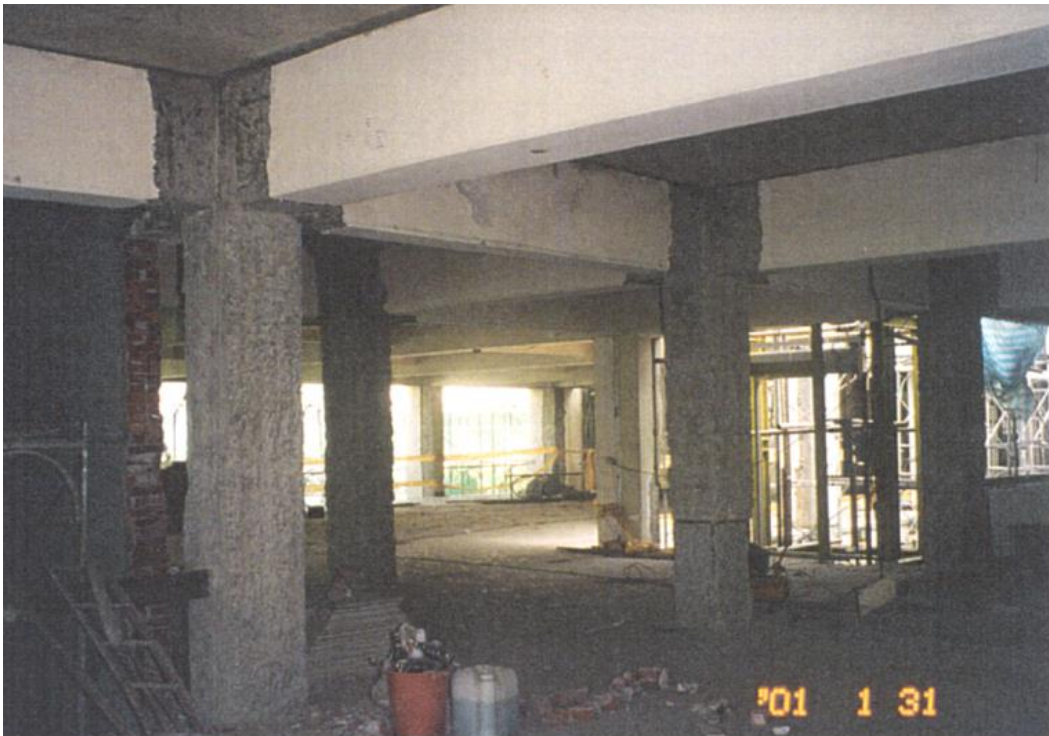
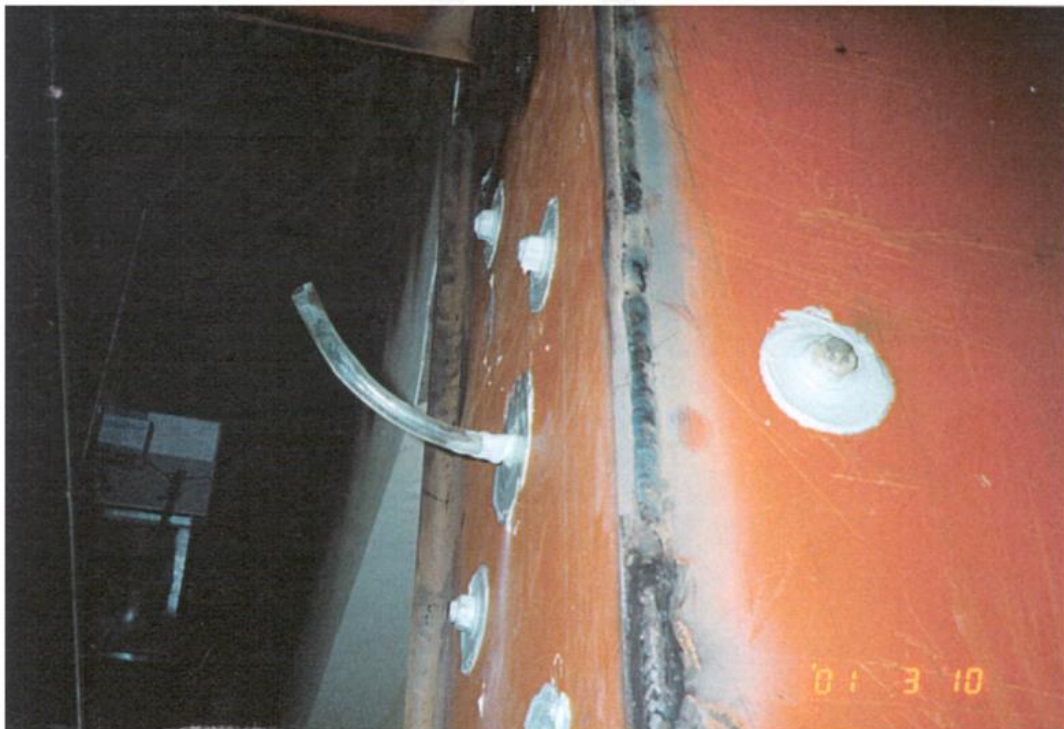
(a) Removing the paint layer

(b) Wrapping with steel sheet

Figure 2.23. Practical application of the composite column reinforcement method (Hsu et al., 2015)

The detailed design diagram of the composite column reinforcement method is shown in Figure 2.22, whereby steel sheet is used to wrap the original column body, and the steel sheet is tied with HILTI; while the interface of steel sheet and the original column body is bonded using epoxy resin. This one composite column reinforcement method can increase the axial force resistance, bending moment resistance, shear resistance of the column, and the toughness of overall structure. Figure 2.23 shows the practical application of the composite column reinforcement method.

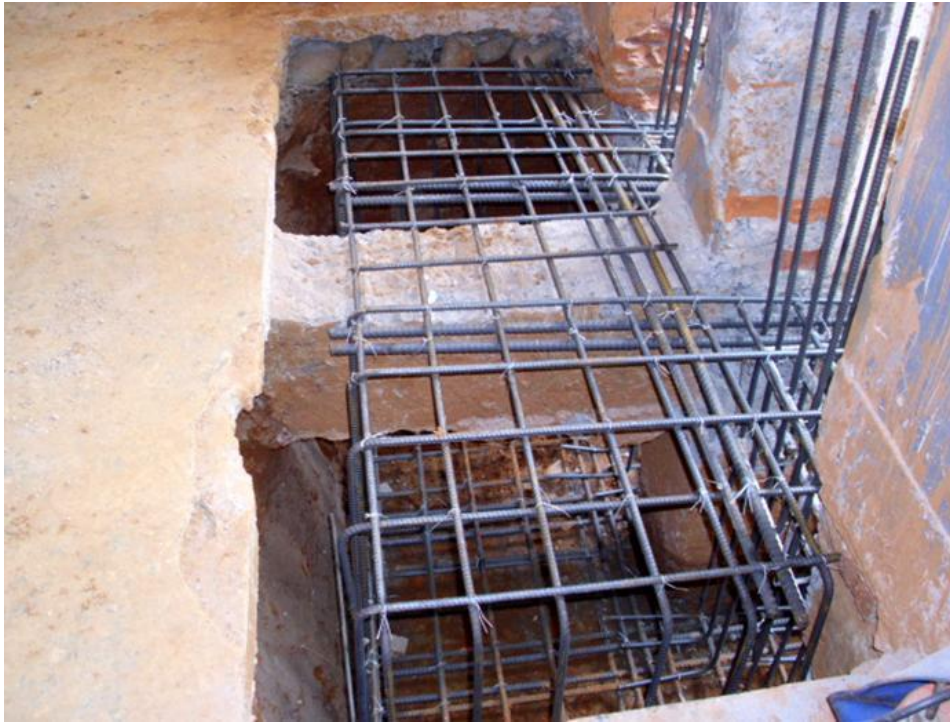
(a) Rebar arrangement drawing

(b) Rebar assembly

Figure 2.24. First method of column foundation reinforcement (Chen, 2015)

Figure 2.24 and Figure 2.25 show the column foundation reinforcement methods. From Figure 2.24, it is found that the technicians added one section of foundation reinforcement steel bars next to the original column and surrounding the original ground beam. From Figure 2.25, it is learnt that in addition to the addition of one section of the foundation reinforcement steel bars next to the original column and surrounding the ground beam, technicians implanted another section of foundation reinforcement steel bars into the original column and the original ground beam.

Finally, referring to all the methods for the reinforcement of school buildings, since the majority of the participating designers are experts in structural engineering, the foundation after reinforcement cannot effectively play its proper and correct function. Referring to Figures 2.24 to 2.26, the shortcomings of foundation reinforcement design include: (1) In the reinforcement of a column foundation, after the foundation steel bars cover one part of original ground beam, the proper and correct structural behavior of ground beams with a foundation has been destroyed; (2) After reinforcement, the column foundation with a larger area should be positioned beneath the original foundation with a smaller area, but the fact is the opposite, so the increment in bearing capacity of column foundation after reinforcement is not as anticipated; (3) Under the situation of reinforcement the foundation steel bars that cover the original ground beam, the original beam will block the reinforced foundation from sinking, thereby the reinforced foundation cannot exhibit the proper and correct bearing capacity, and the original ground beam may also be cleaved by the reinforced foundation with excessive applied force; (4) The dowel bar for a column foundation should be extended from the bending of a column's vertical steel bars into the foundation, so implanting horizontal steel bars to reinforce the foundation is not correct; (5) The dowel bar for shear wall foundations should be extended from the bending of continuous vertical steel bars in the walls of each floor into the foundation; extending from the bending of non-continuous vertical steel bars in the walls of each floor in fact cannot transmit the seismic force upwardly.
