THE MAJOR CAUSE OF EARTHQUAKE DISASTERS : SHEAR BANDINGS

**THE MAJOR CAUSE OF
EARTHQUAKE DISASTERS:
SHEAR BANDINGS**

Institute of Mitigation for Earthquake
Shear Banding Disasters

Capturing Shear Bandings

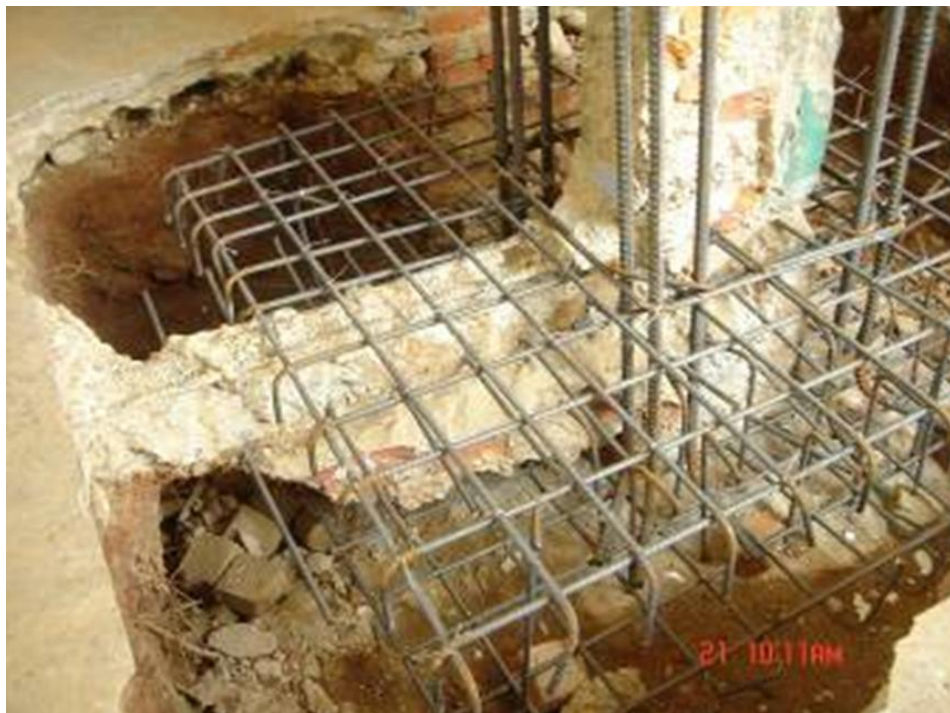
Figure 2.25. Second method of column foundation reinforcement (Chen, 2015)

Figure 2.24 and Figure 2.25 show the column foundation reinforcement methods. From Figure 2.24, it is found that the technicians added one section of foundation reinforcement steel bars next to the original column and surrounding the original ground beam. From Figure 2.25, it is learnt that in addition to the addition of one section of the foundation reinforcement steel bars next to the original column and surrounding the ground beam, technicians implanted another section of foundation reinforcement steel bars into the original column and the original ground beam.

Finally, referring to all the methods for the reinforcement of school buildings, since the majority of the participating designers are experts in structural engineering, the foundation after reinforcement cannot effectively play its proper and correct function. Referring to Figures 2.24 to 2.26, the shortcomings of foundation reinforcement design include: (1) In the reinforcement of a column foundation, after the foundation steel bars cover one part of original ground beam, the proper and correct structural behavior of ground beams with a foundation has been destroyed; (2) After reinforcement, the column foundation with a larger area should be positioned beneath the original foundation with a smaller area, but the fact is the opposite, so the increment in bearing capacity of column foundation after reinforcement is not as anticipated; (3) Under the situation of reinforcement the foundation steel bars that cover the original ground beam, the original beam will block the reinforced foundation from sinking, thereby the reinforced foundation cannot exhibit the proper and correct bearing capacity, and the original ground beam may also be cleaved by the reinforced foundation with excessive applied force; (4) The dowel bar for a column foundation should be extended from the bending of a column's vertical steel bars into the foundation, so implanting horizontal steel bars to reinforce the foundation is not correct; (5) The dowel bar for shear wall foundations should be extended from the bending of continuous vertical steel bars in the walls of each floor into the foundation; extending from the bending of non-continuous vertical steel bars in the walls of each floor in fact cannot transmit the seismic force upwardly.

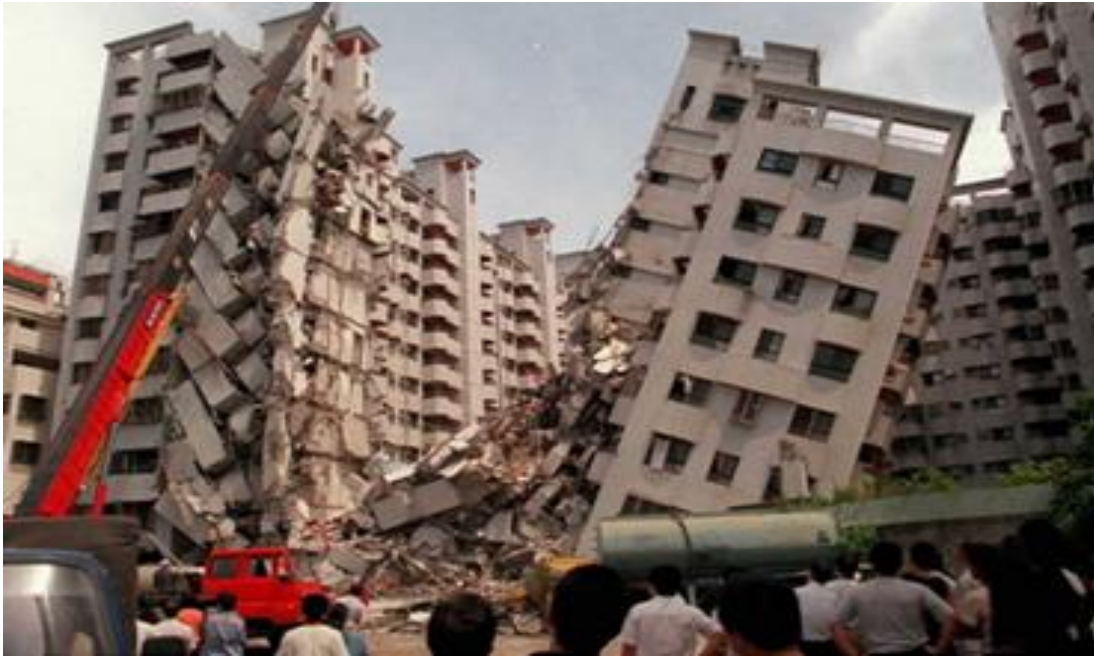
(a) Schematic diagram

(b) A real case

Figure 2.27. Building collapsed by shear banding

Impact of Shear Banding on Building Foundation. When tectonic plates are faulting, once the fault surface is extended towards the foundation soil, uplifting (or subsiding) phenomenon of the fault surface appears on one side of foundation relative to the other side of foundation, the original foundation with the same elevation will have the phenomenon of different elevations because of the presence of shear banding in the foundation soil. When parts of the foundation as well as its columns and beams above are being uplifted (or subsided), these uplifted (or subsided) foundations, columns, and beams will be subjected to excessively uneven stretches and distortional deformation, leading to fracture damage. This is the main cause of the collapse of a building during a tectonic earthquake (details in Figure 2.27).

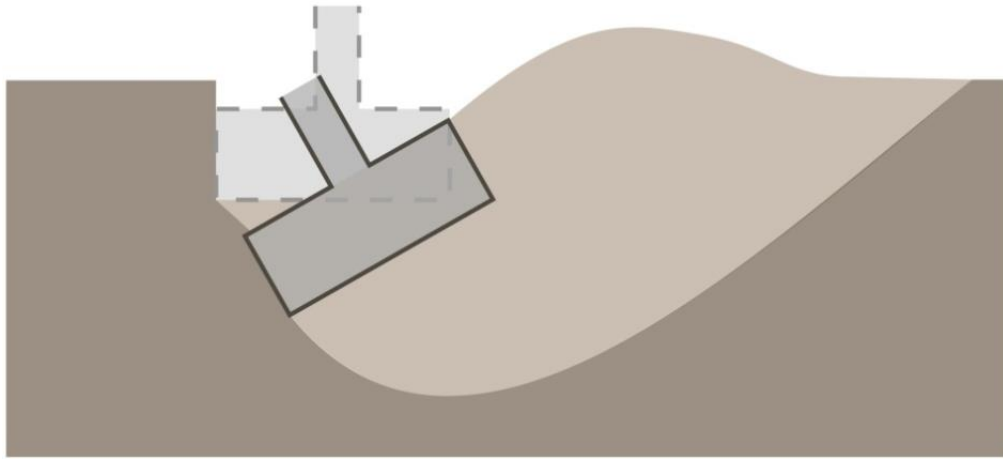
(a) general shear failure

(b) local shear failure

(c) punching shear failure

Figure 2.29. Different types of shear failure in foundation soils

rotate due to the seismic vibration, and the overall building will undergo shear failure of the foundation soil caused by the situation where the safety factor of seismic bearing capacity for foundation is less than 1.0 (details in Fig. 2.29), thereby vertical sinking, lateral movements, or rotations emerge in the bottoms of columns, and the building is therefore severely damaged by tilting (Fig. 2.30).

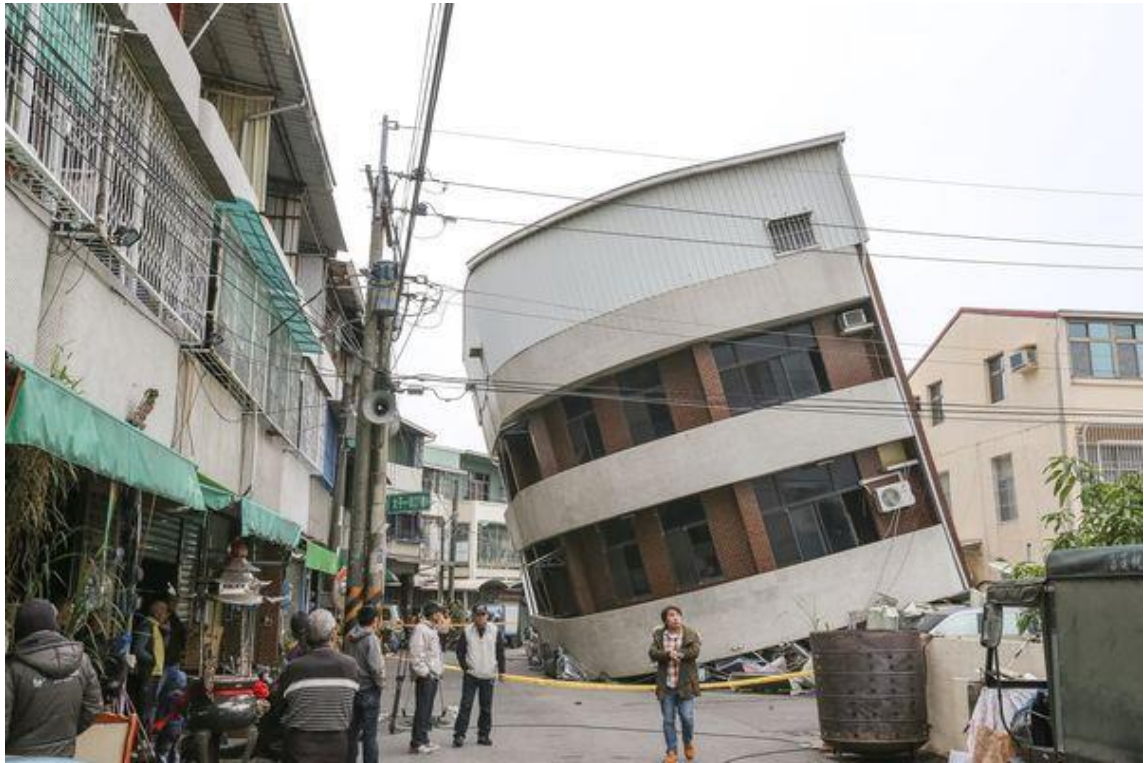
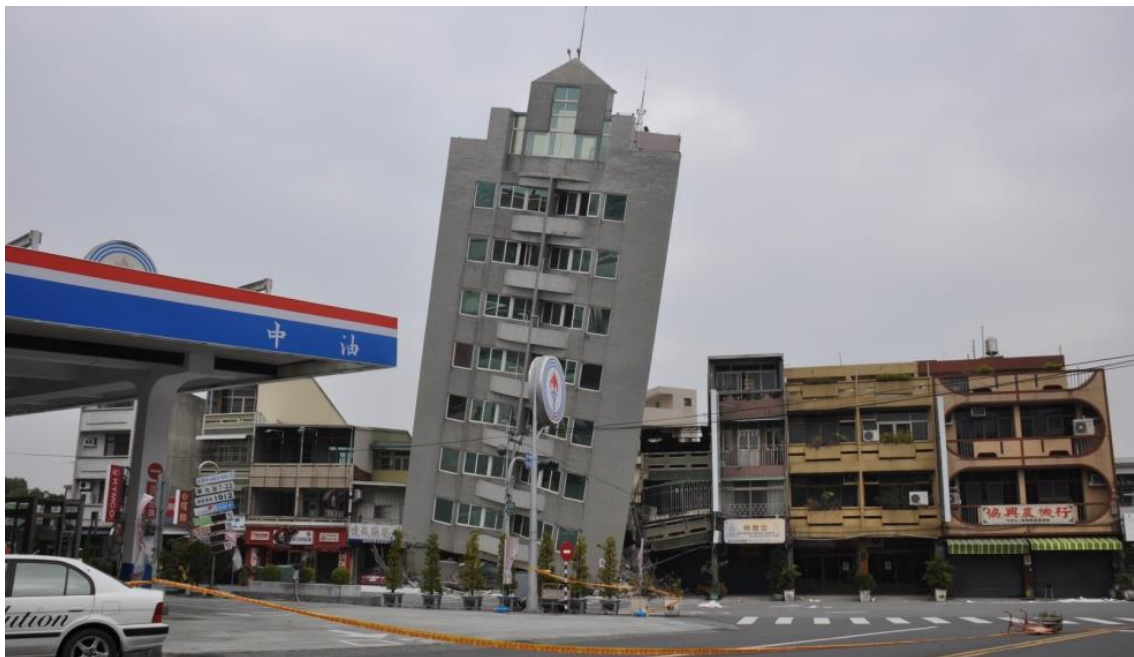
(a) Local tilting of a civil house (New Tang Dynasty, 2016)

(b) Local tilting of King's Town Bank

Figure 2.30. Buildings tilted by insufficient of bearing capacity of foundation during the 2016 Meinong earthquake

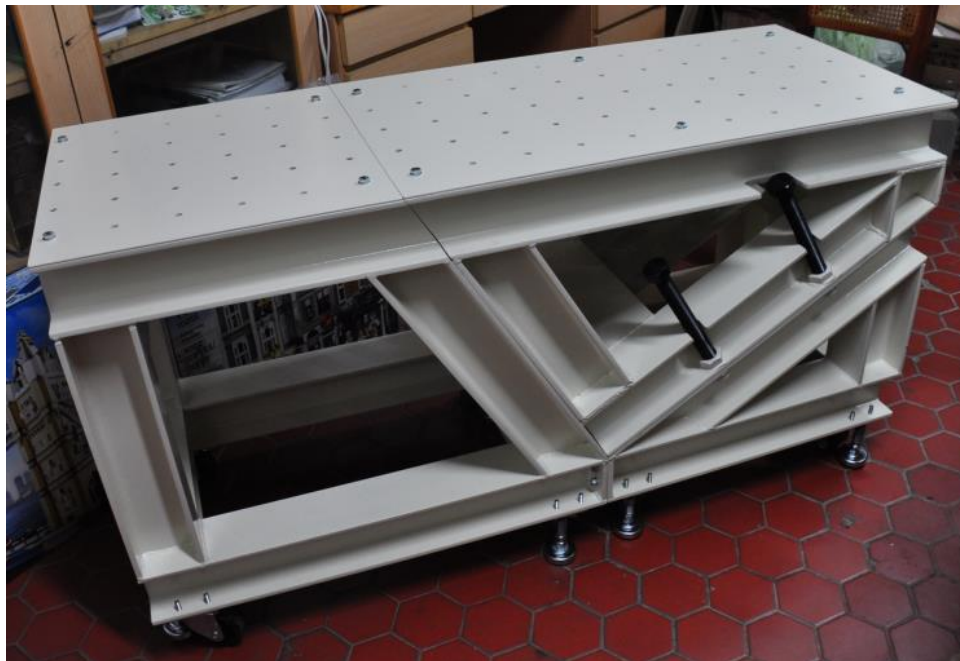
Figure 2.31. The first shear banding table available in the world

The shear banding table shown in Figure 2.31 can be used to execute the validation test under the shear banding effect.

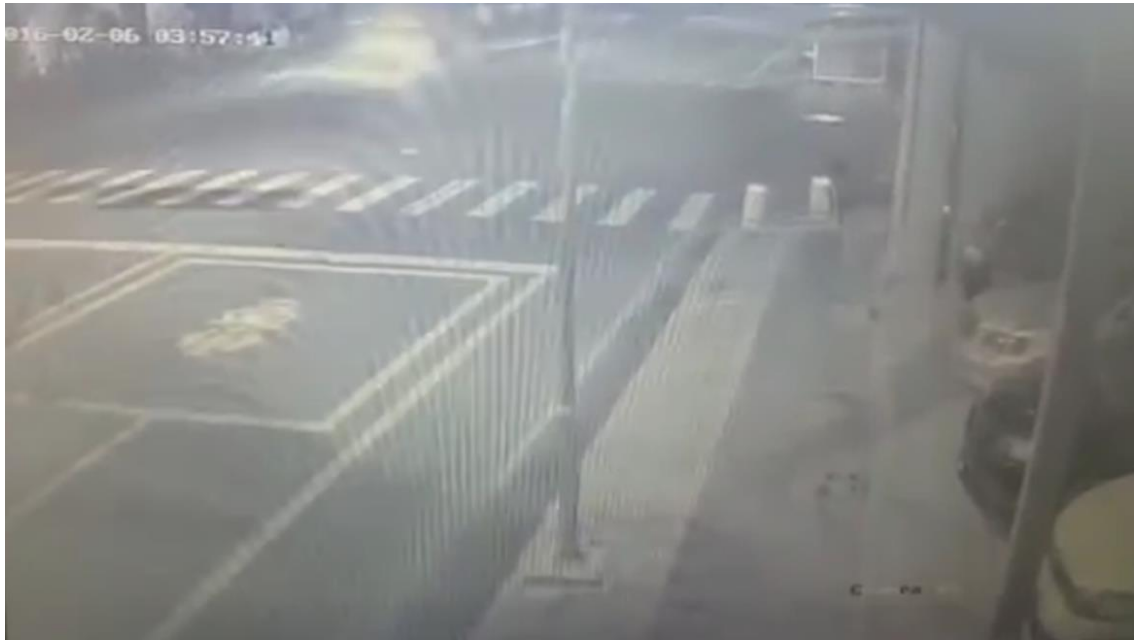
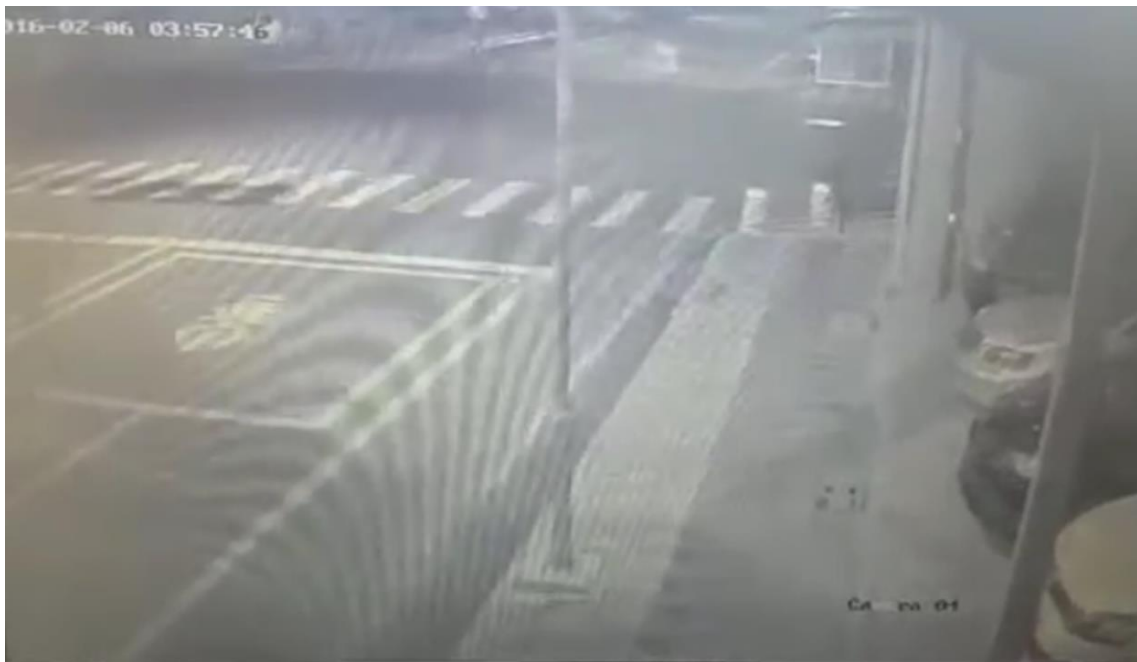
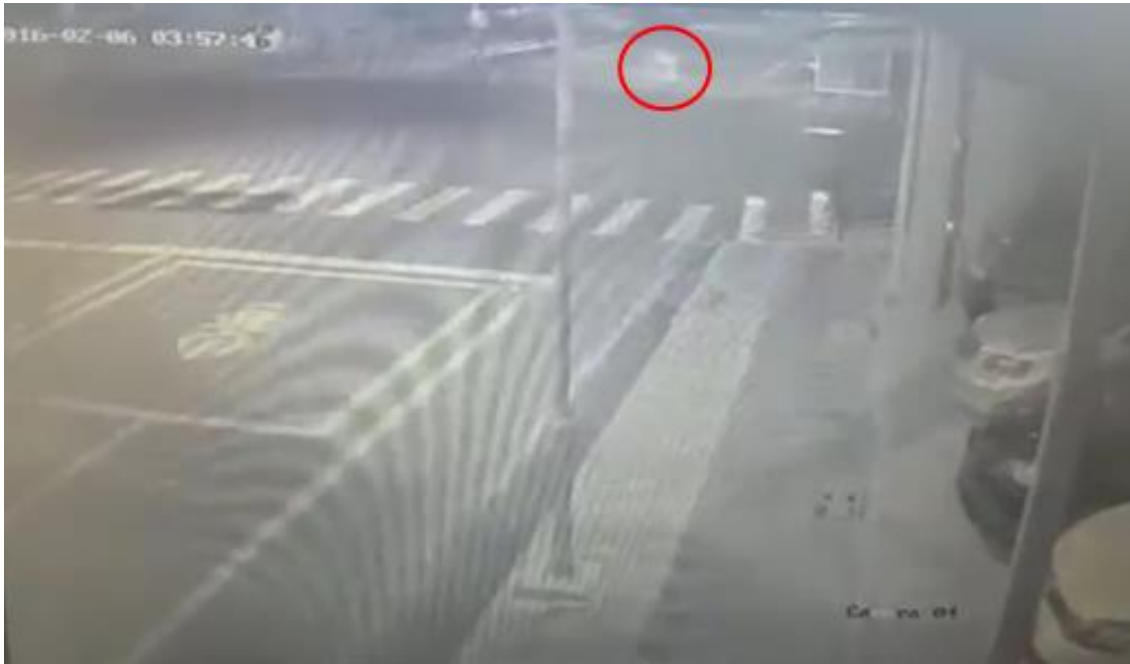
(a) Car passing by the Weiguan building before the pipe burst

(b) Before the collapse and damage of Weiguan building after the pipe burst

(c) Water-jetting position marked by red circle on the image

Figure 2.40 Water-jetting phenomenon after a pipe burst in tap water supply trunk pipe (Sanlih E-Television News, 2016),

Figure 2.40 shows the monitor record images of Weiguan building before and after the collapse and damage. Figure 2.40 proves that before the collapse of Weiguan building, a pipe burst phenomenon appeared in the tap water supply trunk pipe with a diameter of 2m embedded under the Yongda Road adjacent to the intersection of Yongda Road and Guoguang 5th Street, and water-jetting phenomenon existed due to the bursting of this tap water supply trunk pipe.

After the pipe burst phenomenon in the tap water supply trunk pipe occurred as shown in Figure 2.40b and Figure 2.40c, as there were 2m high earth fills above the tap water supply trunk pipe, a hole of 4m depth suddenly appeared on Yongda Road. Because of the sudden appearance of the 4m-deep hole, the constrained conditions of the side walls surrounding the basement of the Weiguan Building were therefore partially disappeared.

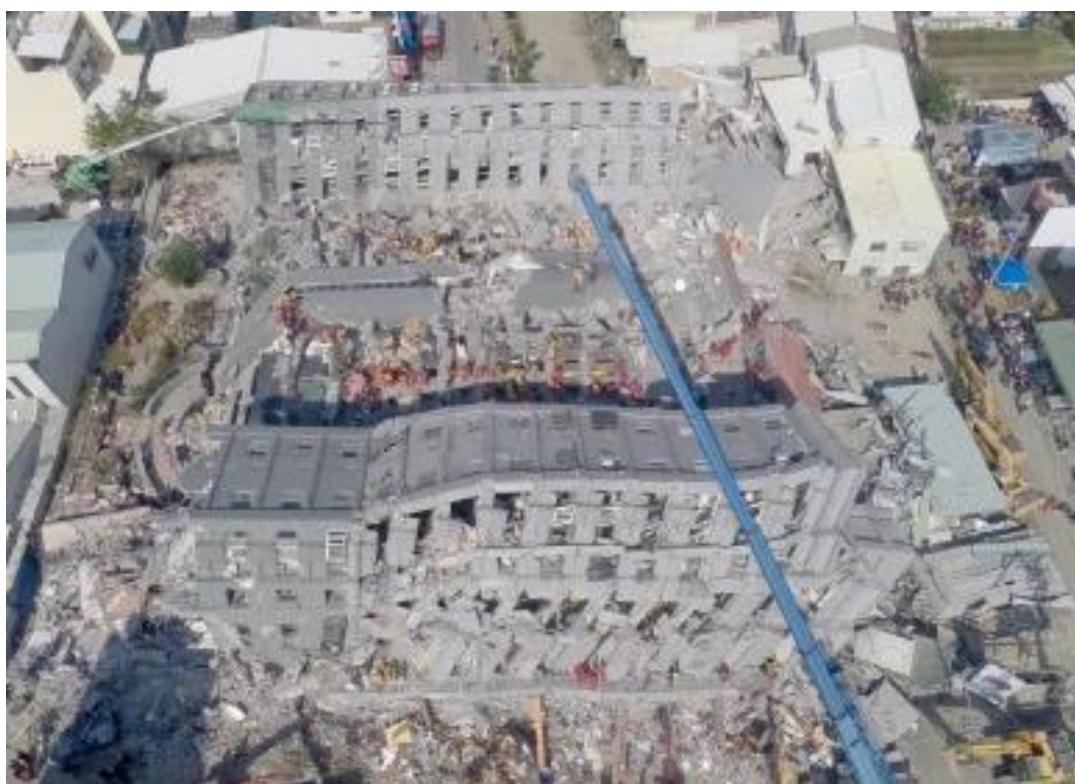
Figure 2.42 Weiguan building after the collapse (Liberty Times Net, 2016)

The fact that Block A and Block H subsided 2.5m below the ground surface as shown in Figure 2.41 proves that the pipe bursts in the tap water supply trunk pipe and the water-jetting phenomenon appearing after the pipe burst did indeed cause the local softening of silty alluvium layer near the gap after the pipe burst in the tap water supply trunk pipe. And the local softening phenomenon of this type of alluvial layer also caused the degree of distorted damage for the subsidence of Block A and Block H 2.5m below the ground surface after collapse to be more severe than the degree of distorted damage for the collapse of Block G and Block I (details in Figure 2.42).

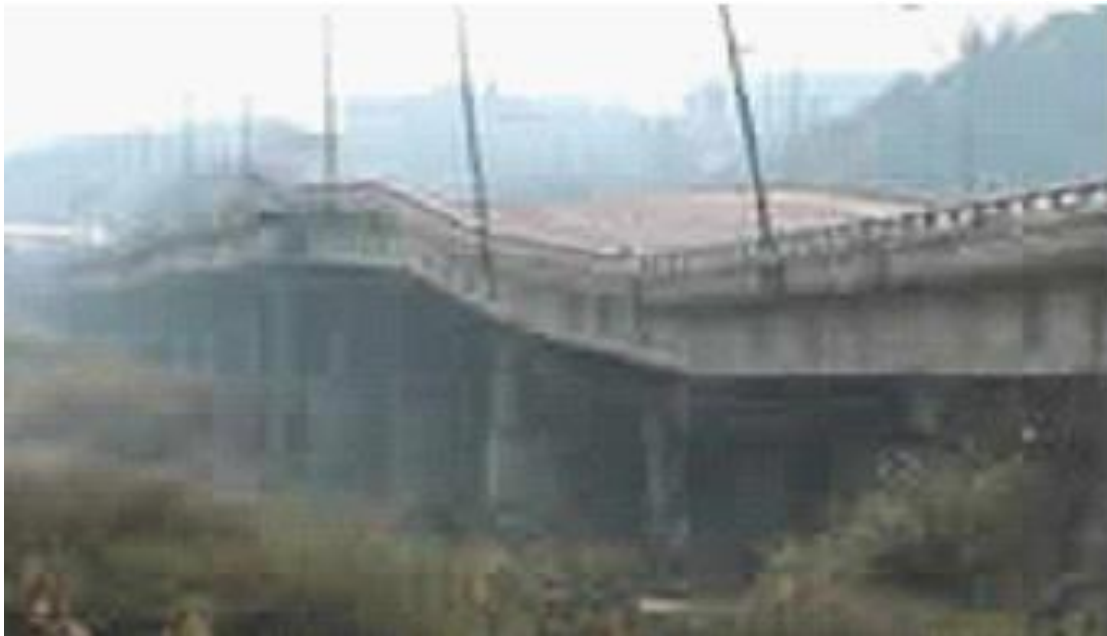
(a) Induced by shear banding table test

(b) Induced by the 921 Jiji tectonic earthquake (the Wu-shi Bridge)

Figure 2.47. Bridge tilted by shear bandings

6. Shaking table can conduct validation tests of seismic vibrations only, but the main cause for collapse (or damage) of buildings in tectonic earthquakes is shear bandings. Therefore, a shear banding table (details in Figures 2.47 and 2.48) and a large scale direct shear test equipment have been proposed to perform the validation tests for the chosen materials of ground modification, in order to ensure that the foundation can maintain stability in a design tectonic earthquake.

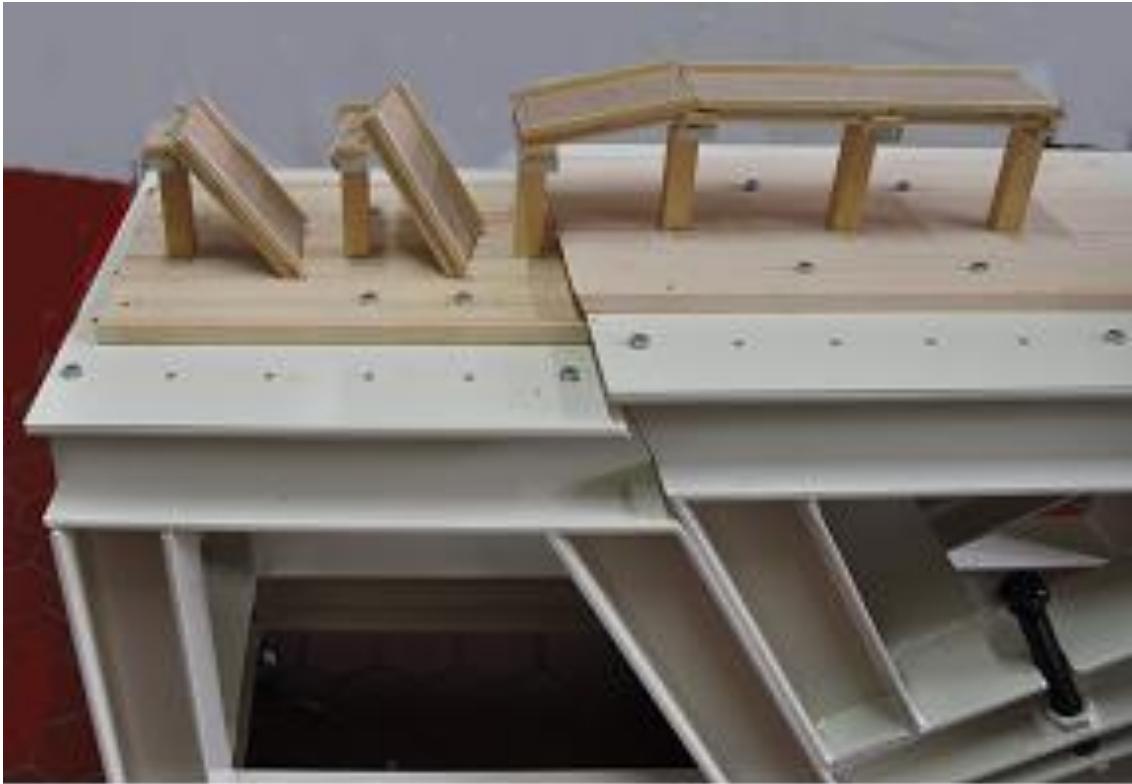
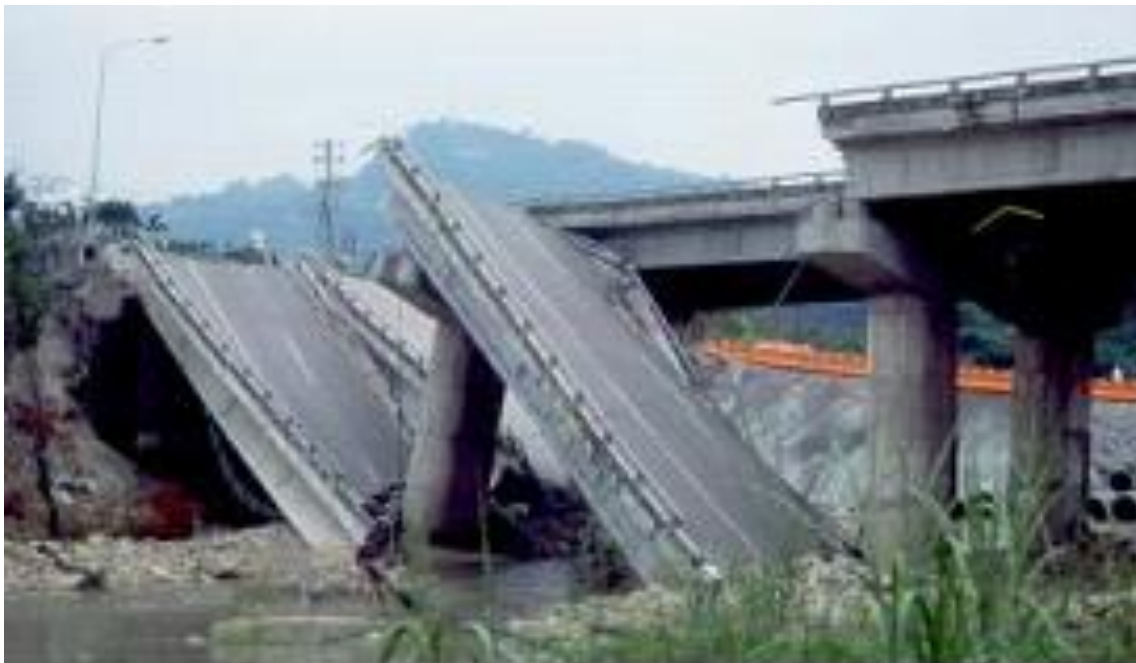
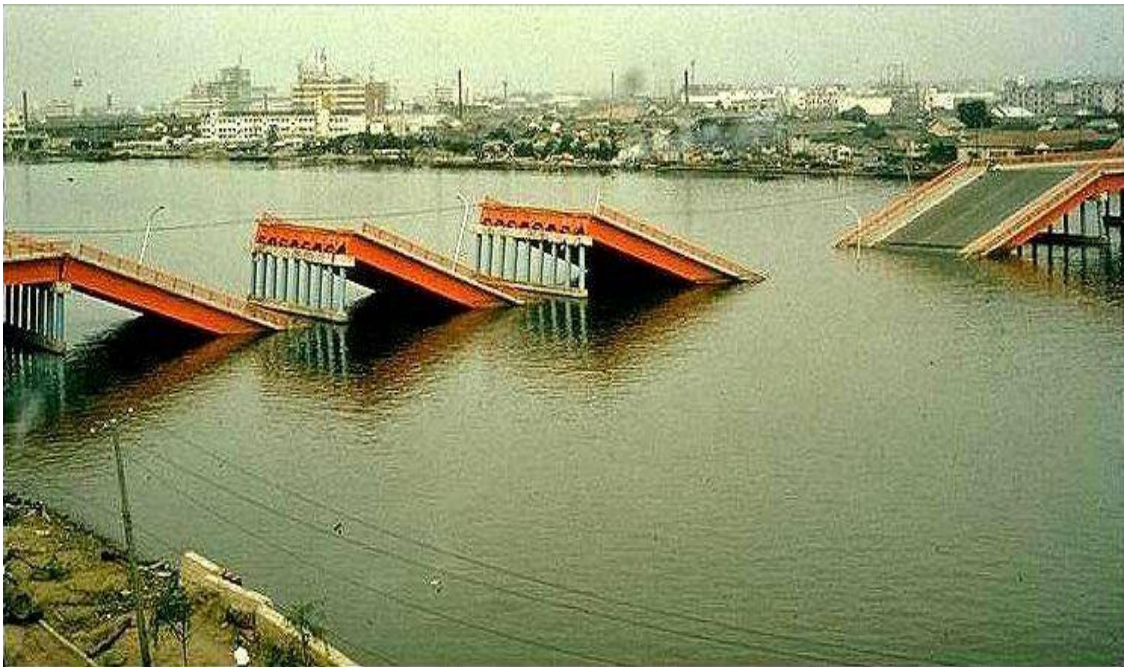
(a) Induced by shear banding table test

(b) Induced by the 921 Jiji earthquake (the Shih-wei Bridge, Taiwan)

(c) Induced by the 1964 Niigata tectonic earthquake
(the Showa bridge, Japan; Wikipedia, 2017)

Figure 2.48. Bridge collapsed by shear bandings

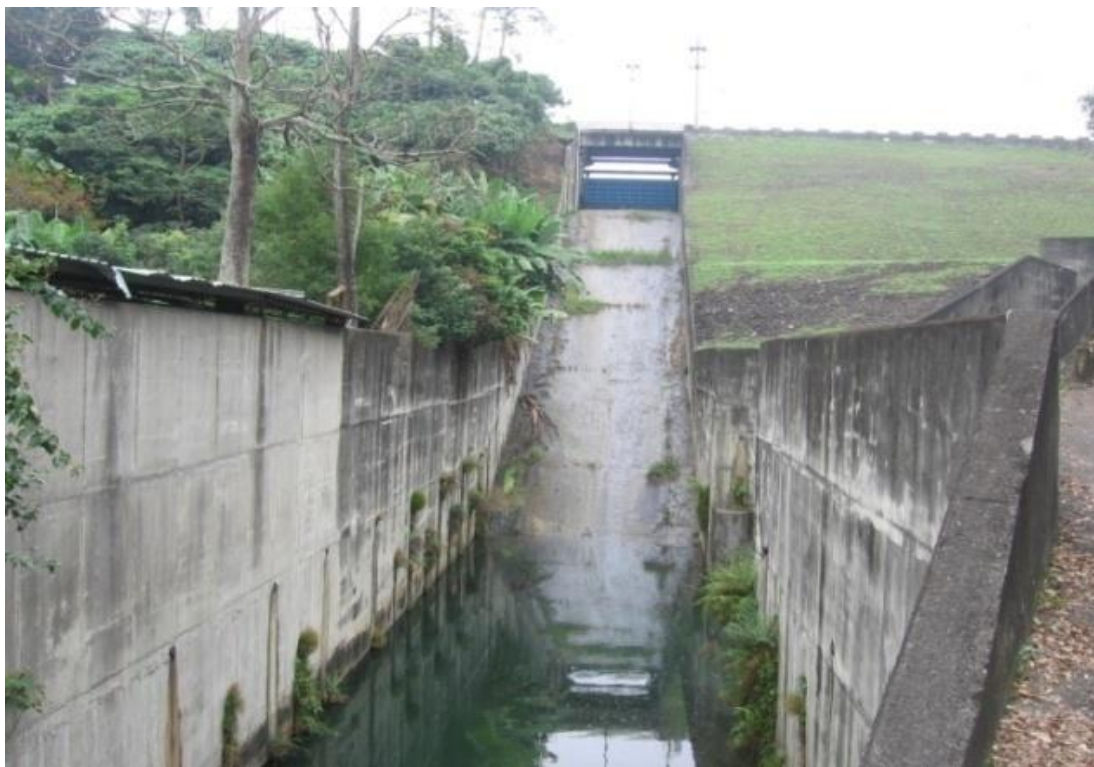
Figure 3.3 Local image of Renyitan Reservoir spillway

The construction of Renyitan Reservoir was completed in 1986, and the spillway on the ridge of the southwest side (Figure 3.1) is backfilled from the valley shown in Figure 3.2. The local image is shown in Figure 3.3.

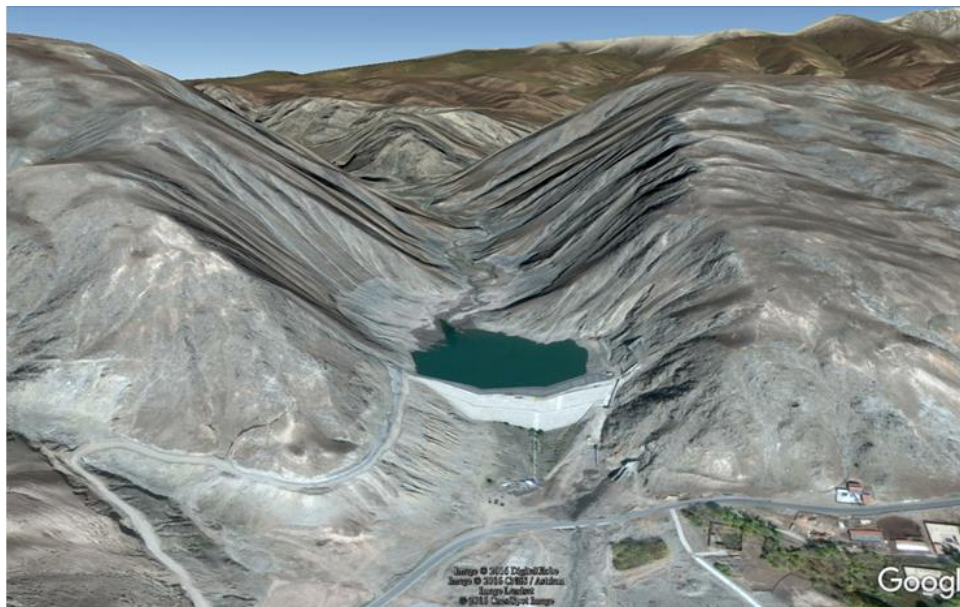
Figure 3.5 Mountains on both sides of Gouhou Dam of China's Qinghai Province (Google Earth, 2017)

Similar to shear banding in metal, river patterns and curved surfaces can be revealed by fractography. Similarly, for the shear banding of a tectonic plate, when shear banding (red line) appears at the appropriate depth of the tectonic plate (Figure 3.4), the river patterns (green and blue lines) and curved surfaces will also appear; these river patterns and curved surfaces create the ups and downs of the mountains as shown in Figure 3.5.

Figure 3.5 and Figure 3.6 show the Gouhou Dam in Qinghai Province of China after the reconstruction work had finished. The reason for reconstruction is the piping failure of the original dam (Figure 3.7).

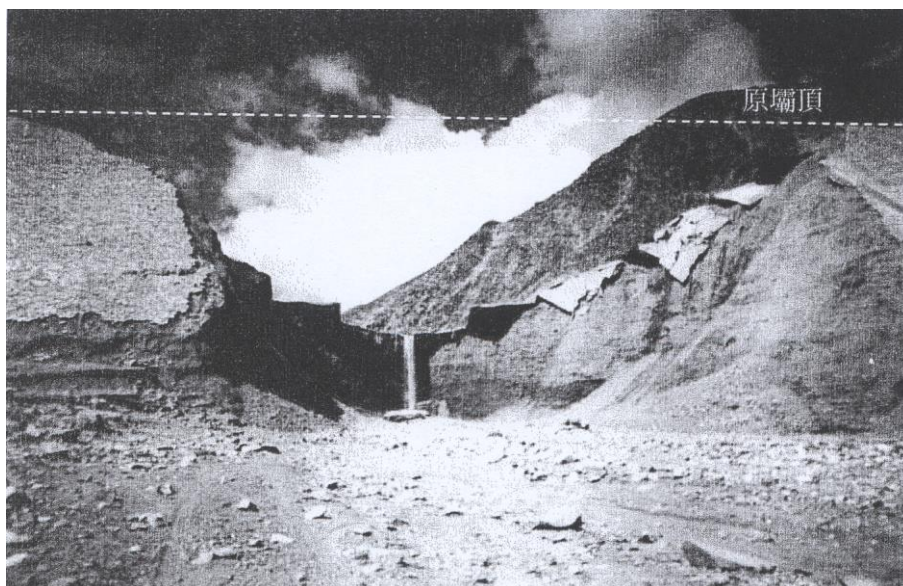
Figure 3.7 Gouhou Dam after dam break (Sinotech Foundation for Research and Development of Engineering Sciences and Technologies, 2008)

Take Gouhou Dam in Qinghai Province of China as an example, Figure 3.7 shows that the shear bands on the riverbank and in the valleys have obviously extended into the dam, thus leaving the remaining dam after piping failure with almost the same types of river patterns and curved surfaces as the old riverbank.

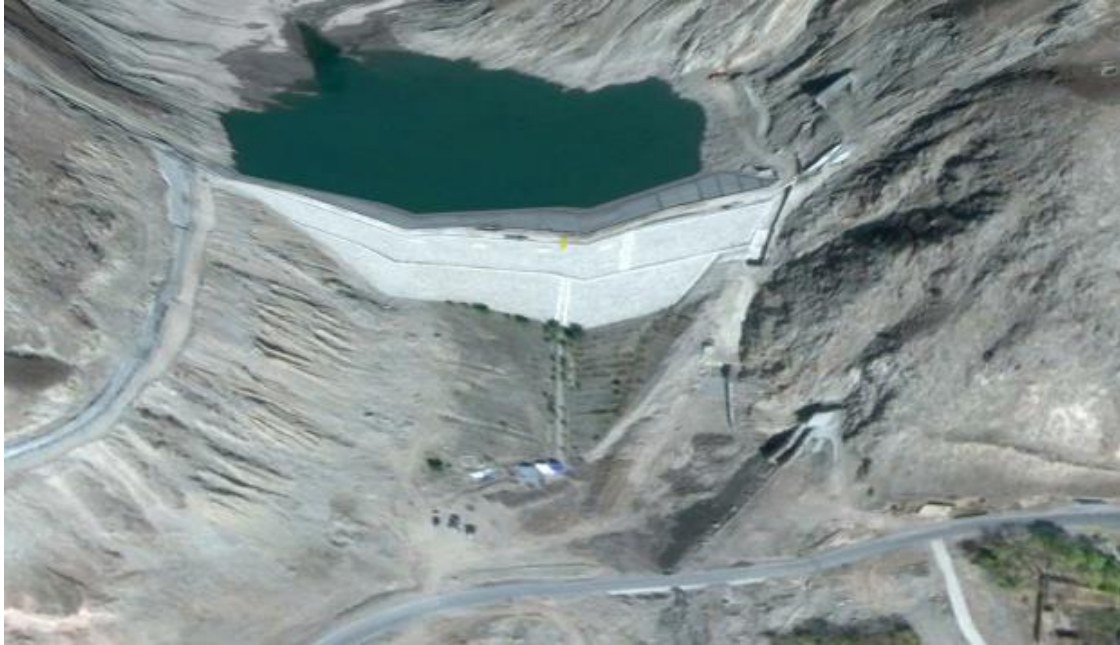
Figure 3.10 Water leakage in the downstream of Gouhou Dam
(Google Earth, 2017)

Although the investigation after the dam damage was very detailed, the reconstruction process was still lacking the concept of a shear band. Therefore even after the reconstruction the dam is still affected by shear banding, and the dam due to abnormal water leakage continues to maintain the wetting phenomenon as shown in Figure 3.10.

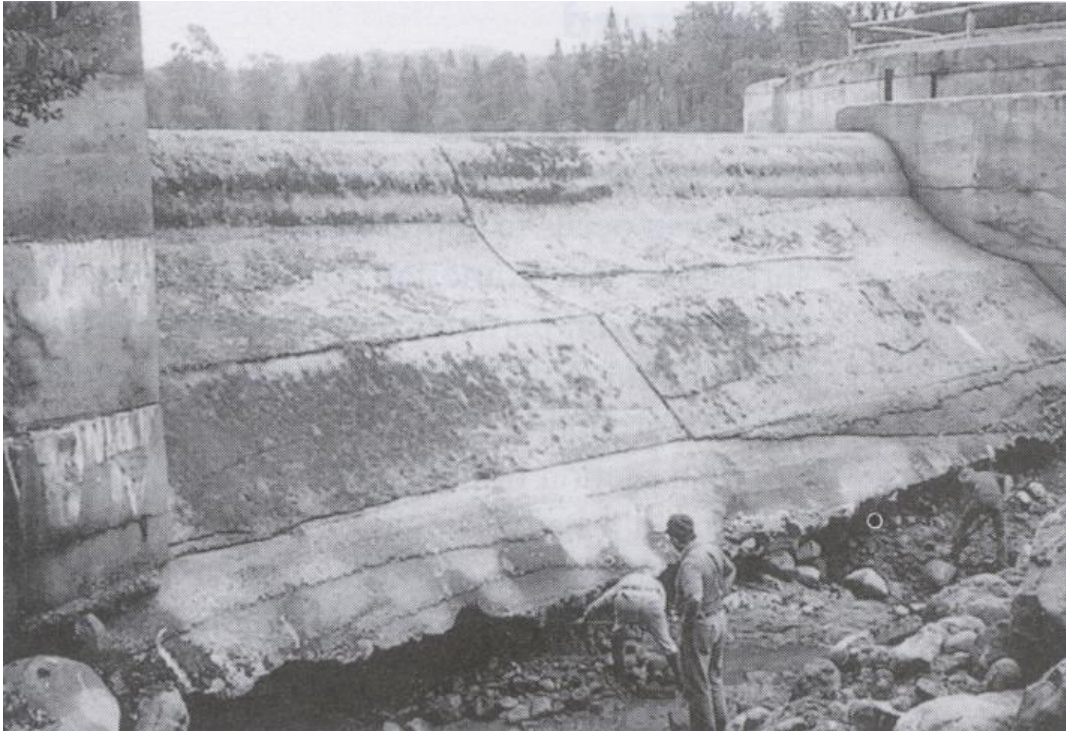
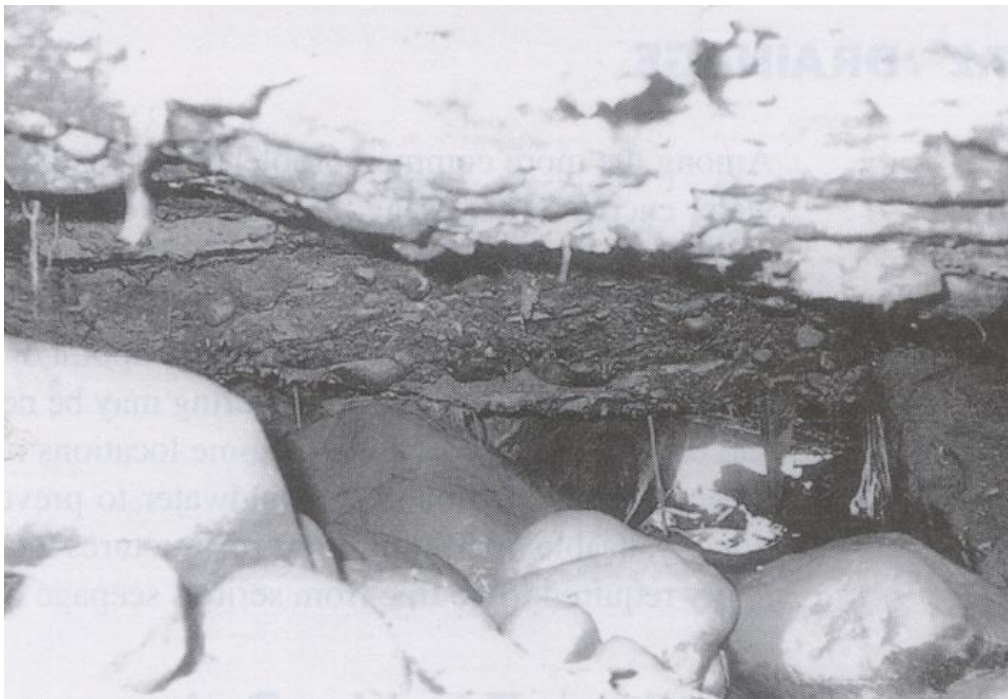
(a) The undermining phenomenon at the toe of a dam

(b) Pipe-shaped discharge tunnel formed under a dam

Figure 3.3. Piping failure for a concrete gravity dam (McCarthy, 2007)

By using flow nets, the hydraulic gradient i for a certain critical point at the toe of a dam where seepage water exits can be determined. If the hydraulic gradient i is equal to or greater than the critical one i_c , soil particles will be lost after the float, and then cause piping failure as shown in Figure 3.3.

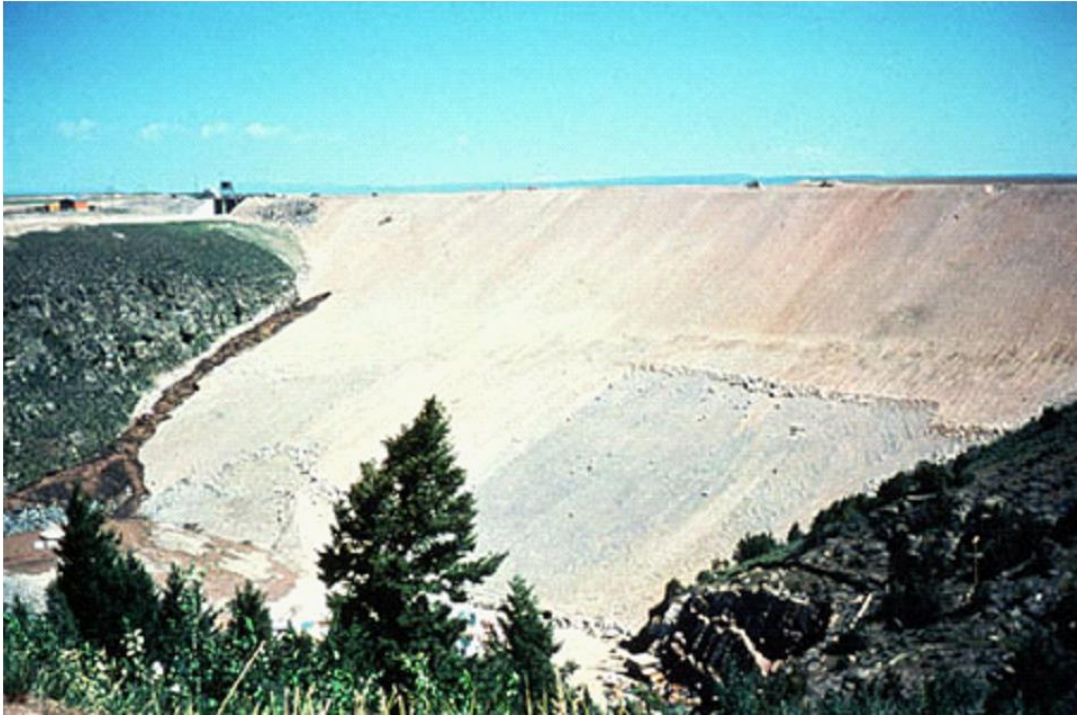
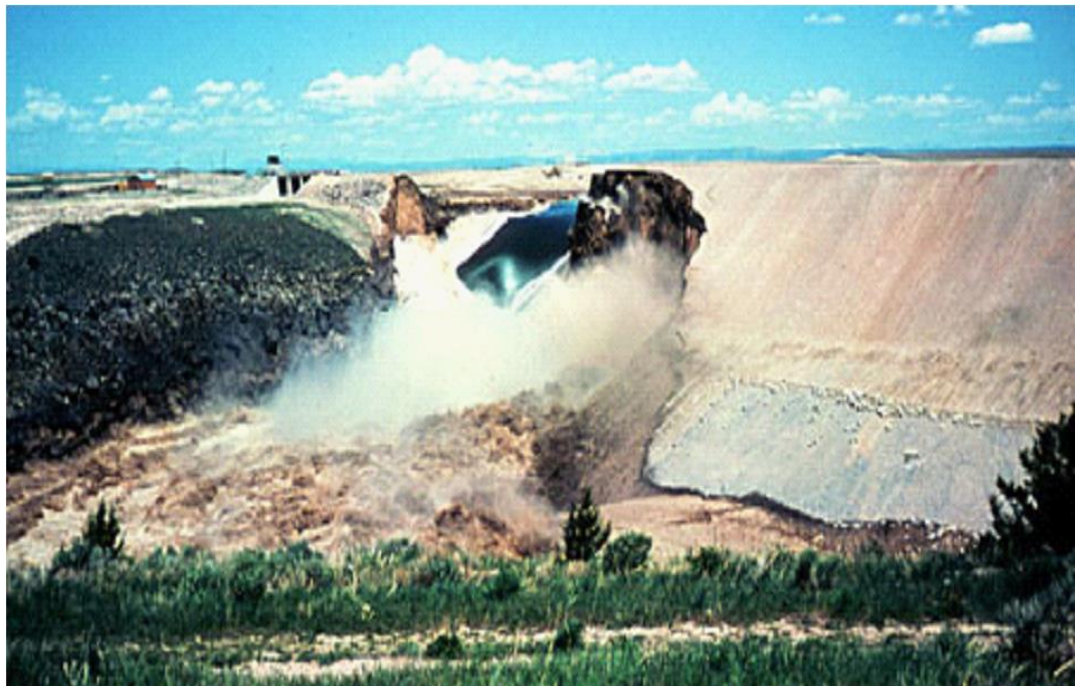
(a) Continuous leaking

(b) Dam body soils were carried away by the torrent

Figure 3.5. Piping failure of Teton Dam (Wikipedia, 2016)

Disaster History. The Summary of the US Teton Dam Disaster (Sinotech Foundation for Research and Development of Engineering Sciences and Technologies, 2008) recorded that there had been no signs of water leakage on the dam before June 3rd, 1976, but on June 3rd, two leaking spots were found in the anti-seepage core at the right side slope of the dam body on the right bank of spillway outlet (See Figure 3.33). On June 4, another leakage was found in the drainage layer at the intersection of the middle portion of downstream slope of the dam body and the right bank of the valley. After that on the morning of 5 June, it was found that the leakage in the drainage layer had developed to piping (See Figure 3.33), and quickly expanded upwards in the event of a deteriorating situation, leading to burst damage (see Figure 3.5).

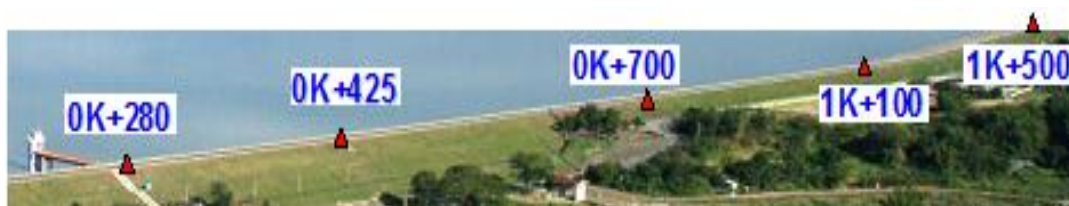
Figure 3.10 Sectional view of the five monitoring wells of A-kung-tien Reservoir (Southern District Water Resources Bureau, 2016)

Figure 3.10 shows the layout of the five monitoring wells. Taking the 0k + 280 section as an example, Figure 3.11 shows that by monitoring the total water head distribution map, it can be estimated that the flow path of the leakage is the reservoir water flowing along the bottom of the silt layer and the sand layer to the leakage exit.

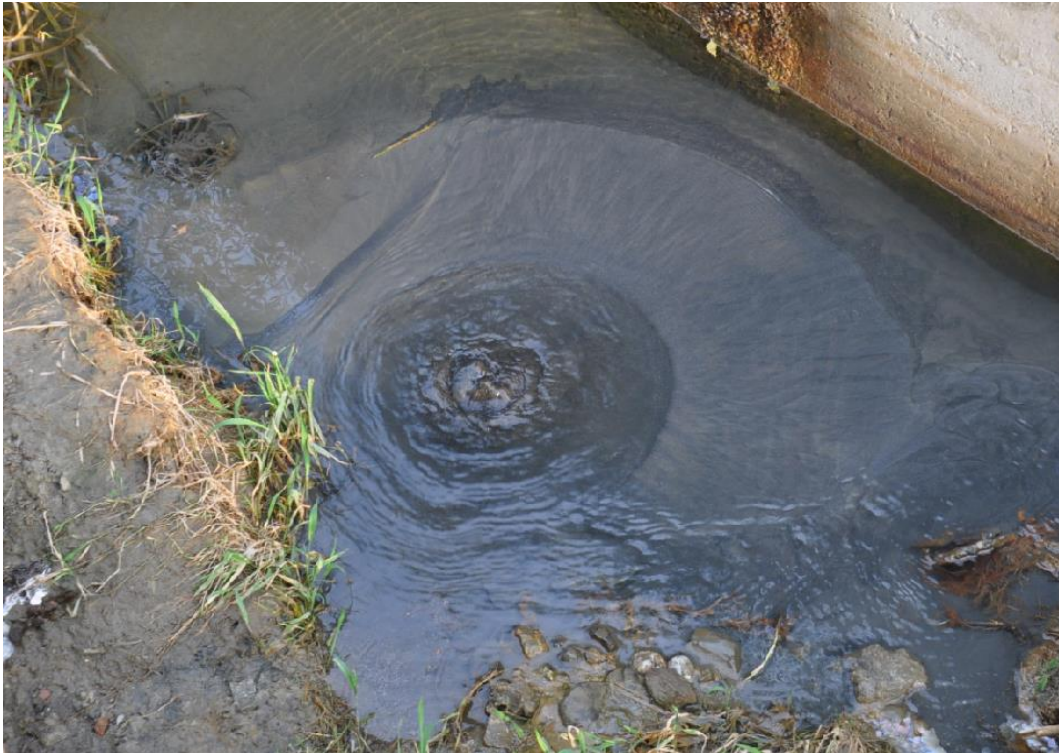
Figure 3.14 Water leakage in the downstream slope of A-kung-tien Reservoir

3. For the water leakage phenomenon shown in Figure 3.16, it is estimated that the diameter of the pipe-shaped discharge tunnel corresponding to the leakage path exit is 1 cm, the water output per second is 1 cm^3 , and the average flow rate in the pipe-shaped discharge tunnel is 1.273 cm/sec. In general, the permeability coefficient of sandy soils is from 1.0×10^{-1} to 1.0×10^{-4} cm/sec. If the maximum hydraulic gradient obtained in the early safety assessment of A-kung-tien Reservoir – 0.07 is true, then the average velocity of the flowing water in the pipe-shaped discharge tunnel is only 7×10^{-3} - 7×10^{-6} cm/sec in this case. At such a low speed, the silt or sand will not be brought out of the water, however Figure 3.14 clearly shows that the gray-black silt and sand continue to be brought out of the water. Therefore, the assessment results based on the seepage theory do not match the real situation; therefore it is necessary to further evaluate the local leakage of the downstream slope of the dam by adopting a method in line with the actual situation.

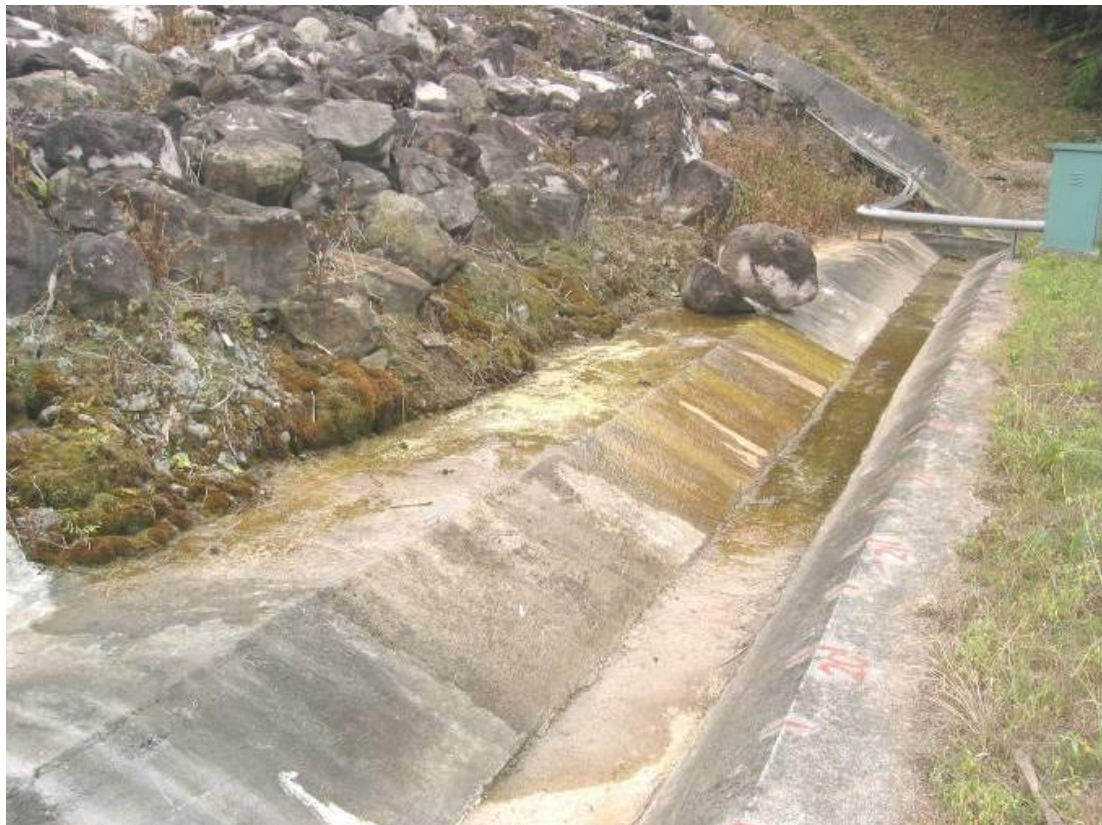
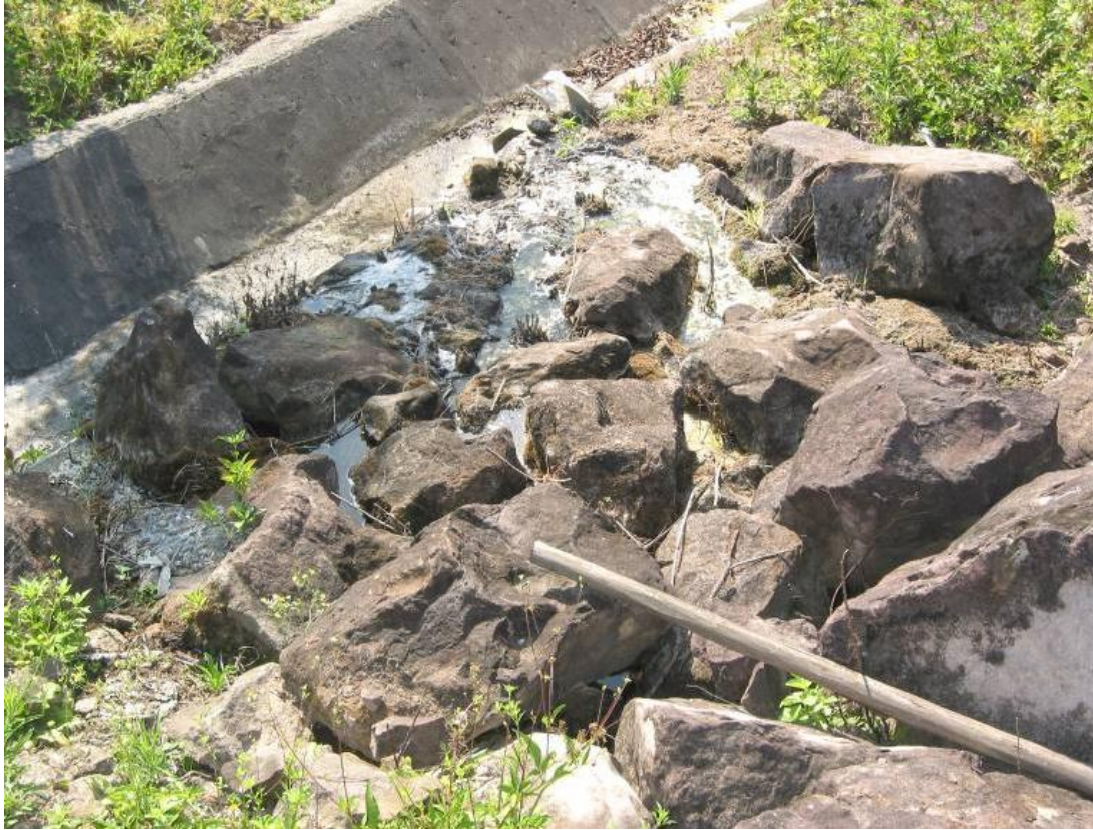
Figure 3.23 Leakage path exits of downstream slope of Hsin-shan Reservoir (Lin, et al., 2010)

(a) Location of local leakage path exits

(b) Local leakage conditions I

(c) Local leakage conditions II

However, after the completion of the reservoir heightening project, seven leakage paths appeared in the downstream slope of the dam (Figure 3.23).
