THE MAJOR CAUSE OF EARTHQUAKE DISASTERS : SHEAR BANDINGS

**THE MAJOR CAUSE OF
EARTHQUAKE DISASTERS:
SHEAR BANDINGS**

Institute of Mitigation for Earthquake
Shear Banding Disasters

Capturing Shear Bandings

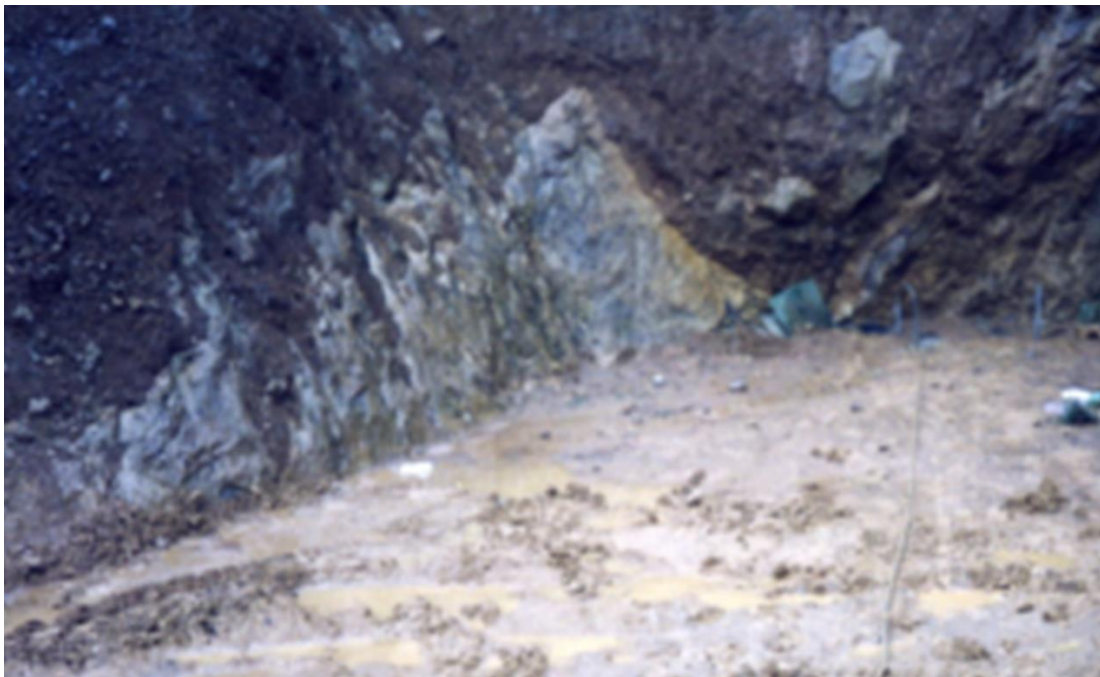
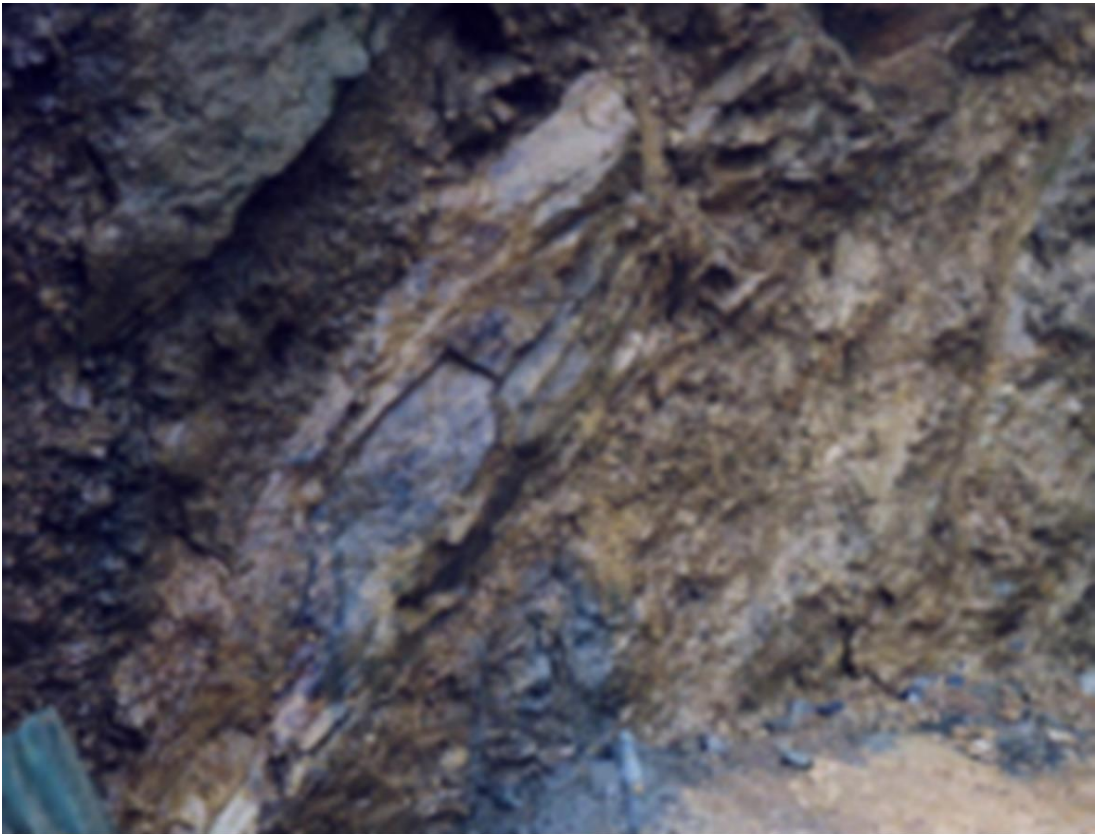
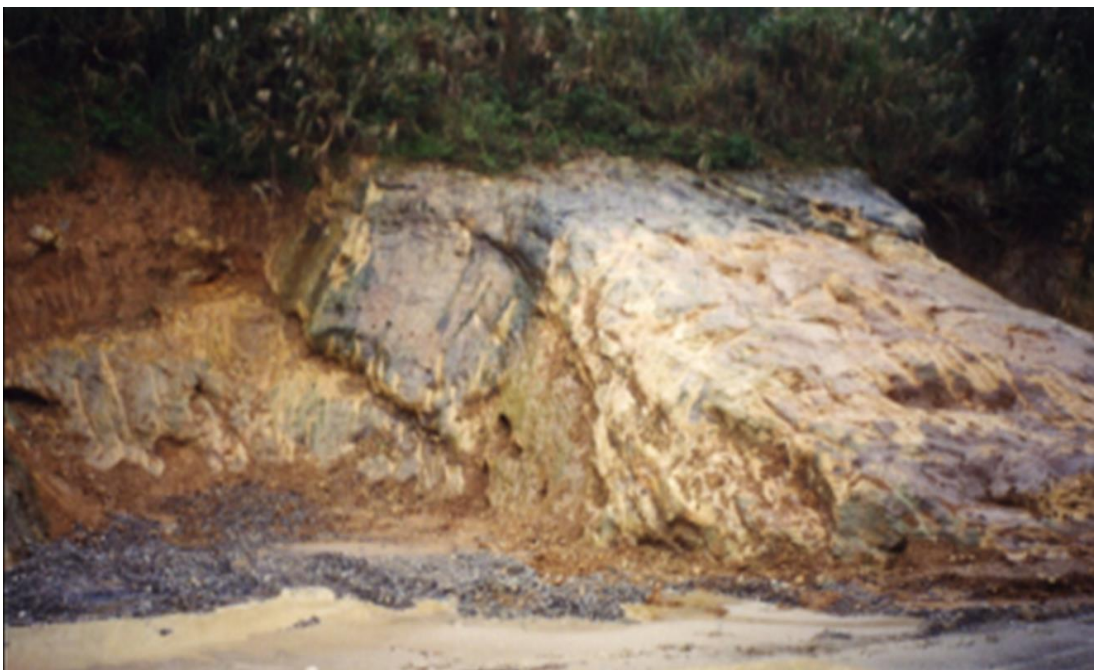
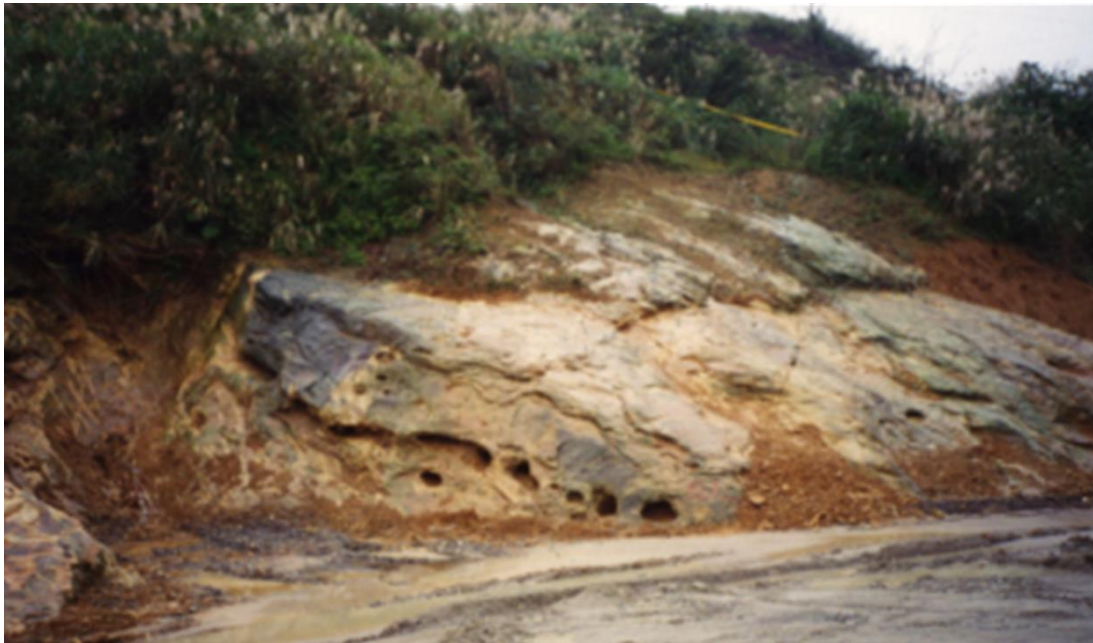
Figure 3.30. River patterns and curved surfaces on the old riverbank of Hsin-shan Reservoir

(a) View number 1

(b) View number 2

(c) View number 3

(d) View number 4

For Hsin-shan Reservoir, the above river patterns and curved surfaces exist on the left and right sides of the dam (see Figure 3.30). These river patterns and curved surfaces will continue to develop in the tectonic plate dislocation, and further extend into the dam body, therefore potential piping failure of the dam continues to increase.

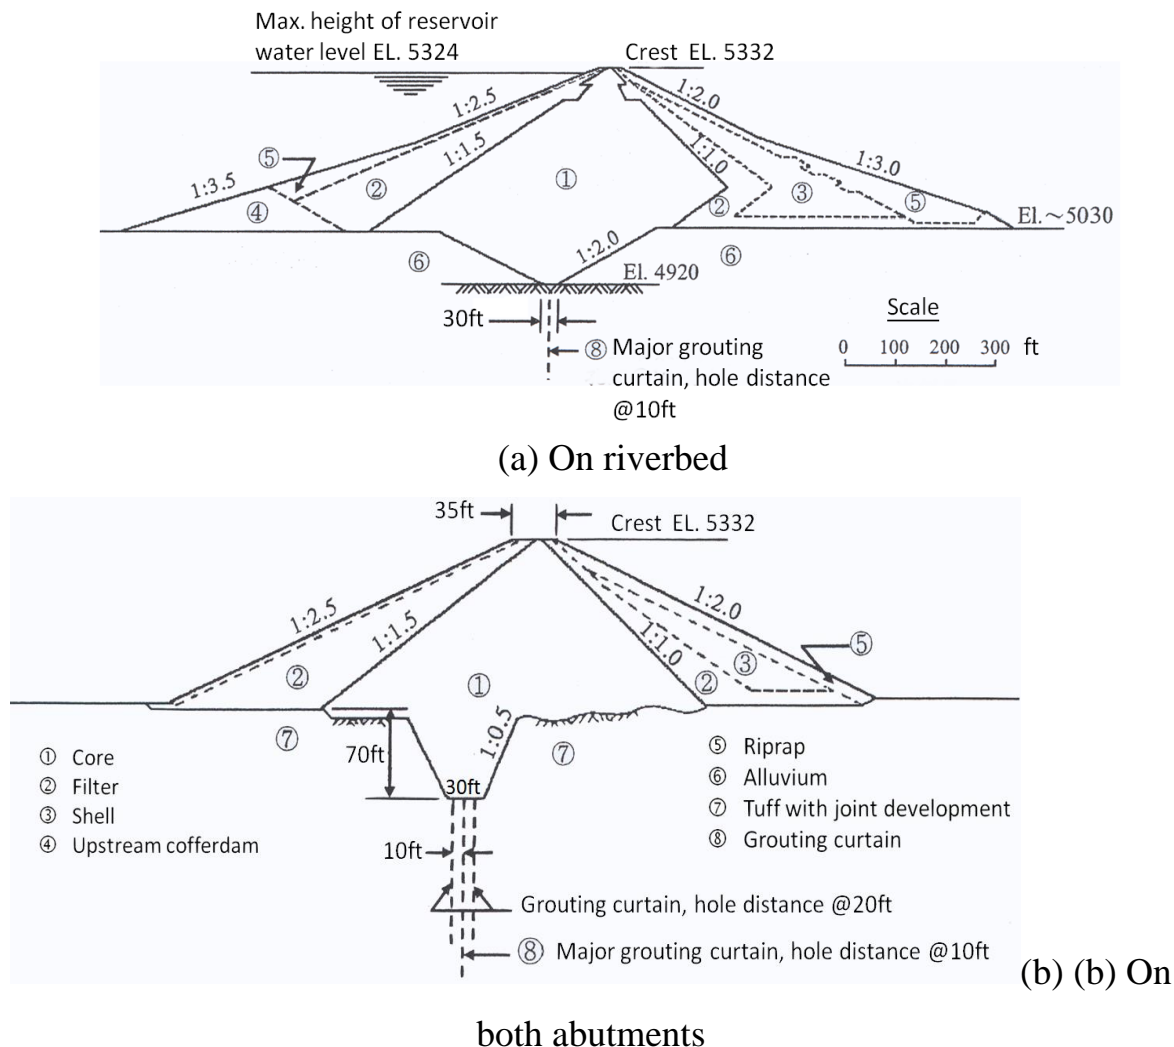
Figure 3.31. Cross section of Teton Dam (Sinotech Foundation for Research and Development of Engineering Sciences and Technologies, 2008)

Basic Information of Teton Dam. Teton Dam is located in Idaho, United States. Figure 3.31 shows that the bottom width of the dam is 149.35m, the top width is 701.04m, the maximum dam height is 125.6m, and the storage capacity is 355412250m^3 (Sinotech Foundation for Research and Development of Engineering Sciences and Technologies, 2008). The cross section of Teton Dam shown in Figure 3.31 contains: ① anti-seepage core, ② drainage zone, ③ miscellaneous fill zone (located at downstream of zone ②), ④ water retaining dam in the upstream during construction, ⑤ protective layer made of boulder.

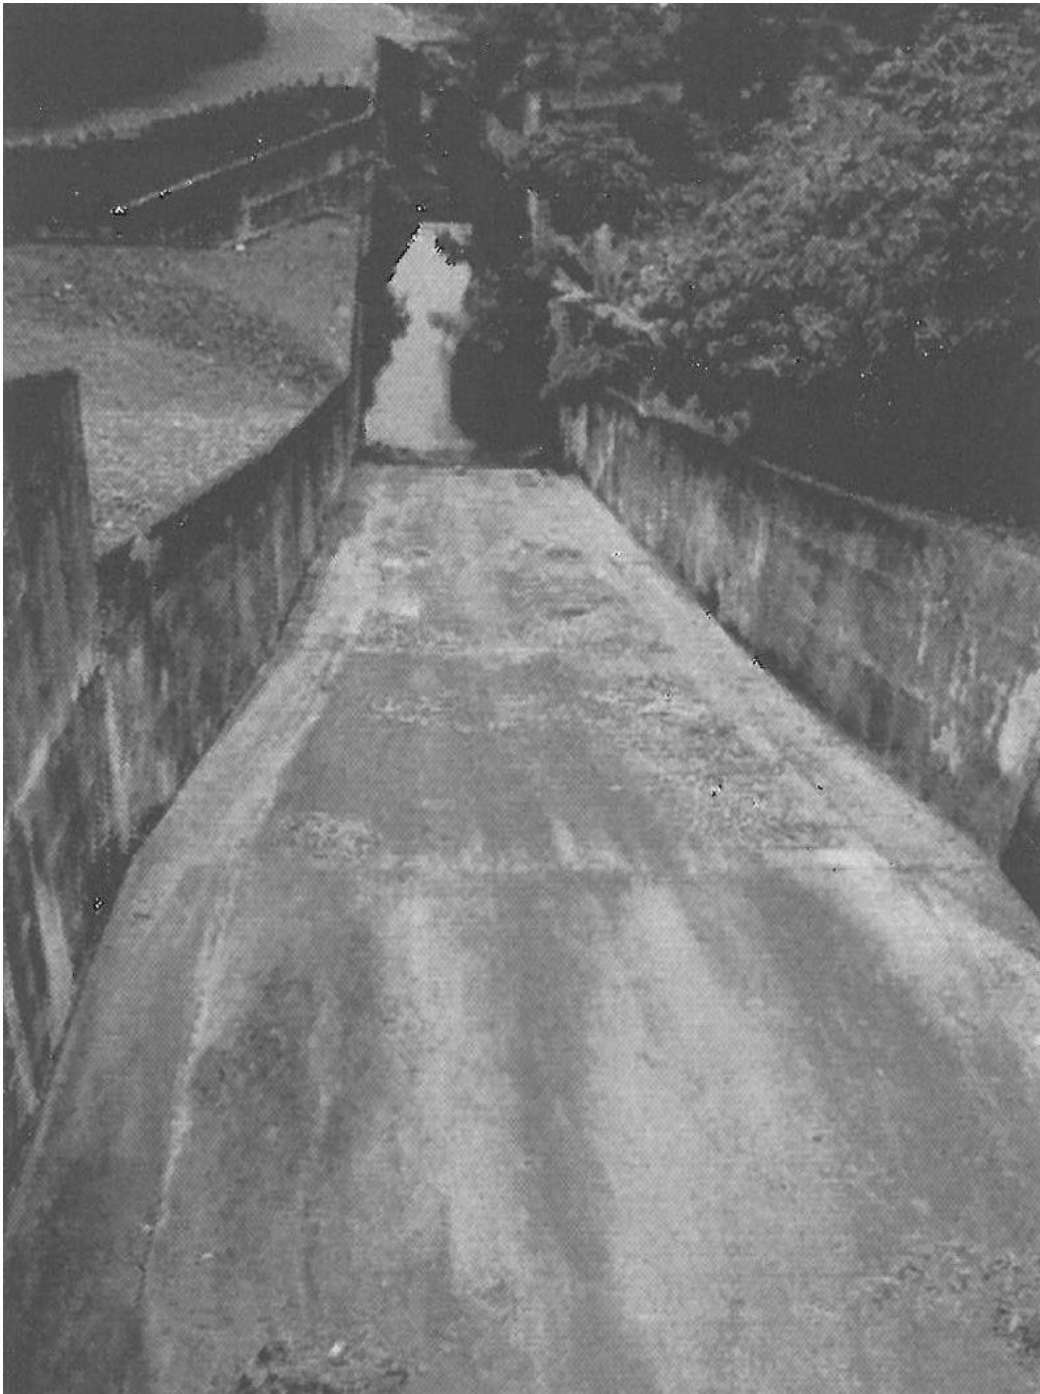
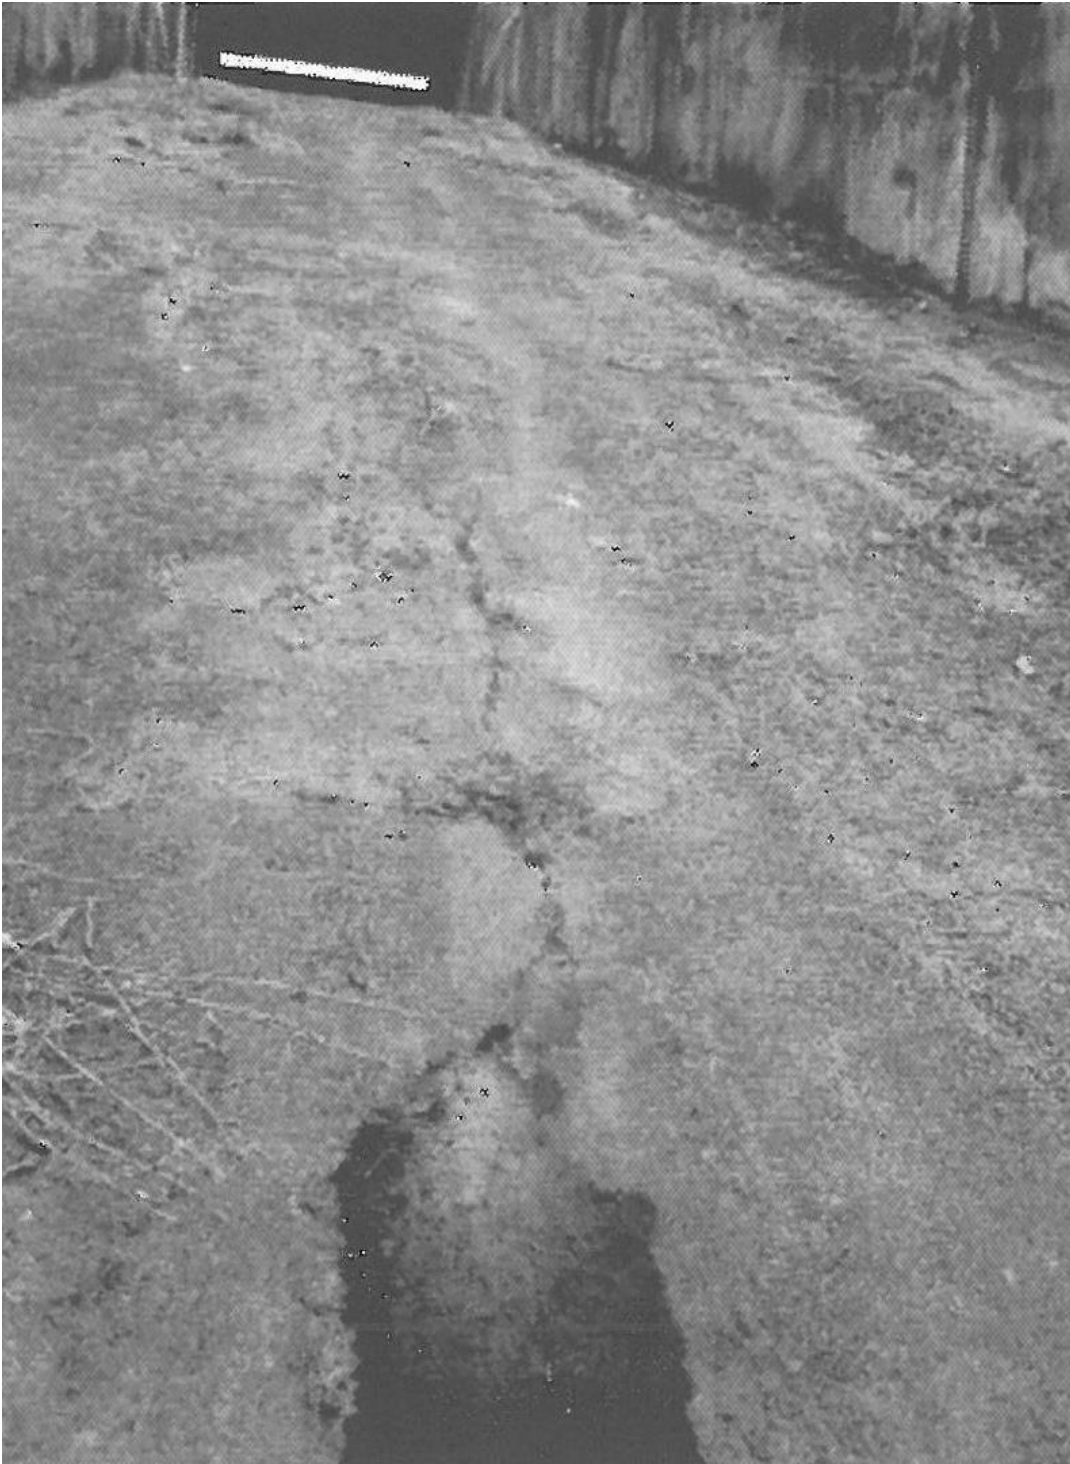
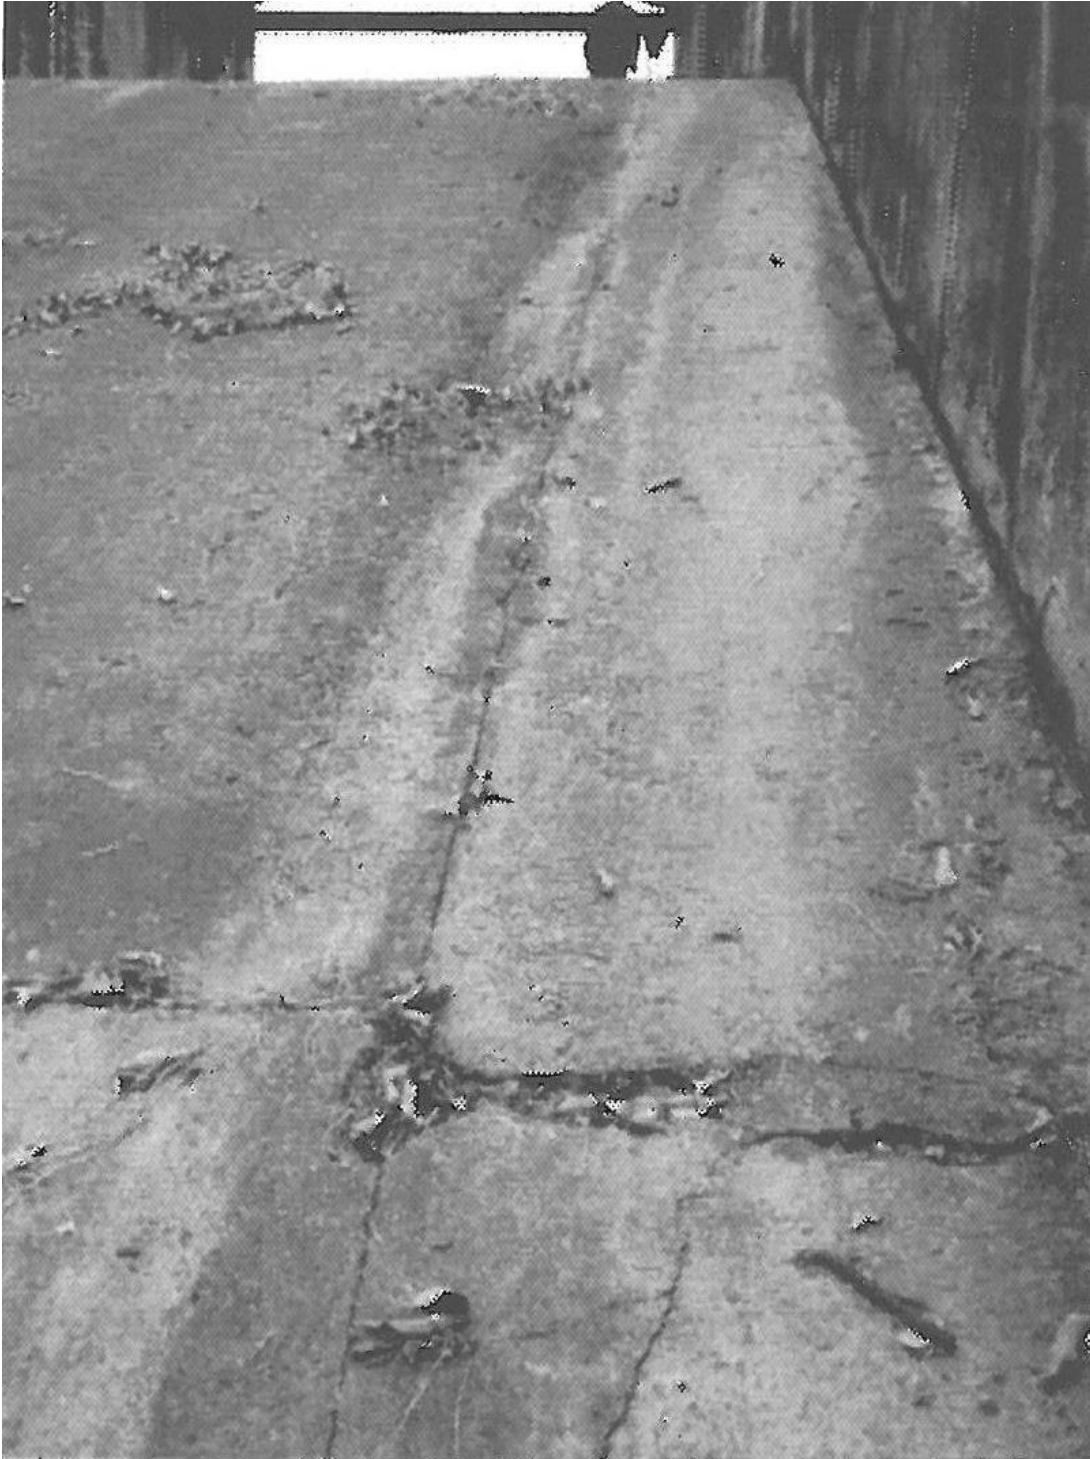
(a) The whole picture of spillway bottom plate cracks, side wall dislocation, and side wall foundation plate cracks

(b) Groundwater seepage after the spillway bottom plate rupture

(c) Groundwater seepage after the extrusion cracks of spillway bottom plate and side wall foundation plate, as well as between the side wall foundation plates

(d) Large amount of groundwater seepage from various expansion joints

Figure 3.45 Damage of Renyitan Reservoir spillway after the 1022 Chiayi earthquake1022 (ZTE Engineering Consultants Co. Ltd., 2008)

Although the PGA of Renyitan Reservoir in the 1022 Chiayi earthquake was considerable, Figure 3.44 shows that the peak ground displacement of various stations in Chiayi was only about 2cm. Although it has been illustrated by Figure 3.45 in the second safety assessment report of Renyitan Reservoir (ZTE Engineering Consultants Co. Ltd., 2008), the 1022 Chiayi earthquake had not seriously affected Renyitan Reservoir spillway, but it has caused the spillway bottom plate cracks, side wall dislocation, extrusion cracks of the side wall foundation plate, and extrusion cracks of the spillway bottom plate and side wall foundation plate, etc.

Although simple repair of the above-mentioned rupture phenomenon has been completed after the 1022 Chiayi earthquake, the problems that may arise from the abnormal water leakages induced by the various cracks as shown in Figure 3.44b, Figure 3.44c, and Figure 3.44d were ignored during the simple repair process.

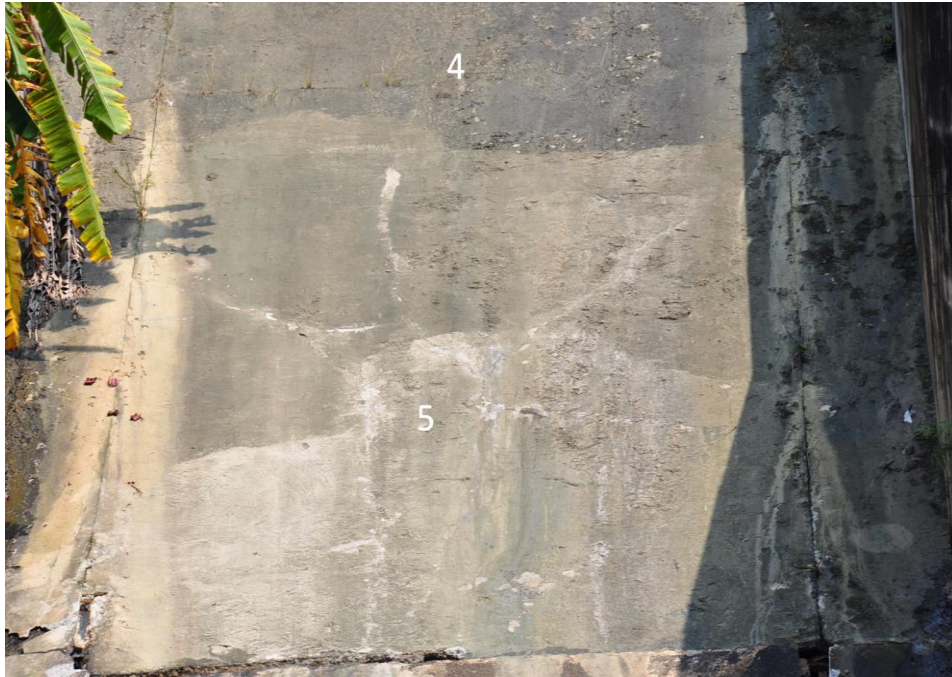
Figure 3.46. The 5th bottom plate and adjacent bottom plates of the spillway

1. Substantial increase in the rupture of the 5th bottom plate (see Figure 3.46)
2. Damage of the 6th bottom plate (see Figure 3.47 and 3.48)

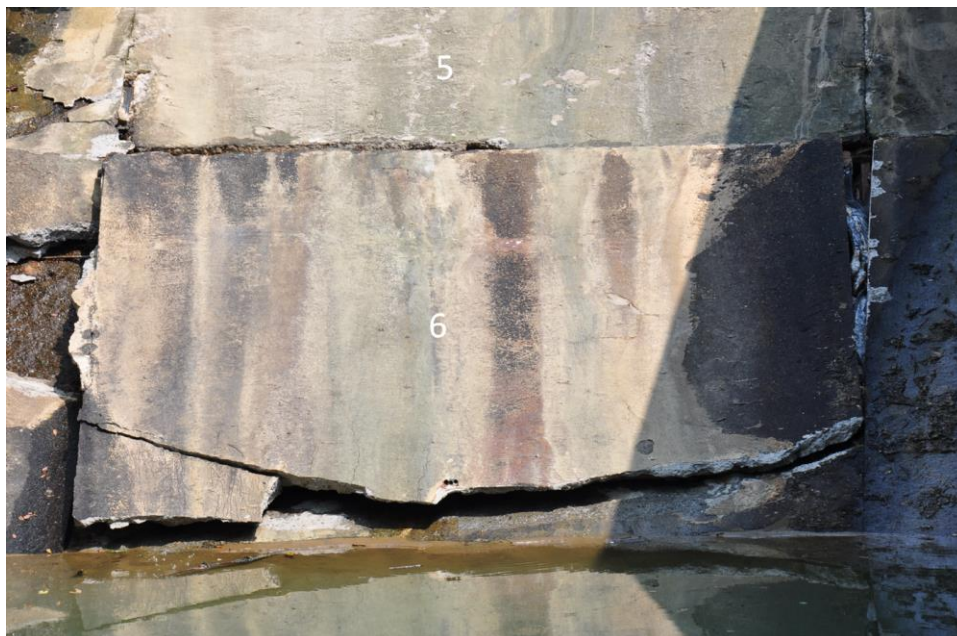
Figure 3.47. The 6th bottom plate and adjacent bottom plates of the spillway

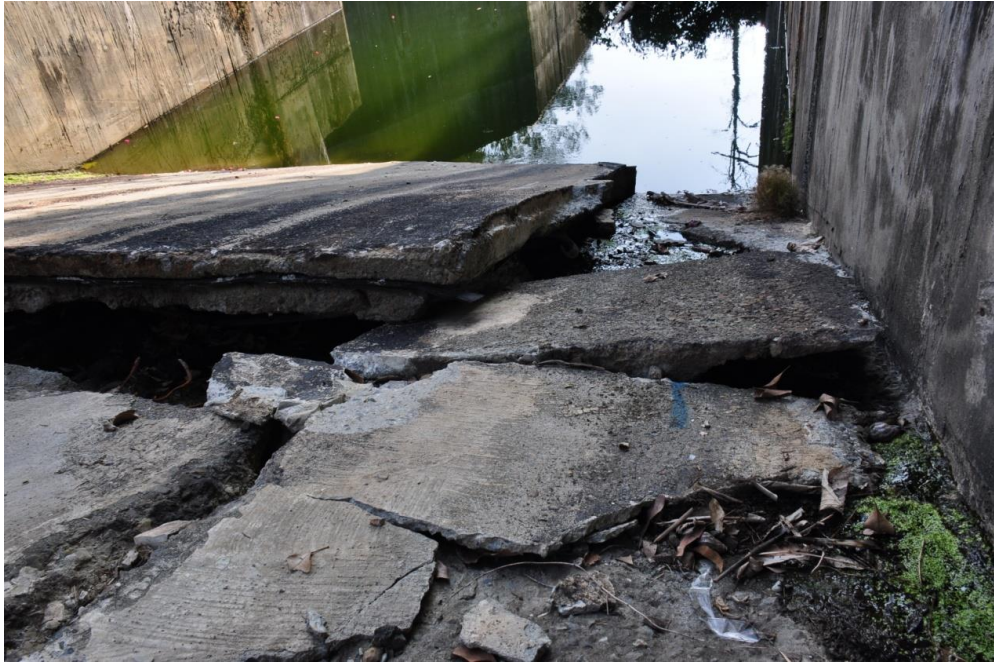
Figure 3.48. The damage to the 6th bottom plate and side wall foundation plate of the spillway

After the piping failure of the spillway, the seepage water through the southwest ridge continued to flow in the rupture zone under the bottom plate and side wall foundations (see Figure 3.48) but the flowing speed of this seepage was not high enough to cause cobble or boulder piping failure, thus proving that the seepage through the ridge was not the main cause of the piping failure of the spillway.

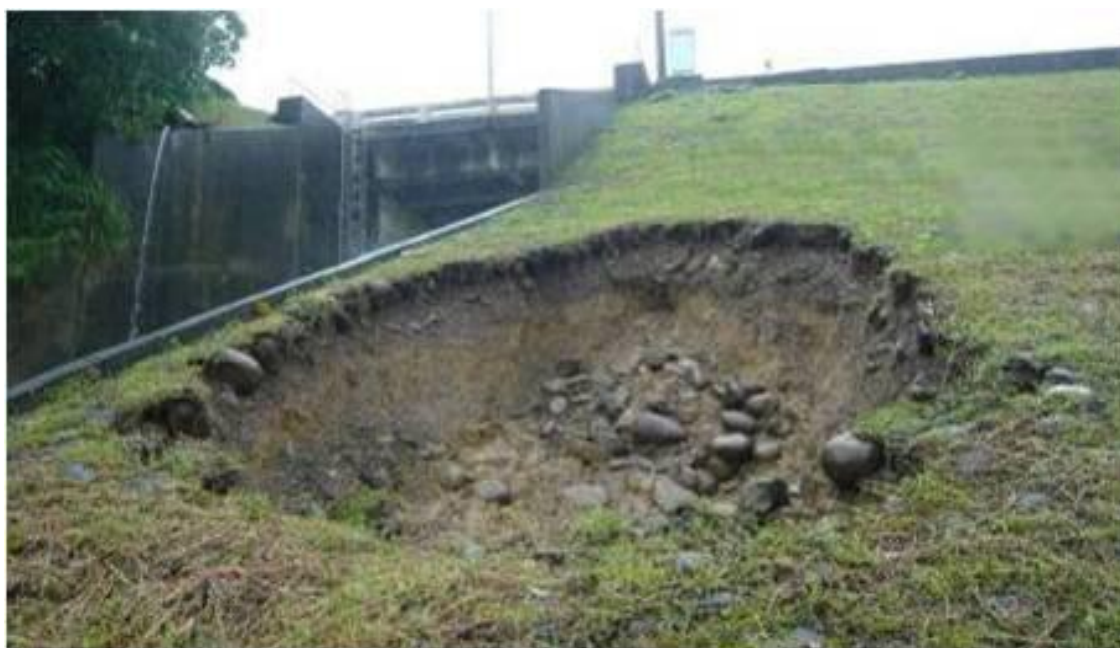
Figure 3.50. Big holes appeared on the top of the left side wall of the 3rd bottom plate

3. Large amount of water and soil particles flew from below the 5th and 6th bottom plates (see Figure 3.49)
4. Big holes appeared on the top of the left side wall of the 3rd bottom plate (see Figure 3.50)

Figure 3.44 shows the six shear bands on different strikes identified by the horizontal displacement velocity vector map. Due to the fact that other shear bands on the same strike will appear in groups, it may have an impact on Renyitan Reservoir spillway, causing bottom plate rupture (Figure 3.60), bending deformation of side walls (Figure 3.60), dislocation of side walls (Figure 3.61), and particles of different sizes deposited in the stilling basin (Figure 3.62), thus there was a big pit on the back of the wall (see Figure 3.50)

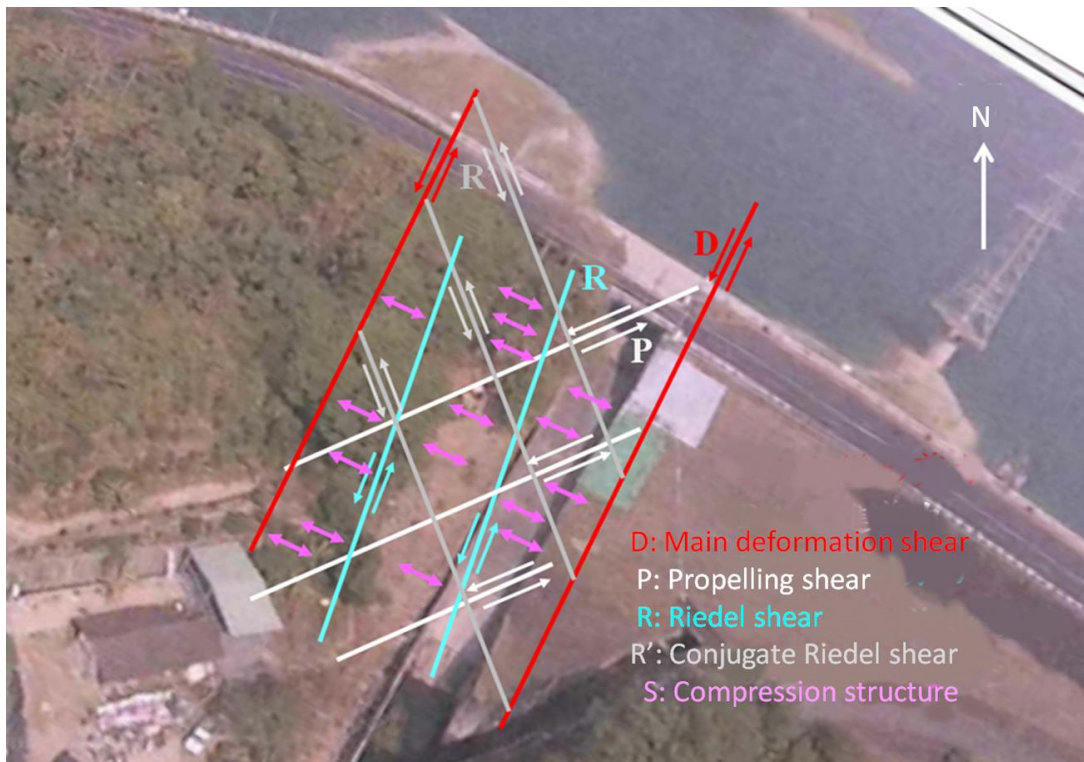
Figure 3.53. Aerial image of the adjacent area of Renyitan Reservoir (background map from Taiwan Waterworks Fifth District Management Office, 2013)

Secondly it also can be identified through the aerial image in Figure 3.53 that the below shear bands exist in the overall shear band in the adjacent area of Renyitan Reservoir spillway: the principal displacement shear D (red) on $N25^{\circ}E$, the thrust shear P (white) on $N66^{\circ}E$, the riedel shear R (blue) on $N20^{\circ}E$, the conjugated Riedel shear R' (grey) on $N21^{\circ}W$, and the compression texture S (pink) on $N64^{\circ}W$.

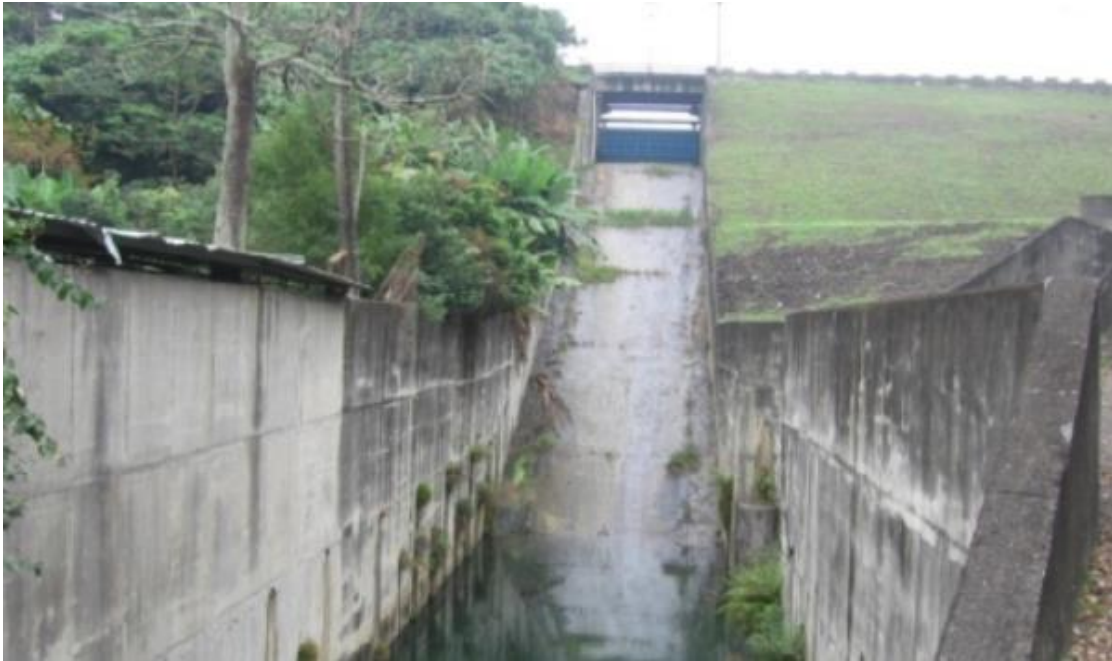
Figure 3.56. Local image for the spillway of Renyitan Reservoir before the 1022 Chiaya earthquake

Taking the piping failure of Renyitan Reservoir spillway as an example, Figure 3.54 shows that Renyitan Reservoir spillway is located on the west ridge of the northwest side of the dam. Figure 3.55 shows the sectional view of the west ridge. Figure 3.56 shows the local image of Renyitan Reservoir spillway before the 1022 Chiayi earthquake.

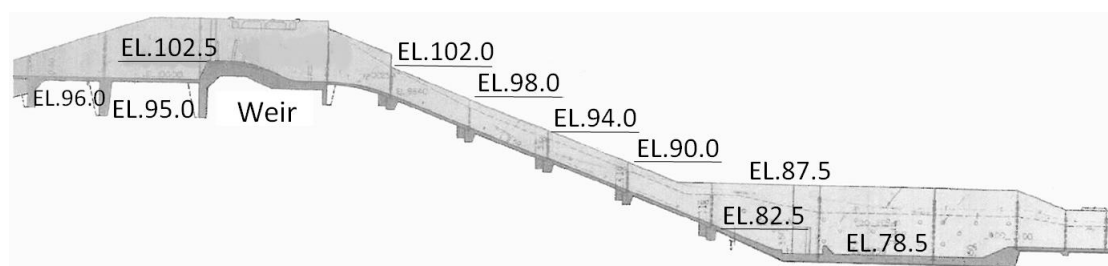
Figure 3.59 Sectional view for the spillway of Renyitan Reservoir (ZTE Engineering Consultants Co. Ltd., 2008)

Figure 3.59 is the sectional view of Renyitan Reservoir spillway. It is known from Figure 4.9 that, the height of the overflow weir is 102.5m, the spillway width is 9m, the slope is 25° , the design discharge is 75cms, and the maximum flow rate is continuously increased from 6m/sec at the end of the overflow weir to 22m/sec at the bottom of the spillway.

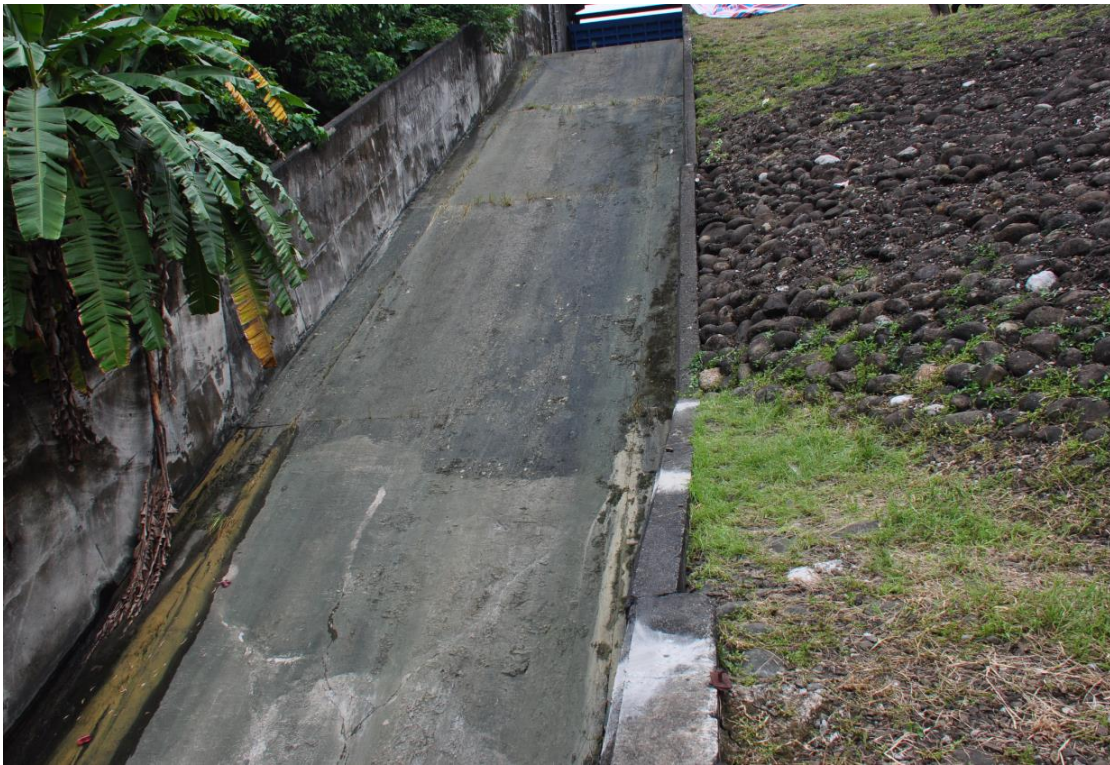
Figure 3.60 Bottom plate rupture and bending deformation of the side wall of the spillway for Renyitan Reservoir

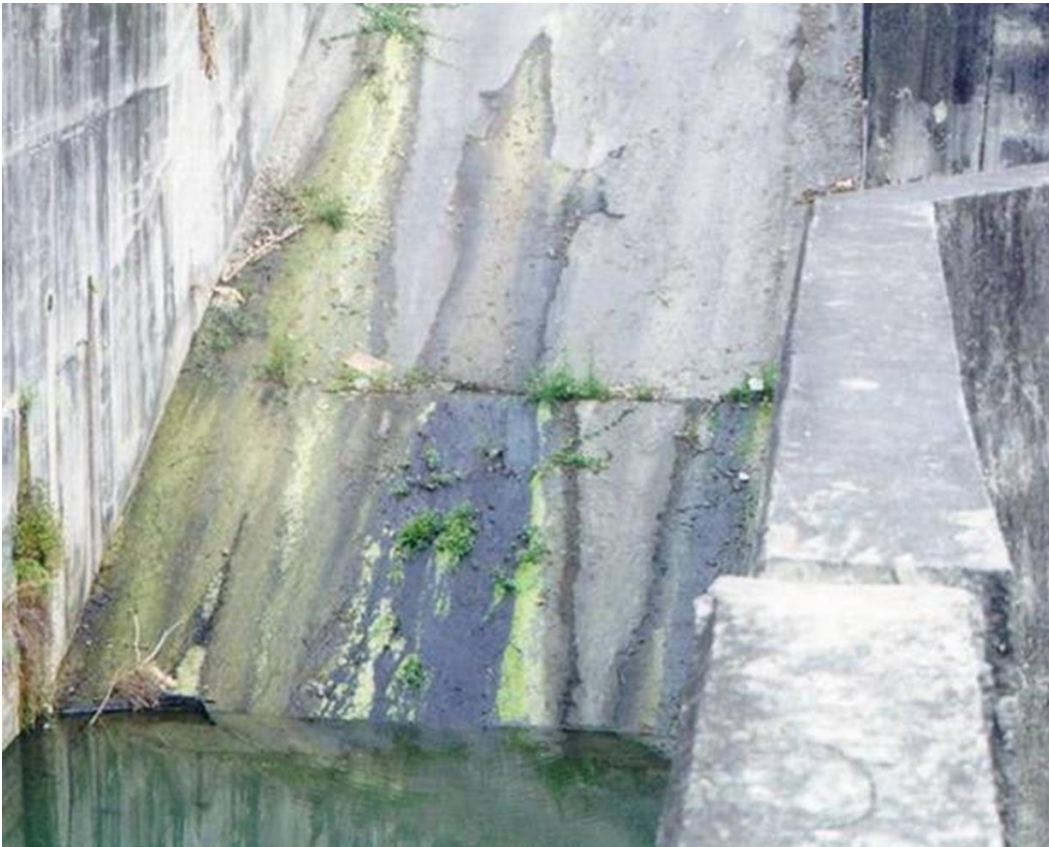
Figure 3.61 Dislocation of the side wall of Renyitan Reservoir spillway

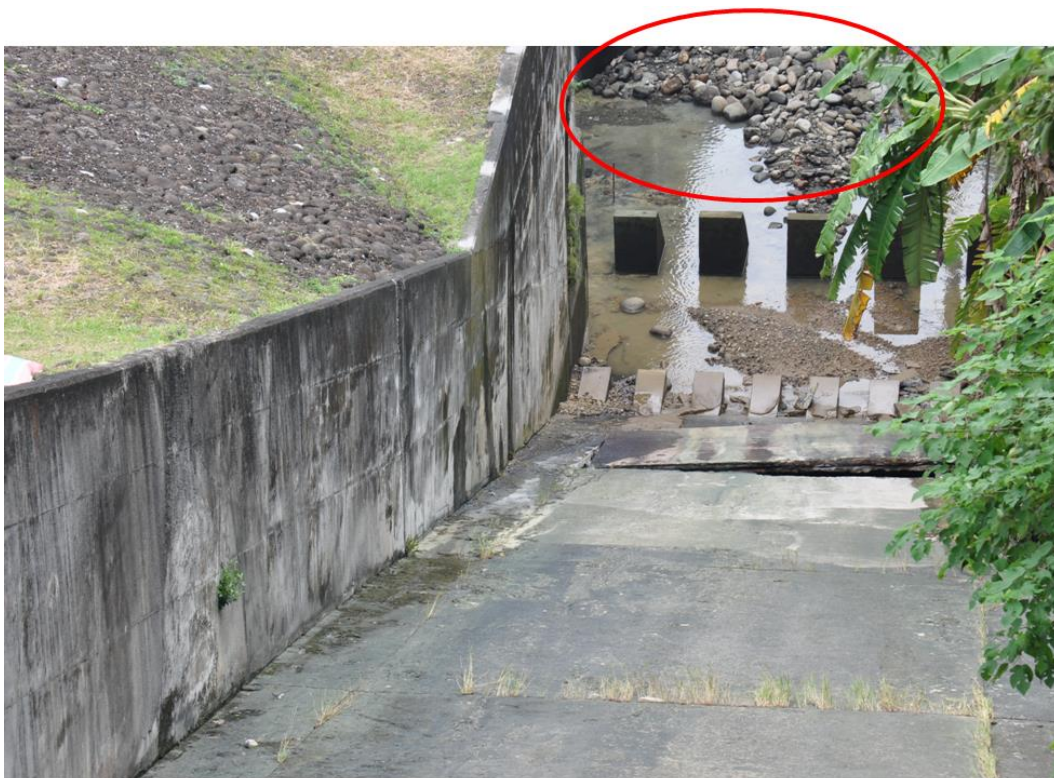
Figure 3.62 Soils of different sizes flowed out due to piping failure of Renyitan Reservoir spillway

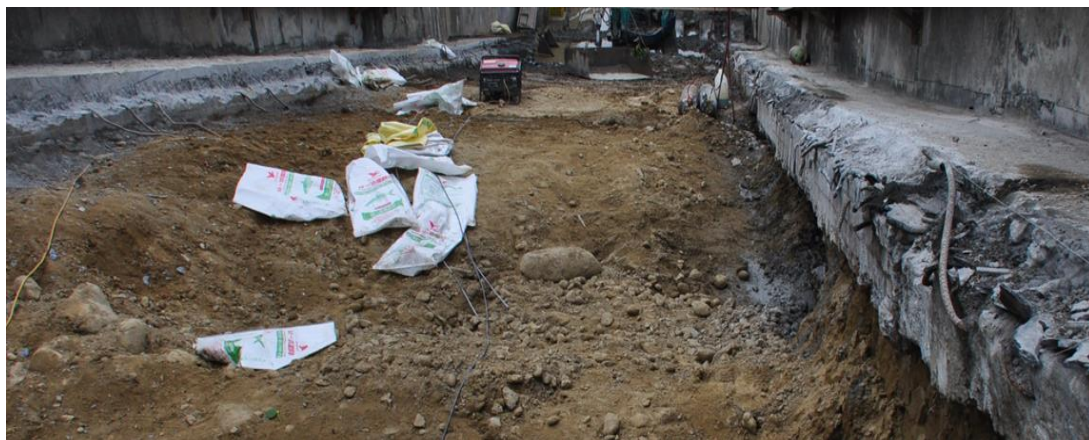
Figure 3.63. The space after the soil loss of the spillway bottom plate

In the process of repairing the spillway bottom plates, when the 3rd bottom plate to the 6th bottom plate were removed, it was first found that there was a large loss of soils under the 3rd to 6th bottom plate (see Figure 3.63), and there was also a large loss of soils under the 2nd and 3rd sidewall foundations on the left bank (see Figure 3.64). Secondly, during the repair, when the spillway gate was closed, Figures 3.63 and 3.64 show that the soils around the pipe-shaped discharge tunnel were gradually air-dried. This phenomenon proves that the water source causing piping failure came from the flood and discharged to downstream through the spillway after the gate was open.

For the shear band soils that remained in the field after the piping failure, although the degree of rupture was relatively low, it can still be identified through Figure 3.63 and Figure 3.64 that there were principal deformation shear D, thrust shear P, Riedel shear R, conjugated Riedel shear R', and compression texture S existing in the overall shear band (see Figure 3.65 and Figure 3.66).

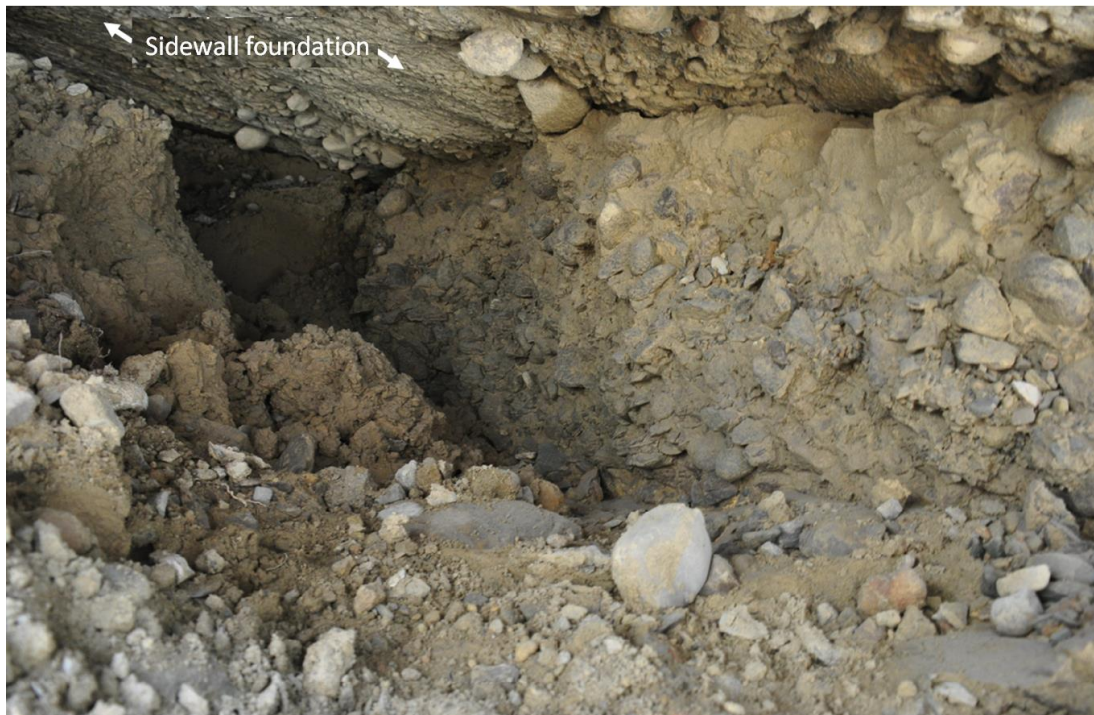
Figure 3.64. The space after the soil loss of the spillway sidewall foundation

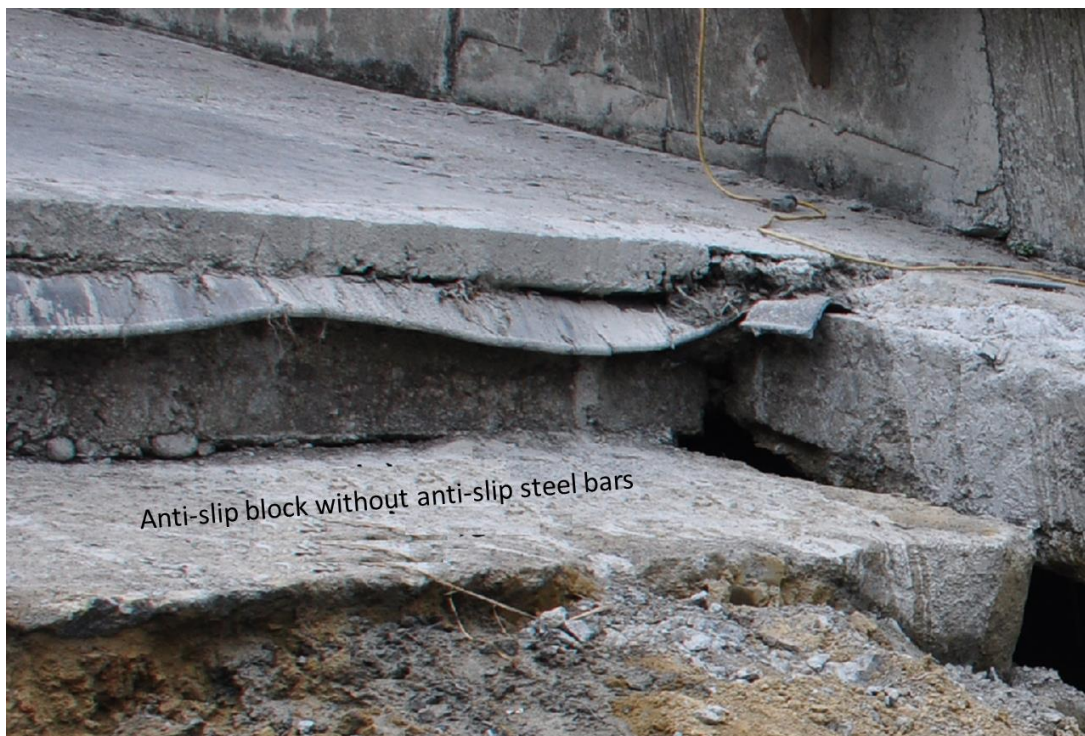
(a) Anti-slip block without anti-slip steel bars prior to the repair project

Figure 3.68. Anti-slip block with or without anti-slip steel bars for the bottom plate of Renyitan Reservoir spillway

The slopes of the bottom plate and side wall foundation of Renyitan Reservoir spillway are both 25° . During the spillway repair process, after the spillway bottom plates No. 3 to No. 6 were removed, it was found that there was no anti-slip steel bars provided to the anti-slip block prior to the repair project (see Figure 3.68a). Therefore, anti-slip steel bars were immediately added into the repair project (see Figure 3.68b).

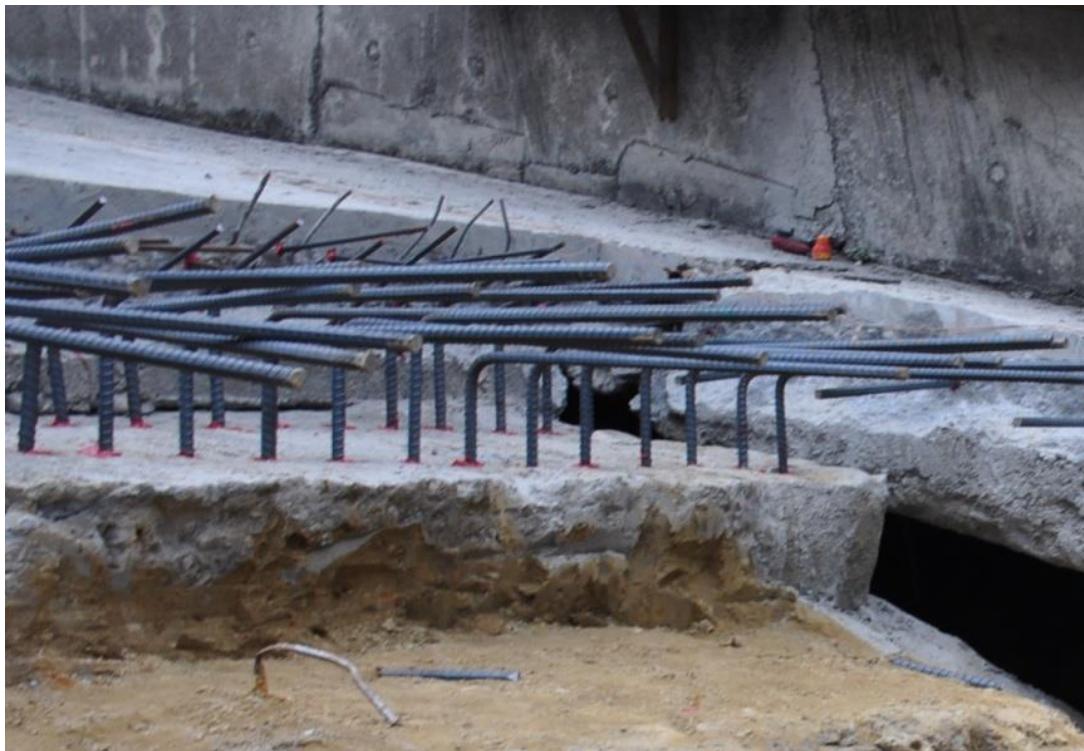
(b) Anti-slip steel bars were added into the repair project

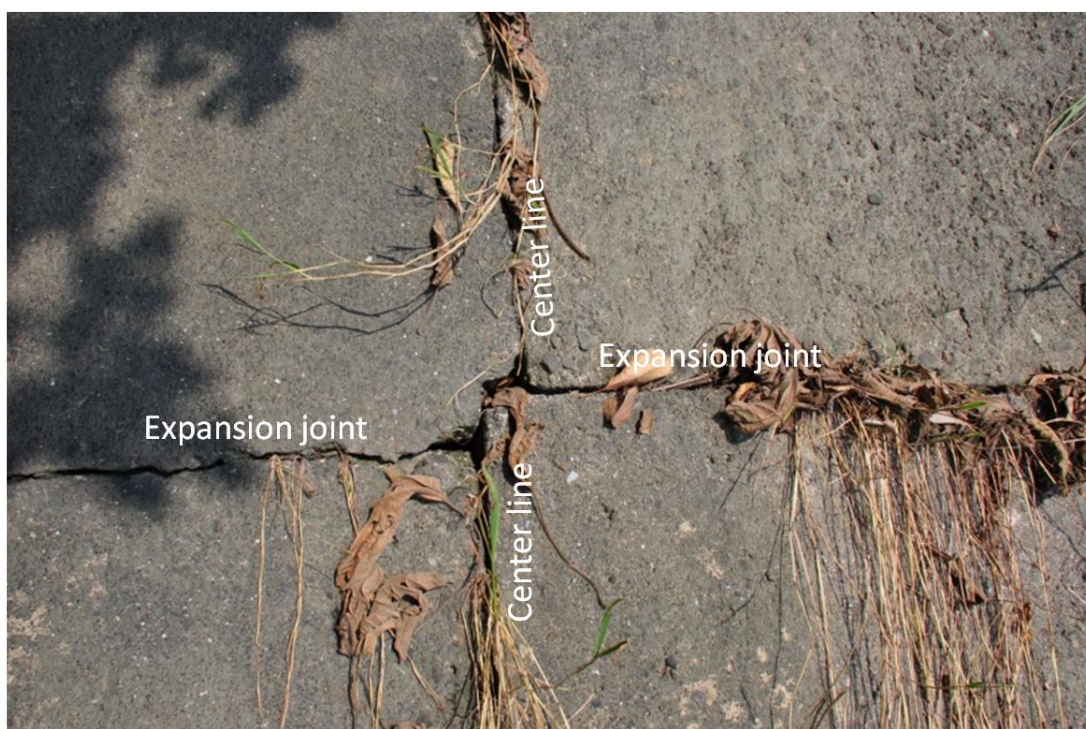
Figure 3.69. Dislocation of the center line and expansion joint of the bottom plate of Renyitan Reservoir spillway

As the anti-slip steel bars were not provided, the anti-slip function could not play. Therefore, whether in normal times, in heavy rains, or in earthquake, both the spillway bottom plate and side wall foundation will slide. Once the spillway bottom plate slid (see Figure 3.69), the shear textures in the soil below the bottom of the spillway were induced (see Figure 3.66). Especially after the warping and rupture of the 6th bottom plate and side wall foundation, the various bottom plates and side wall foundations above it will all slide due to the loss of sliding resistance below, thus increasing the rupture degree of the spillway bottom plates, side wall foundations, and the soil underneath. The discharged flood flows easier into the soil in the shear bands below the spillway bottom plates and side wall foundations, and the pipe-shaped discharge tunnel is also formed. After that the width and height of the pipe-shaped tunnel are continuously increasing, and finally the cobbles and boulders in the pipe-shaped discharge tunnel can also be carried away by the torrent.
