THE MAJOR CAUSE OF EARTHQUAKE DISASTERS : SHEAR BANDINGS

**THE MAJOR CAUSE OF
EARTHQUAKE DISASTERS:
SHEAR BANDINGS**

Institute of Mitigation for Earthquake
Shear Banding Disasters

Capturing Shear Bandings

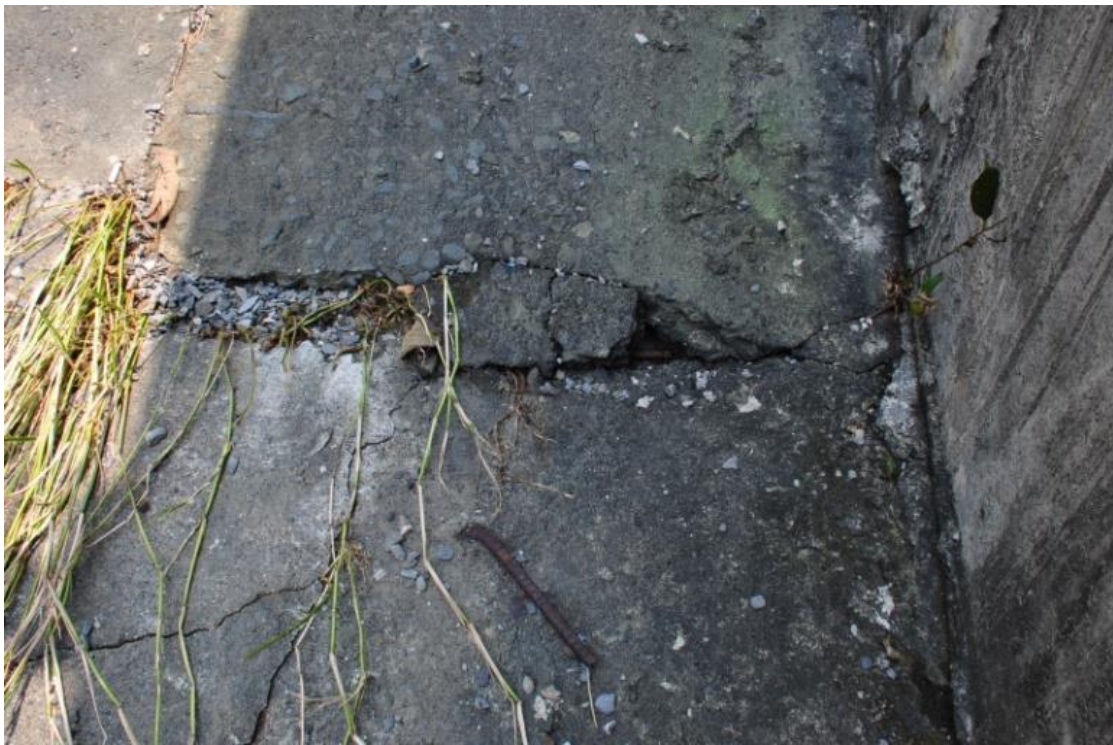
Figure 5.3 Side Wall Foundation Rupture

The Cause of the Piping Failure of Renyitan Reservoir Spillway. In the above sections, it is found that shear banding not only caused the bottom plate rupture of Renyitan Reservoir spillway, but also caused the dislocation of the expansion joints and the center line (Figure 5.2) as well as the side wall foundation rupture (Figure 5.3).

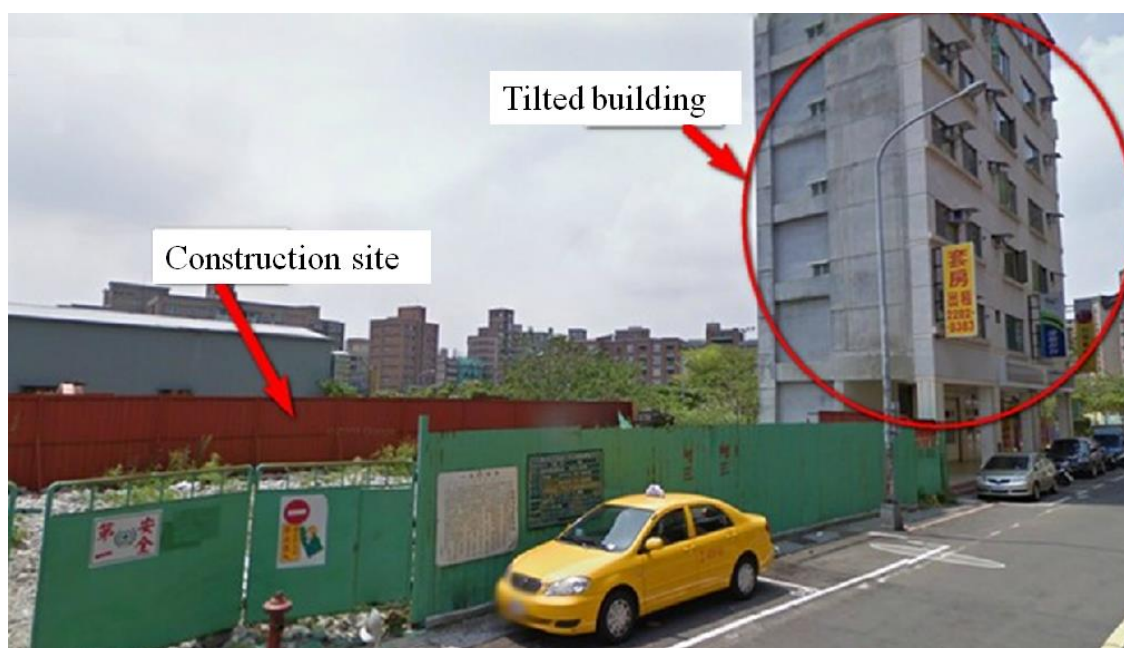
Figure 4.1. The leaning phenomena in neighboring buildings caused by construction in Luzhou District of New Taipei City (background picture is from Wang, 2012)

For two neighboring buildings built in different eras, if the new building induces leaning on the old building (Figure 4.1) or cracking (Figure 4.2) during construction, which then results in disputes, according to different laws or regulations, these disputes shall be judged as construction neighboring damage disputes.

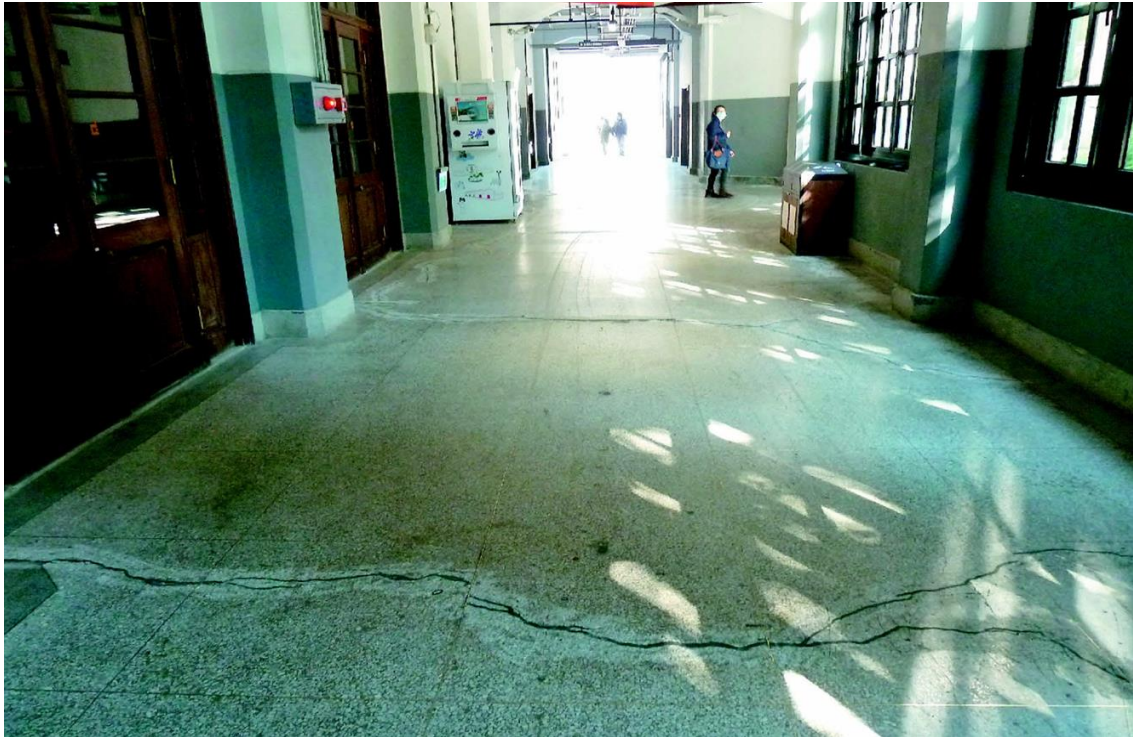
Figure 4.2. The cracking phenomena in neighboring buildings caused by construction of the Taipei Dome project in Songshan District of Taipei City (Zhou, 2017)

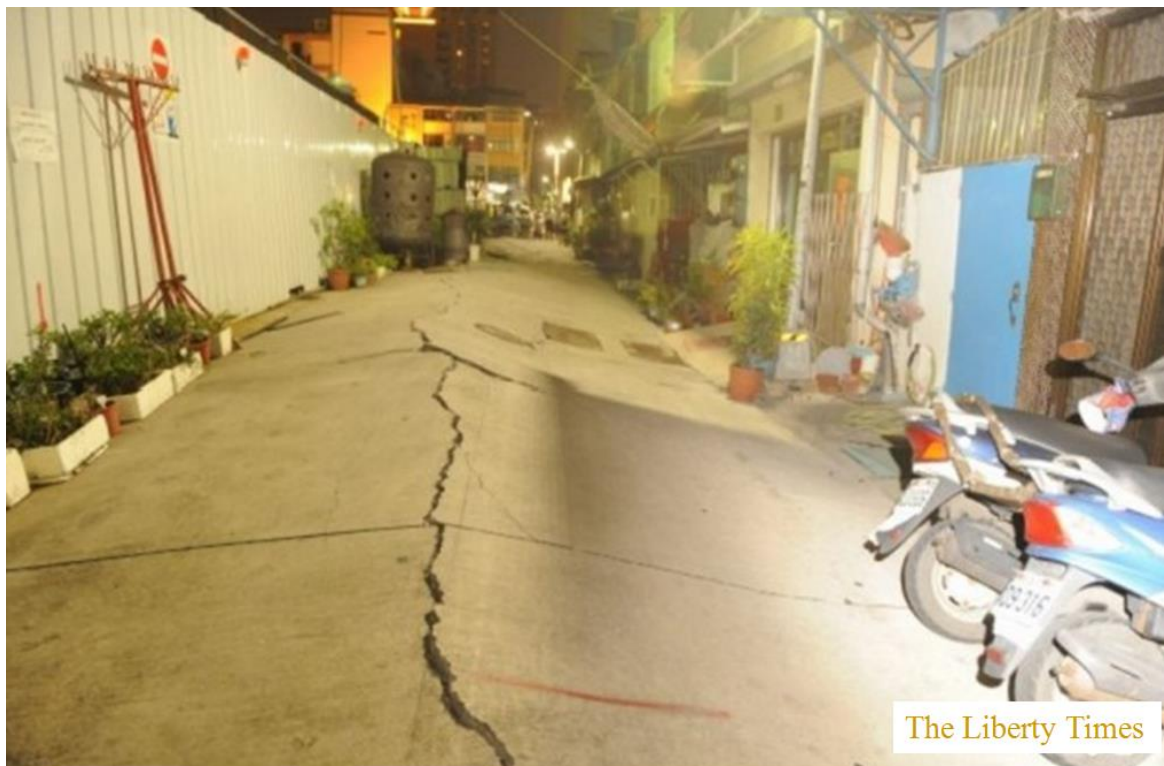
(a) Cracking on neighboring roads

(b) Depression and cracking on neighboring buildings

Figure 4.3. The neighboring damage problems induced by consistent excavation on slurry wall trenches in the building construction site at the cross road of Ziqiang Road and Qingnian Road in Kaohsiung (Huang, 2016)

Under the active training and management of the Kaohsiung government, between July 1993 and June 2004, the number of construction neighboring damage disputes declined dramatically however, these disputes could still not be eliminated (Figure 4.3). The essential reason is that the specialists and scholars who draft the laws, regulations, rules, and authentication manuals concentrate on the techniques of excavating retaining walls but they neglect other reasons that induce neighboring damage. In this case, the construction-planning consulting organization can only advise the construction sites where neighboring damage is likely to occur with technical

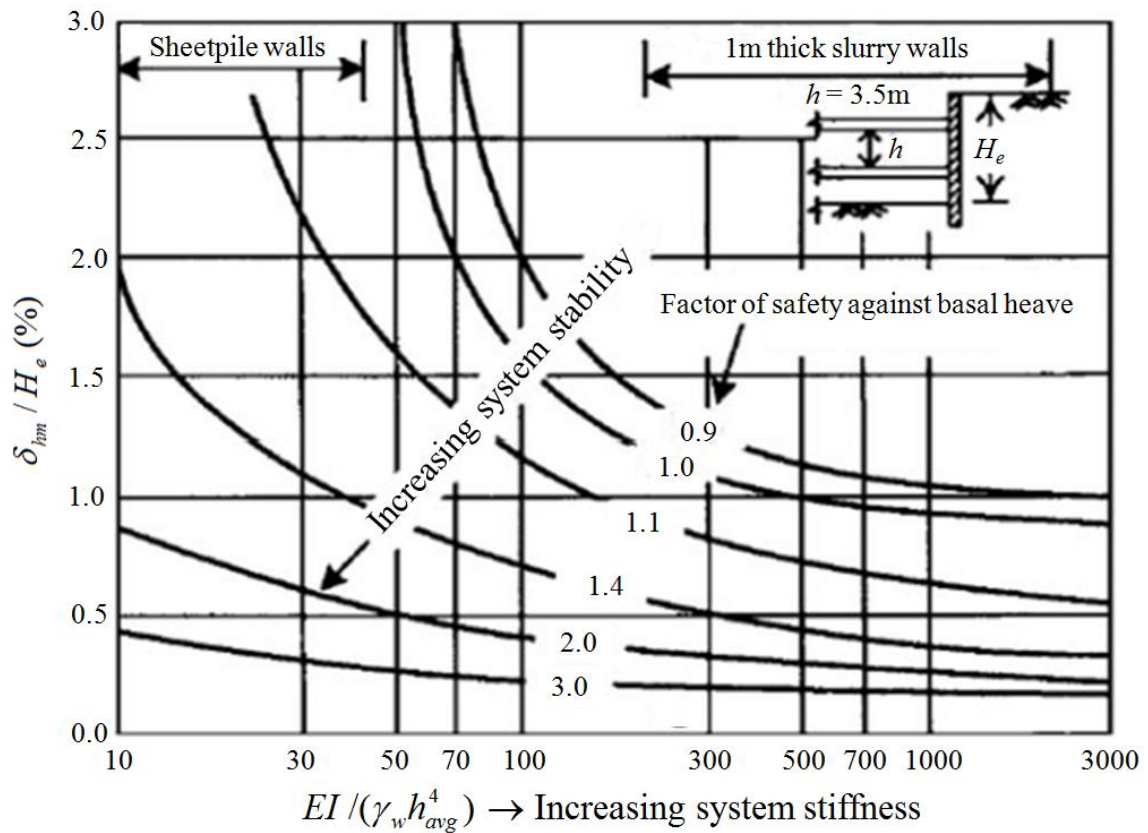
Figure 4.8. Correlating curves of δ_{hm} / H_e , strength of support system EI and FS (Clough and O'Rourke, 1990)

For excavation in a soft clay layer, δ_{hm} correlates with FS . When considering FS , retaining walls strength EI , and average distance of support h_{avg} together, Clough and O'Rourke (1990) demonstrated in Figure 4.8: (1) when $FS=3.0$, $\delta_{hm} / H_e < 0.5\%$; (2) when $FS \leq 1.4$, δ_{hm} / H_e increase dramatically and in this case retaining walls strength EI has a great influence on δ_{hm} / H_e ; (3) When $FS \leq 1.1$, although the construction quality is good, δ_{hm} / H_e can still be larger than 2.0%.

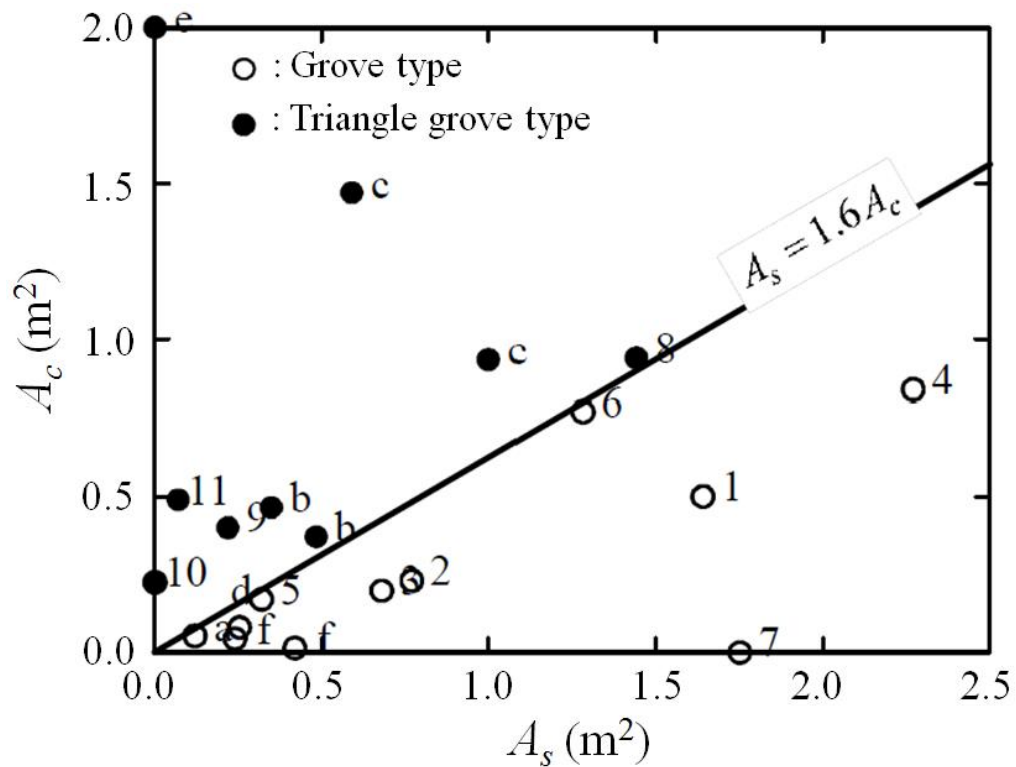
Figure 4.12. Relationship of ground settlement and retaining walls lateral displacement (Hsieh and Ou, 1998)

Figure 4.12 shows the relationship between the retaining walls lateral displacement and ground settlement based on A_c and A_s from 16 excavation cases according to Hsieh and Ou (1998). From Figure 4.12, it can be seen that when $A_s > 1.6A_c$, the type of ground settlement is concave; when $A_s < 1.6A_c$, the type of ground settlement is spandrel; Therefore, the relationship above can be used to determine the type of ground settlement.

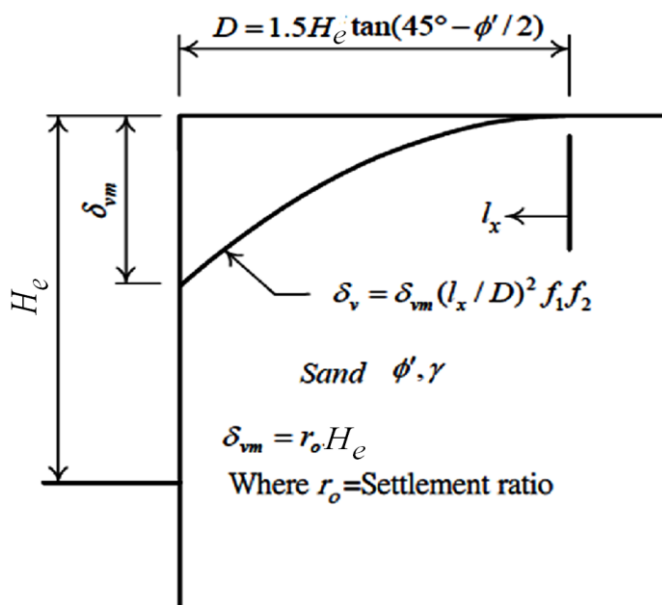
(a) Curves of settlement

(b) Curves of settlement ratio

Figure 4.26. Half-empirical method of estimating ground settlement on sandy layers (Bauer, 1984)

The method proposed by Bauer (1984) is a half-empirical method, which can be used to estimate ground settlement induced by excavation on sand layers (Figure 4.26). Factors include relative density D_r , friction angle ϕ' , construction quality, and construction difficulties. The procedures are demonstrated as follows:

- a. According to relative density D_r , the settlement ratio r_0 can be defined by the following equation or Figure 4.26b:

- d. Calculate the settlement δ_v at the corresponding position on l_x presented in Figure 4.26a:

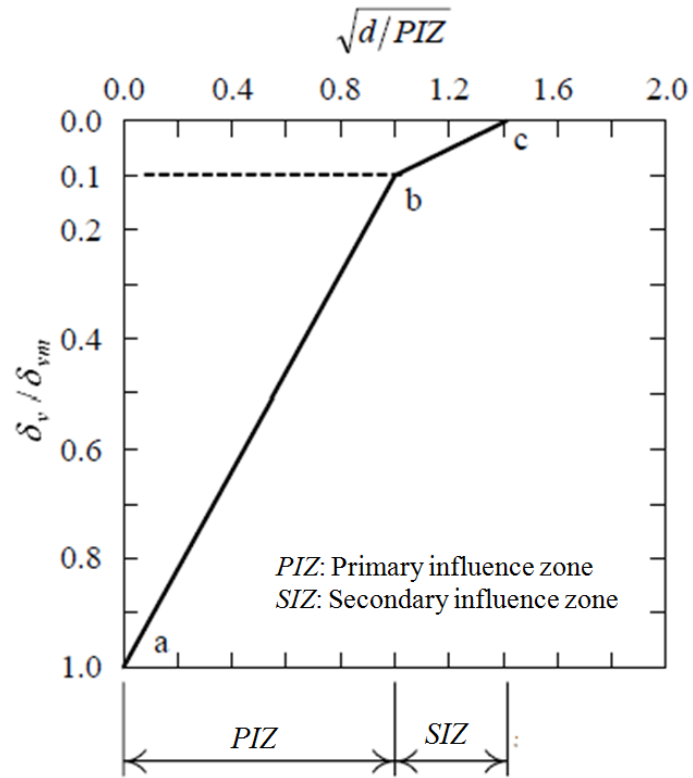
(a) Spandrel type

(b) Concave type

Figure 4.32. Assessment of ground settlement (Hsieh and Ou, 1998)

In Figure 4.32a, line ab represents the PIZ with a steep slope; line bc represents the SIZ with a gentle slope

Hsieh and Ou (1998) used Figure 4.32b to show the distribution of ground settlement induced by excavation with three lines, where line abc represents the PIZ and line cd represents the SIZ :

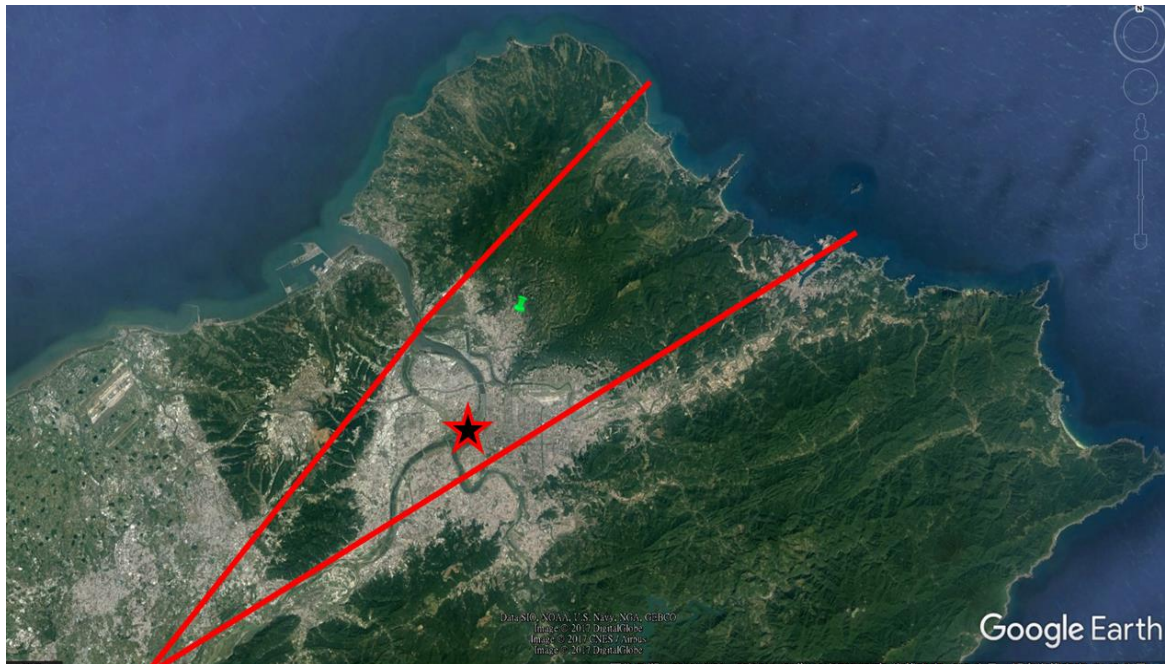
Secondly, Taipei experienced destructive tectonic earthquakes 7~8 times in the twentieth century, where a tectonic earthquake epicenter is located near the corner of Danshui River, Chongyang Bridge, which is close to the neighboring damage site of Cathay Pacific Tienmu Shopping Mall. In addition, Figure 4.48 shows that the neighboring area of this epicenter contains two groups of shear bands with strikes of $N64^{\circ}E$ and $N20^{\circ}E$ respectively, their strikes are close to the strikes of principal deformation shear D and Riedel shear R, respectively. If the neighboring damage site of Cathay Pacific Tienmu Shopping Mall is linked to the epicenter, then the strike of this line is same as the strike of Riedel shear R shown in Figure 4.46.

- Note: 1. Green circle pin is the location of neighboring damage in Cathay Pacific Tienmu Shopping Mall
2. Center of the black star is the epicenter of earthquake

Figure 4.48. Epicenter of 7~8 destructive earthquakes that occurred in Taipei in the twentieth century (Chang, 2004)

The permeability of pyroclastic deposits is high while the permeability of silty sand, high plasticity clay, and low plasticity clay is low, and the pyroclastic deposit is a pressure aquifer. Figure 4.48 shows that when the construction site is located on a gentle slope, if the ground water table is expected to be lowered to 1m below the excavated surface by draining water before excavation, then the decline of the ground water table on the right and left side of building B is quite similar according to Figure 4.53, and the settlement on the right and left side of building B is quite similar too, so the cracking issues on building B are slight. However, the decline of the ground water table on the right and left side of building A is quite different, so the settlement on the right and left side of building A is quite different too and the cracking issues on building A are more serious.

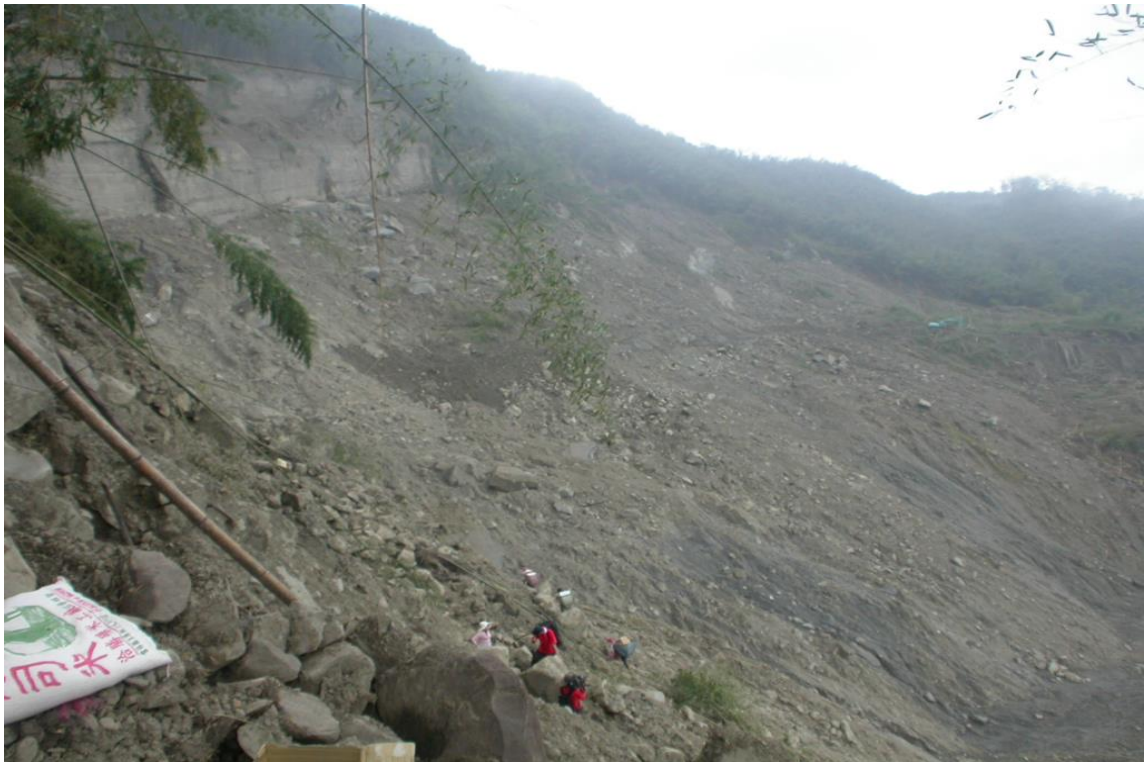
retreating sliding failure that occurs in the shear banding tilted slope is shown in Figure 4.52, where ABE blocks slide first, followed by BCFE blocks, and CDGF blocks are the last to slide. The actual shear banding tilted slope consisting of sliding surface GF, FE, and EA is similar to that made by three sliding surfaces ch, hm, and mp in Figure 4.51. This result also validates the mechanism of sliding failure in the shear banding tilted slopes presented in Figures 4.50 and 4.51, and the potential of sliding failure in the shear banding tilted slope is considerable.

(a) After sliding failure

(b) Section of sliding

Figure 4.52. Retreating sliding failure on tilted slopes of shear band

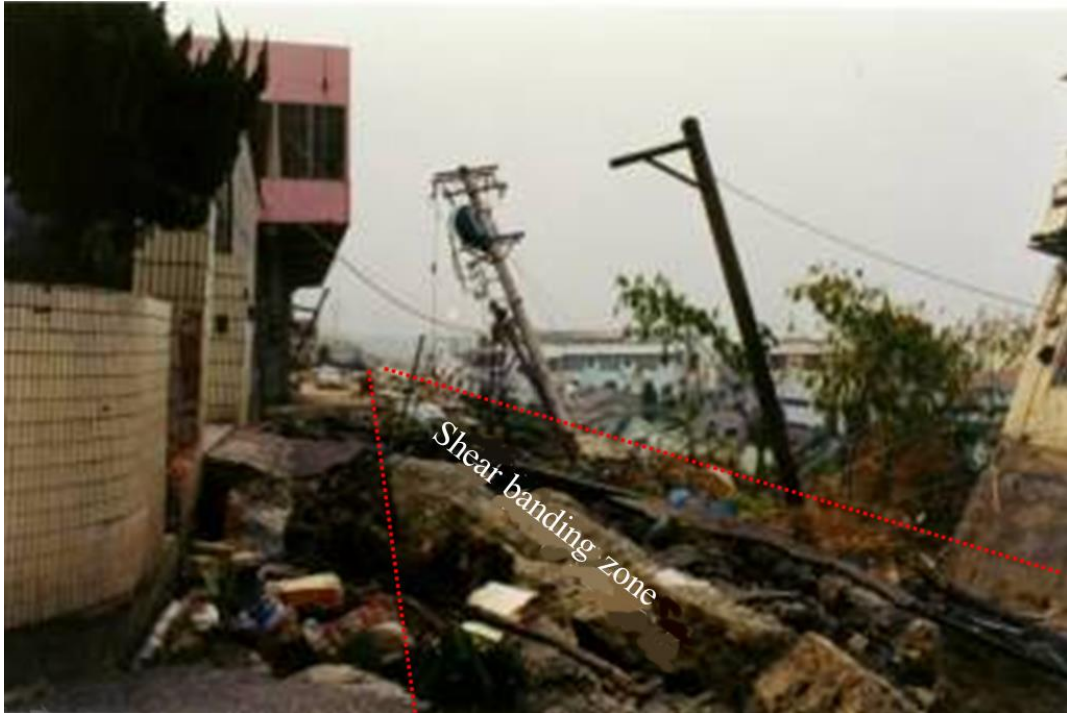
When a tectonic earthquake of large magnitude occurs, shear bandings can dramatically increase the degree of rock fracture in the shear banding zone (Figure 4.54).

Figure 4.54. Leaning failure of buildings induced by shear banding in 921 Earthquake

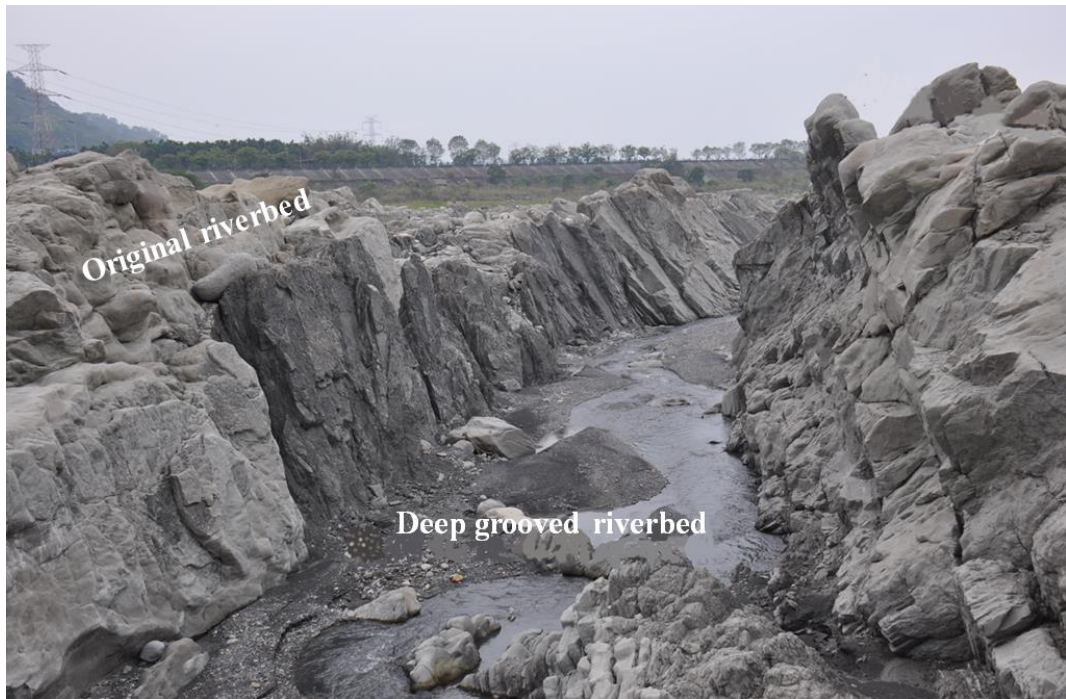
When a shear band is located on a river bed, the rock fragments in the shear banding zone are going to flow with flood, which can lead to deep channelization of the riverbed (Figure 4.55), river bank erosion (Figure 4.56), and wash-out (Figure 4.57).

Figure 4.55. Deep channelization phenomenon on a shear banding zone of riverbed

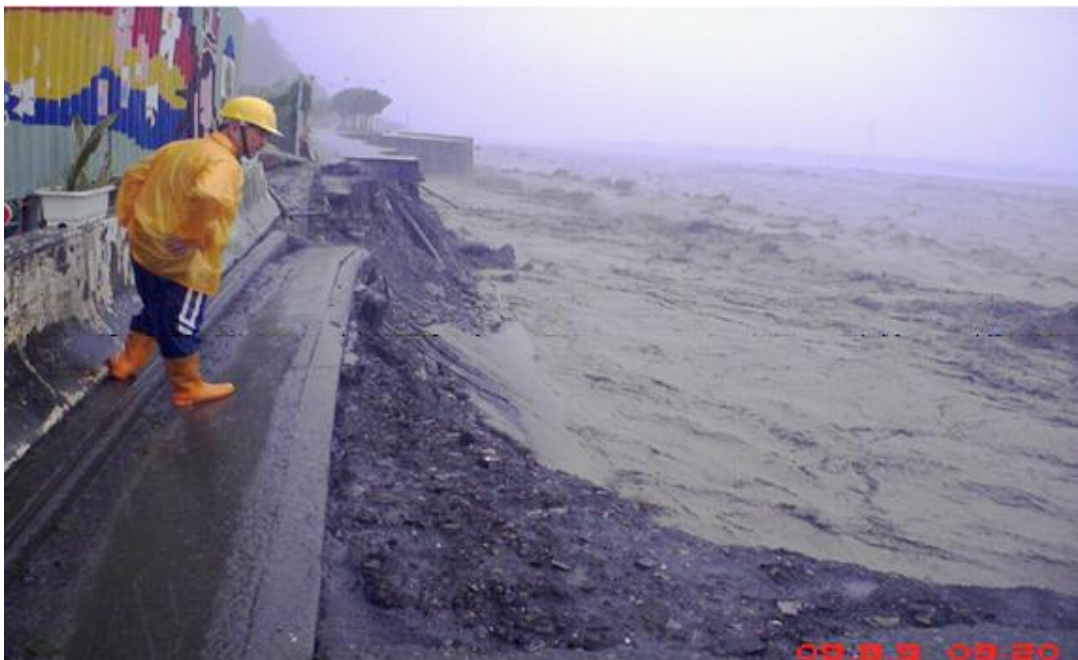
Figure 4.56. Erosion phenomenon of a shear banding river bank

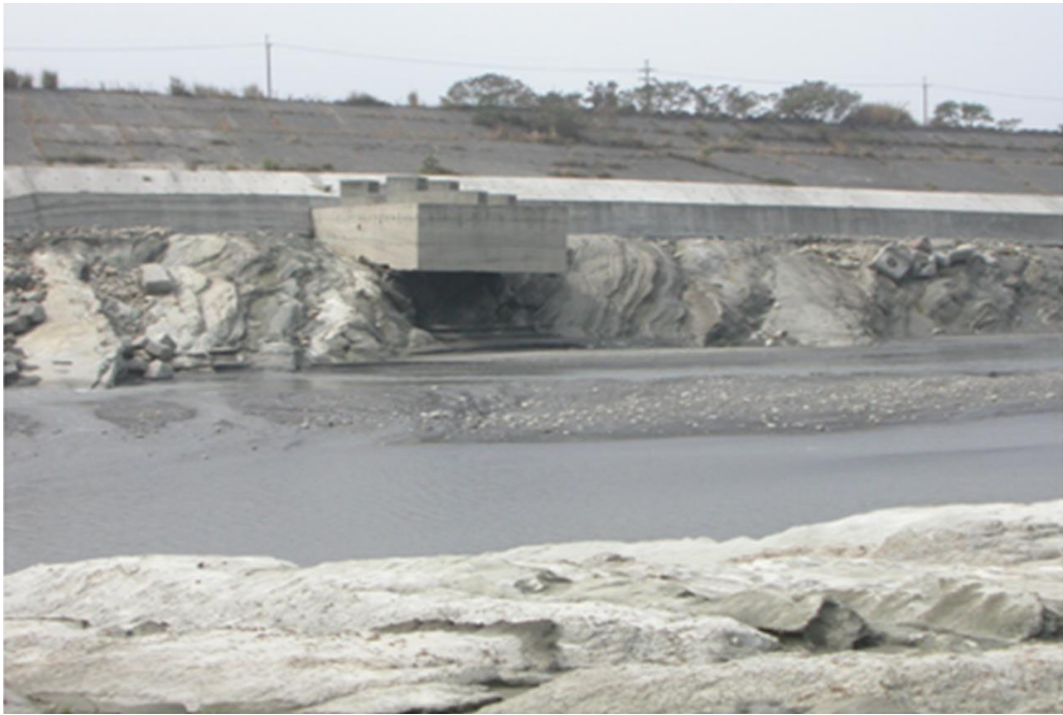
Figure 4.57. Wash-out phenomenon of a shear banding river bank

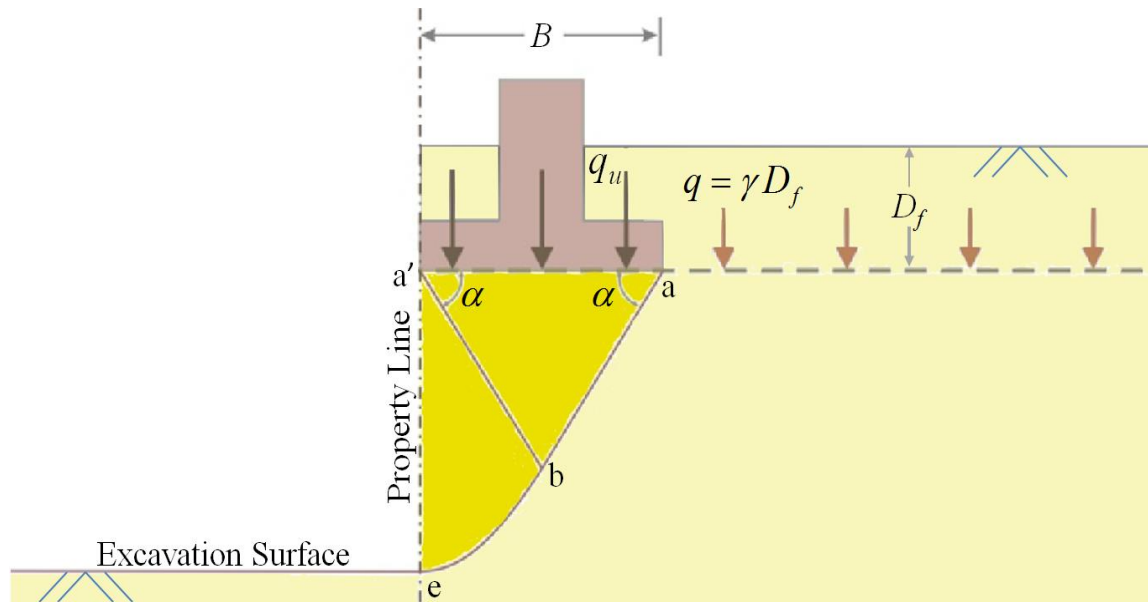
The Range of Shear Failure of Foundation Soil after Excavation. When the excavation of new building is carried out, the old building's range of shear failure of ultimate bearing capacity is changed from the total range of $abcd$ and $a'bc'd'$ in Figure 4.59 to the range of $abea'$ in Figure 4.60.

Figure 4.60. The range of shear failure surface of ultimate bearing capacity after construction

Figure 4.60 shows that after the excavation of new building, the old building's range of shear failure of ultimate bearing capacity has dramatically decreased. And during the excavation of a new building, the reason why the foundation bearing capacity decreases so much is due to the loss of symmetry. The second reason is that part of the range of shear failure, which exceeds the property line, is demolished in the construction of the new building.

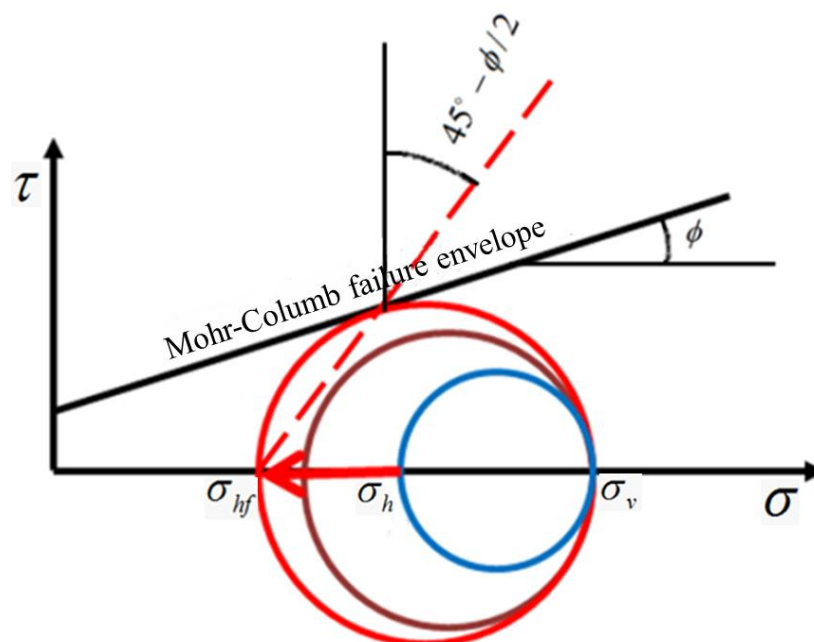
Before the excavation of a new building, if the stresses of the old building's foundation soil are under K_o conditions such that the corresponding Mohr circle marked in blue line is presented in Figure 4.64a, then during the excavation of the new building, if the vertical stress σ_v of soil on one side of excavation zone remains unchanged, and the lateral stress σ_h continues to decrease, then Mohr's circle of soil failure is shown by the red line of Figure 4.64a, where σ_{hf} is the lateral stress when a Rankine active failure surface occurs in the foundation soil, while the red broken line represents the angle $45^\circ - \phi/2$ between Rankine active failure surface and the vertical line.

(a) Lateral decompression failure presented by Mohr's circle

(b) Rankine active failure surfaces

Figure 4.64. Rankine active failure surfaces induced by lateral decompression of soil on one side of excavation

Above all, during the construction of a new building, to prevent the old building from Rankine active sliding failure induced by lateral decompression of the foundation soil as well as the neighboring damage disputes, then the location of foundation in Figure 4.64 must move backwards by at least $H_e \tan(45^\circ - \phi/2)$ from the property line (Figure 4.65).

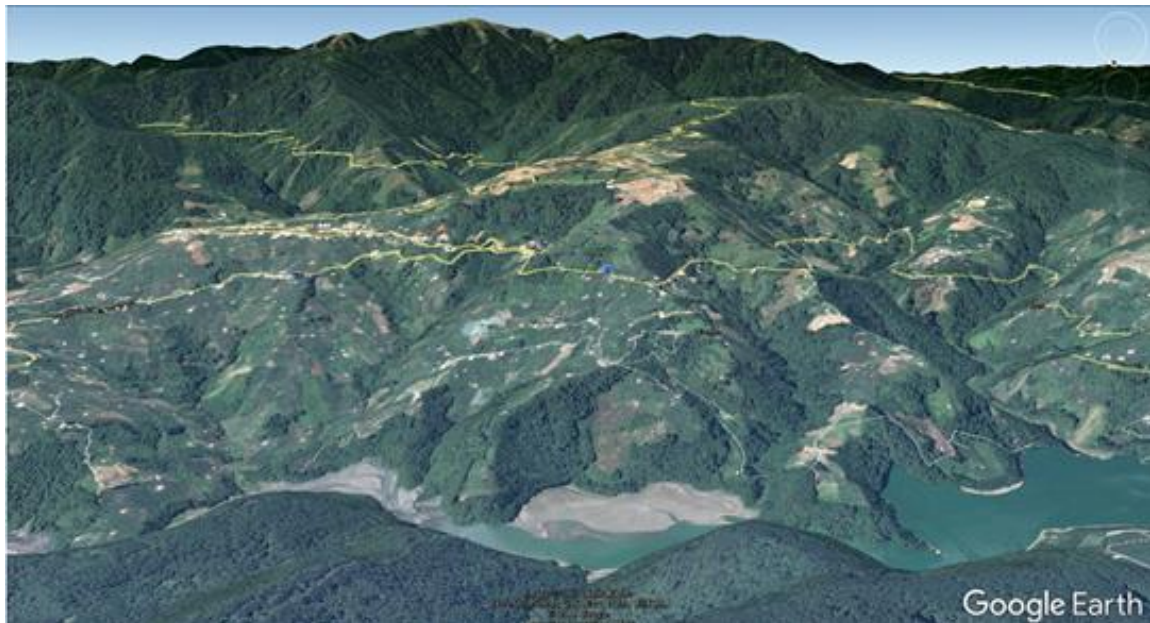
Figure 5.2. Mountainous agriculture development zones, roads, and landslide areas in Lishan (Google Earth, 2017)

In the past, the Soil and Water Conservation Bureau, Council of Agriculture, Executive Yuan (2017) thought Lishan landslide area was an ancient collapse area and blamed Lishan landslide on agricultural development in the mountainous area and road construction. However, Figure 5.2 shows that in Lishan area, there are many roads such as Tai-8 Route, Tai-7a Route, Central 131 County Road (Fushou Road), and agricultural roads, etc. Most roads going across mountainous agricultural development zones do not induce significant landslides. Only when the roads or mountainous agricultural development zones intersect with shear banding zones, can the landslide phenomenon occur. Figure 5.2 conversely shows that a large number of landslides occur on the shear banding tilted slopes where no roads or mountainous agriculture development zones exist.

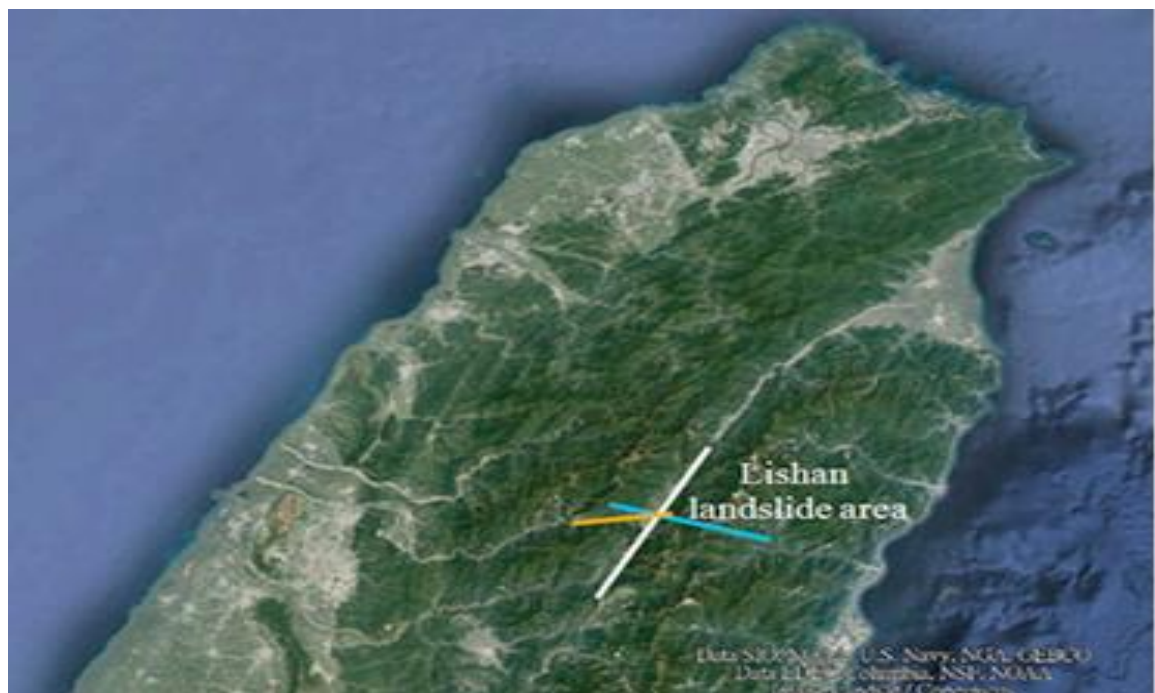
Figure 5.3. Lishan landslide area is the intersection zone of three shear bandings (background picture is from Google Earth, 2017)

In order to understand the actual cause of Lishan landslides, firstly Figure 5.3 shows that the Lishan landslide area is exactly at the intersection of three shear bandings, whose strikes are $N32^{\circ}E$ (white line), $N74^{\circ}W$ (blue line), and $N83^{\circ}E$ (orange line) respectively.

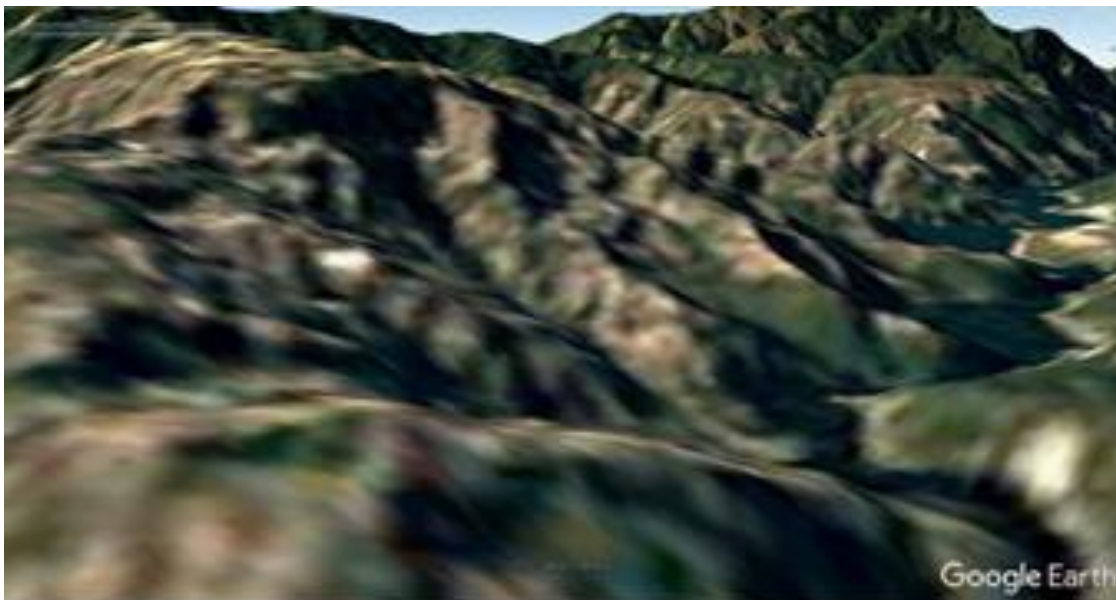
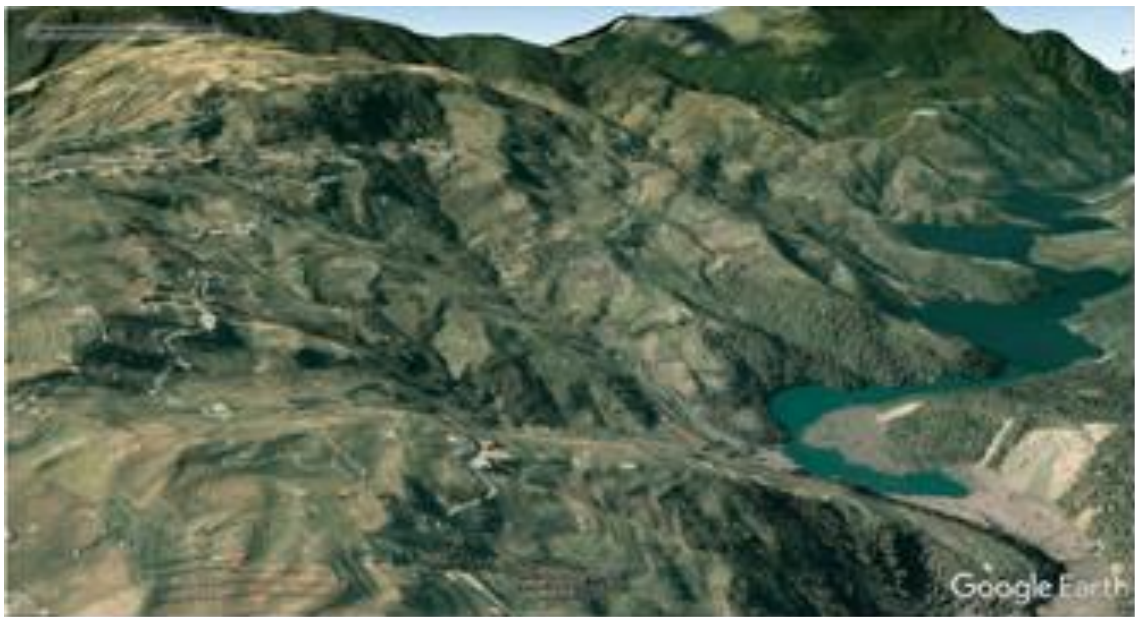
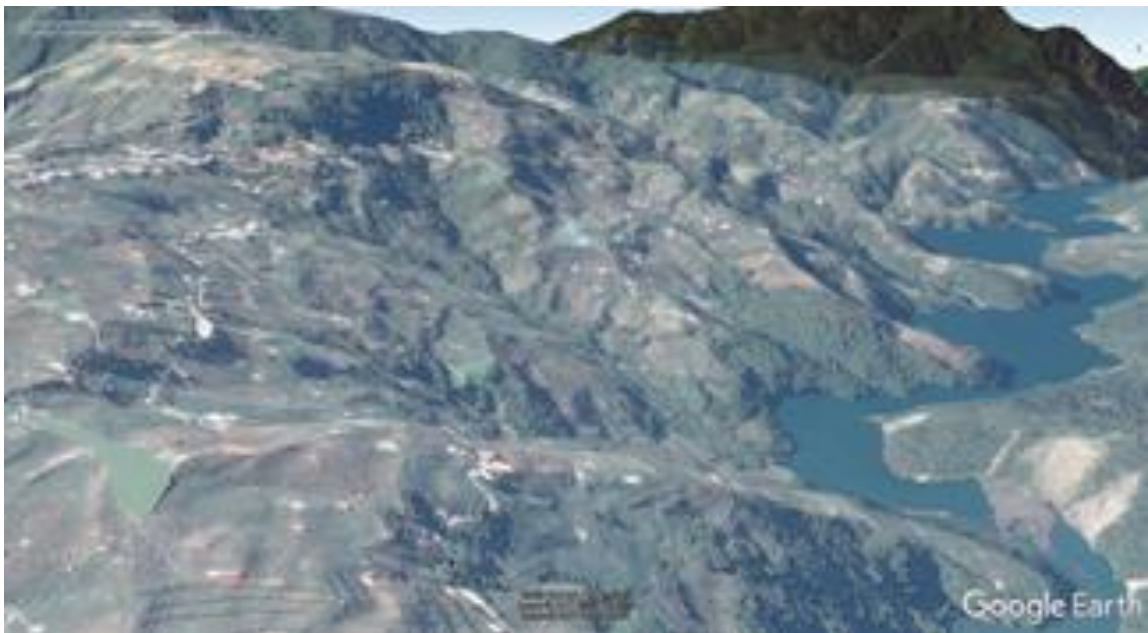
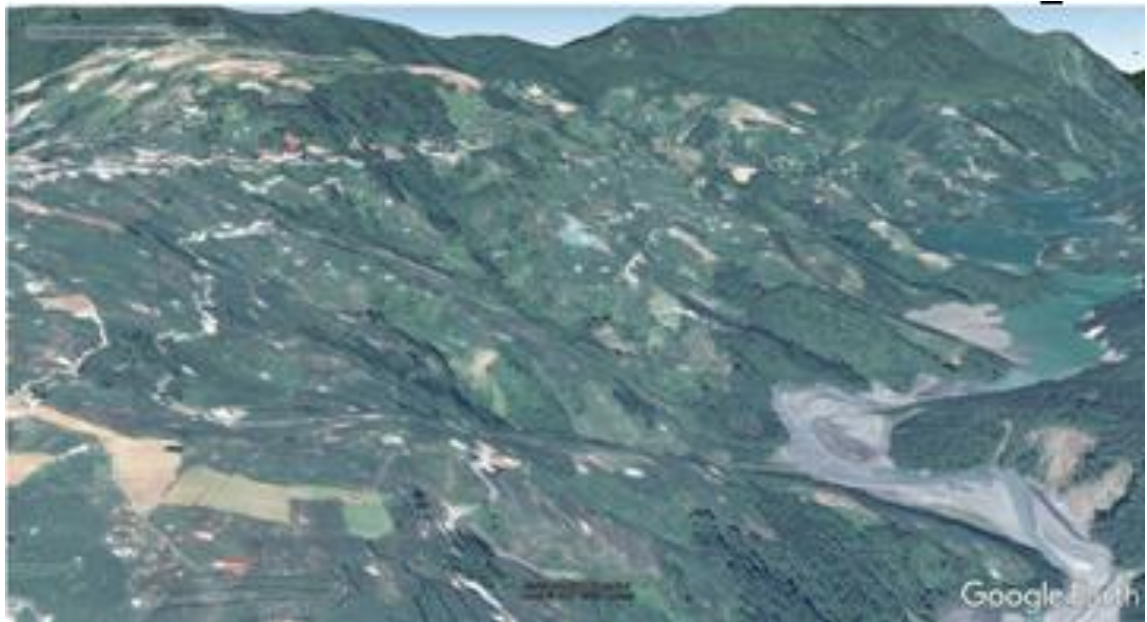
Figure 5.4. Historic satellite images of Lishan landslide area
(Google Earth, 2017)

Secondly, Figure 5.4 shows the historical satellite images of persistent partial-delamination landslide failures in this area during the period from Dec. 31st 1989 to Dec. 31st 2016. Therefore, the discussion mentioned above that Lishan landslide area is an ancient collapse area does not comply with the facts.

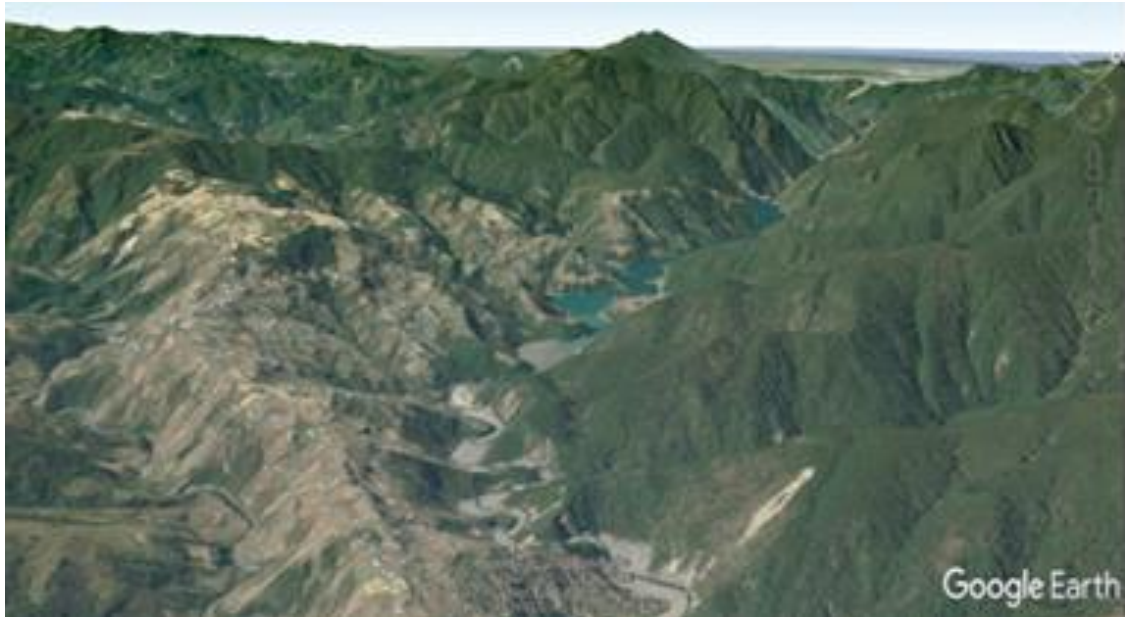
Figure 5.5. The up-and-down ridge line of Lishan and twisty river valley (Google Earth, 2017)

Based on these results, shear banding is accompanied by shear textures that have different strikes. Therefore, the three shear bandings shown in Figure 3 would induce the up-and-down ridge line and twisty river valleys in the Lishan area shown in Figure 5.5.

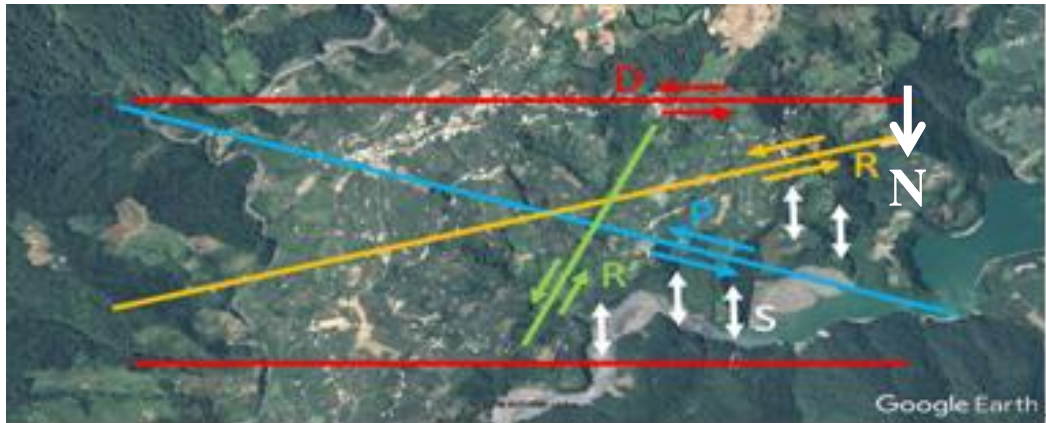
(a) First shear band and its shear textures

(b) Second shear band and its shear textures

(c) Third shear band and its shear textures

Figure 5.6. Shear bands and shear textures identified by satellite images (background picture is from Google Earth, 2017)

According to the satellite image of areas near Lishan and the displaced topographic features of the shear band, the strikes can be identified from Figure 5.6a that principal deformation shear D (red) is $N21^{\circ}W$, thrust shear P (blue) is $N3^{\circ}W$, Riedel shear R (yellow) is $N38^{\circ}W$, conjugate Riedel R' (green) is $N88^{\circ}W$, and compression texture S (white) is $N67^{\circ}E$. Besides, from Figure 5.6b, another five groups of shear textures can be identified, their strikes are: principal deformation shear D (red) is $E0^{\circ}$, thrust shear P (blue) is $N72^{\circ}W$, Riedel shear R (yellow) is $N74^{\circ}E$, conjugate Riedel R' (green) is $N24^{\circ}E$, and compression texture S (white) is $N0^{\circ}$. Finally, from Figure 5.6c, another five groups of shear textures can be identified, their strikes are: principal deformation shear D (red) is $N42^{\circ}E$, thrust shear P (blue) is $N61^{\circ}E$, Riedel shear R (yellow) is $N26^{\circ}E$, conjugate Riedel R' (green) is $N24^{\circ}W$, and compression texture S (white) is $N48^{\circ}W$.

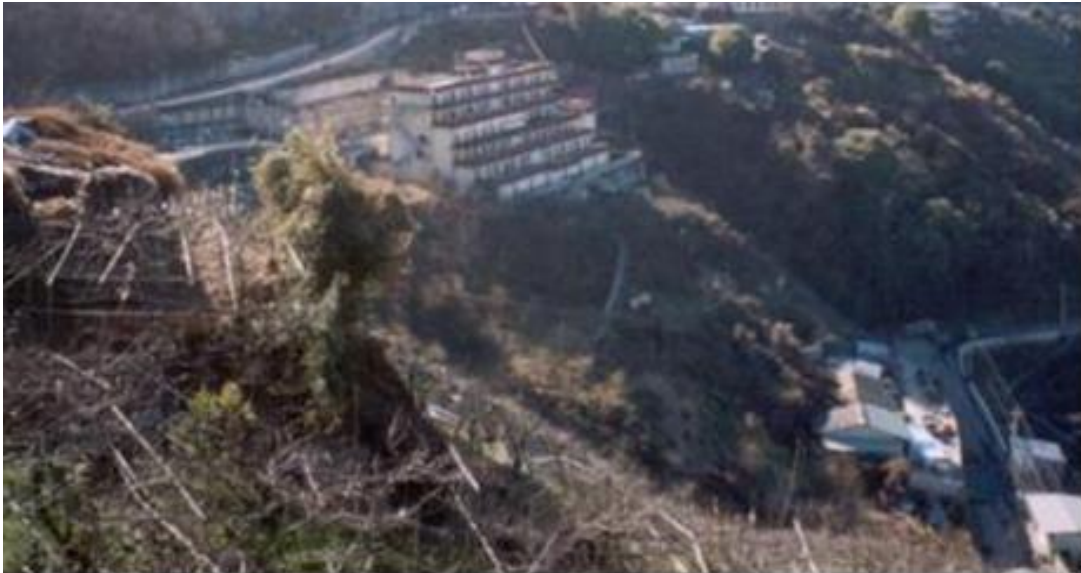
Figure 5.9. Landslide of wedge type on the location of Guest Hotel

The mechanism adopted by authors. The authors conducted landslide analysis on the location of the Guest Hotel during a persistent slide (Figure 5.9). In this analysis, a wedge landslide mechanism comprising five surfaces (sliding surface 1, sliding surface 2, gentle slope, steep slope, and tension crack) was adopted, as shown in Figure 5.10.

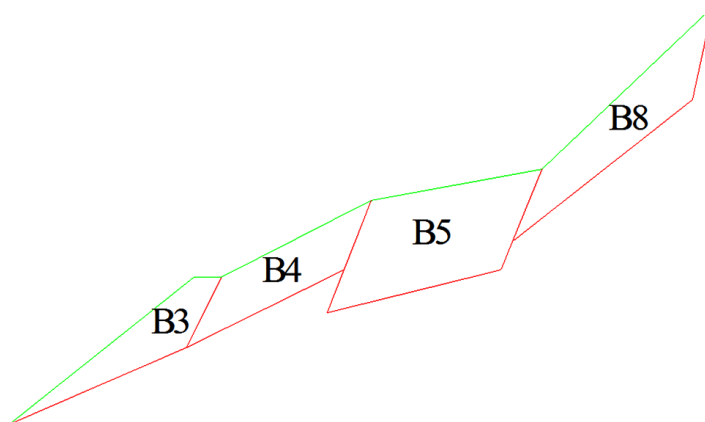
Figure 5.11 2-D diagrams for the four potential sliding failure blocks shown in Figure 8

In addition to the slope stability analysis (Figure 5.9) with a wedge landslide mechanism, the authors also conducted slope stability analysis on four sliding blocks B3, B4, B5, and B8 shown in Figure 5.8. Before the analysis, the potential sliding failure planes of four sliding blocks B3, B4, B5, and B8 of Figure 5.8 were found based on the exploration on the site. However, failure surfaces were not circular or non-circular, but were wedge-type consisting of five planes, which had a steeper slope at lower elevation. Therefore, the four sliding blocks B3, B4, B5, and B8 in Figure 5.8 can be redrawn to be four wedge-type sliding blocks as shown in Figures 5.11 and 5.12, where only after the sliding failure of wedge-type block B3, can sliding failures occur to the other three wedge-type blocks in order.
