THE MAJOR CAUSE OF EARTHQUAKE DISASTERS : SHEAR BANDINGS

**THE MAJOR CAUSE OF
EARTHQUAKE DISASTERS:
SHEAR BANDINGS**

Institute of Mitigation for Earthquake
Shear Banding Disasters

Capturing Shear Bandings

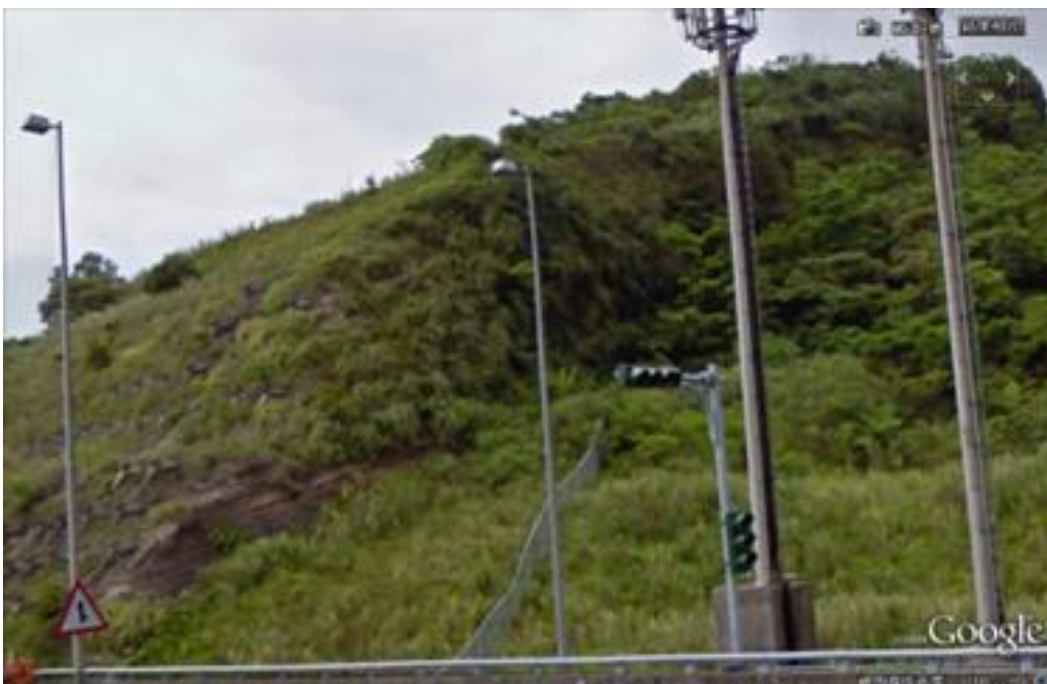
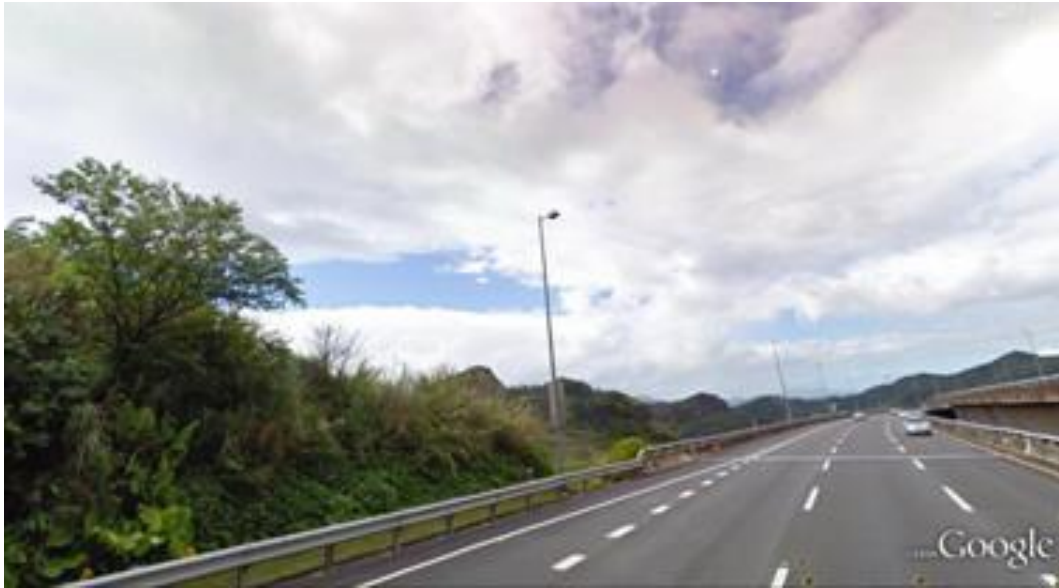
Figure 6.1. Shear banding features of National Freeway No. 3 3.1K (Google Earth, 2017).

Figure 6.1 shows that during the shear bandings that formed the mountains in the area around 3.1K of National Freeway No. 3, the rock layer interface is at a small angle of approximately 16° – 19° from the horizontal. This section of the road is constructed as a cut road. The upper slope lost lateral support once excavation was completed, and the slope experienced creeping, very slow slipping, slow slipping, fast slipping, and very fast slipping under frequent felt earthquakes. This eventually caused slip failures of the slope even if there was no wind, no rain, and no earthquake (refer to Figure 6.2).

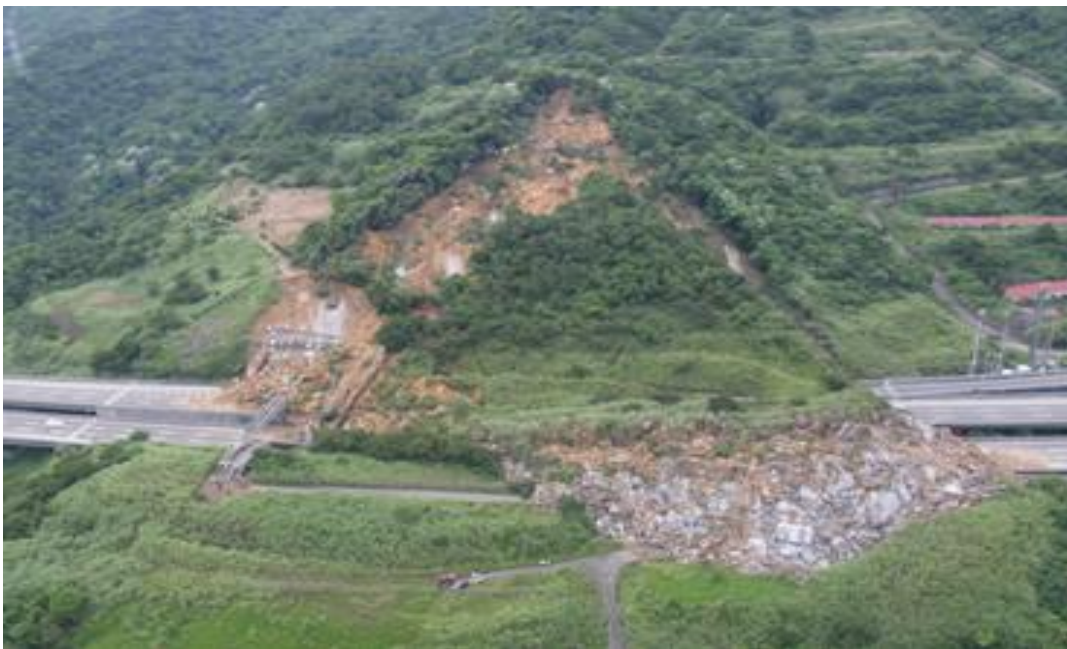
Figure 6.2. National Freeway No. 3 3.1K landslide (Taiwan Geotechnical Society, 2011).

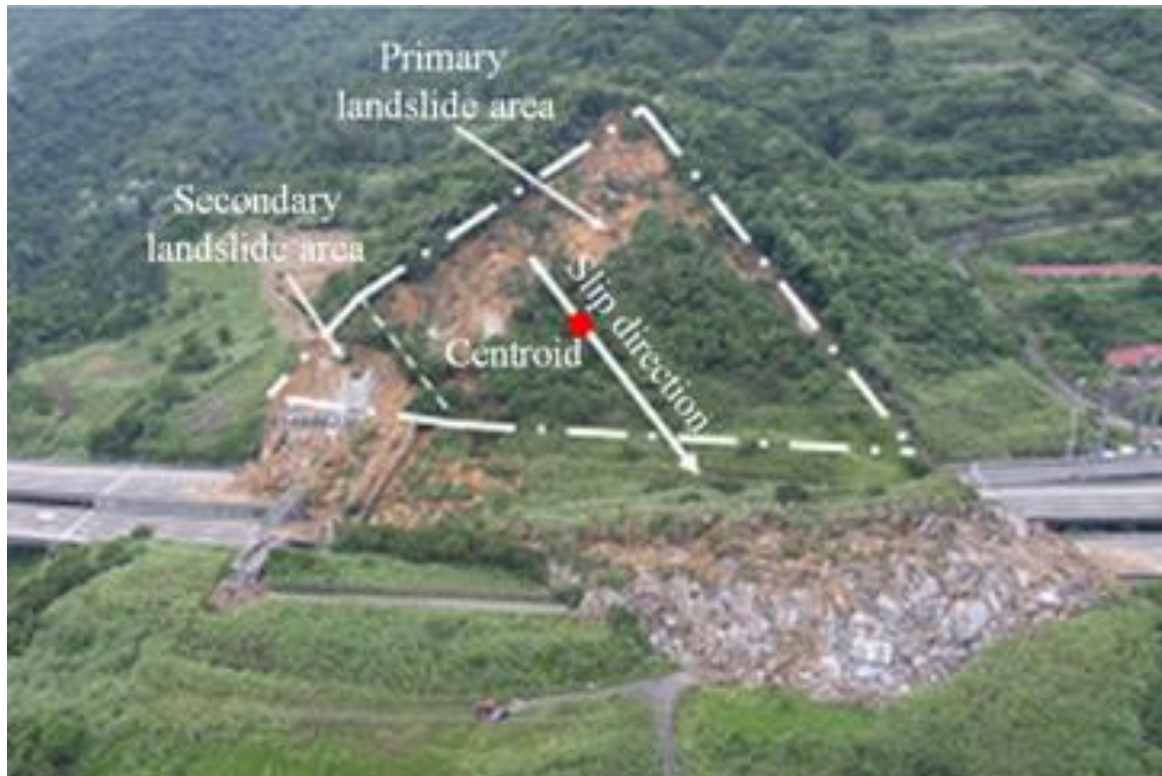
Figure 6.6. The slip areas adopted by the authors (background image from Taiwan Geotechnical Society, 2011).

Analysis Profiles. Figure 6.6 presents the landslide areas adopted by the authors. They are the primary and secondly landslide areas.

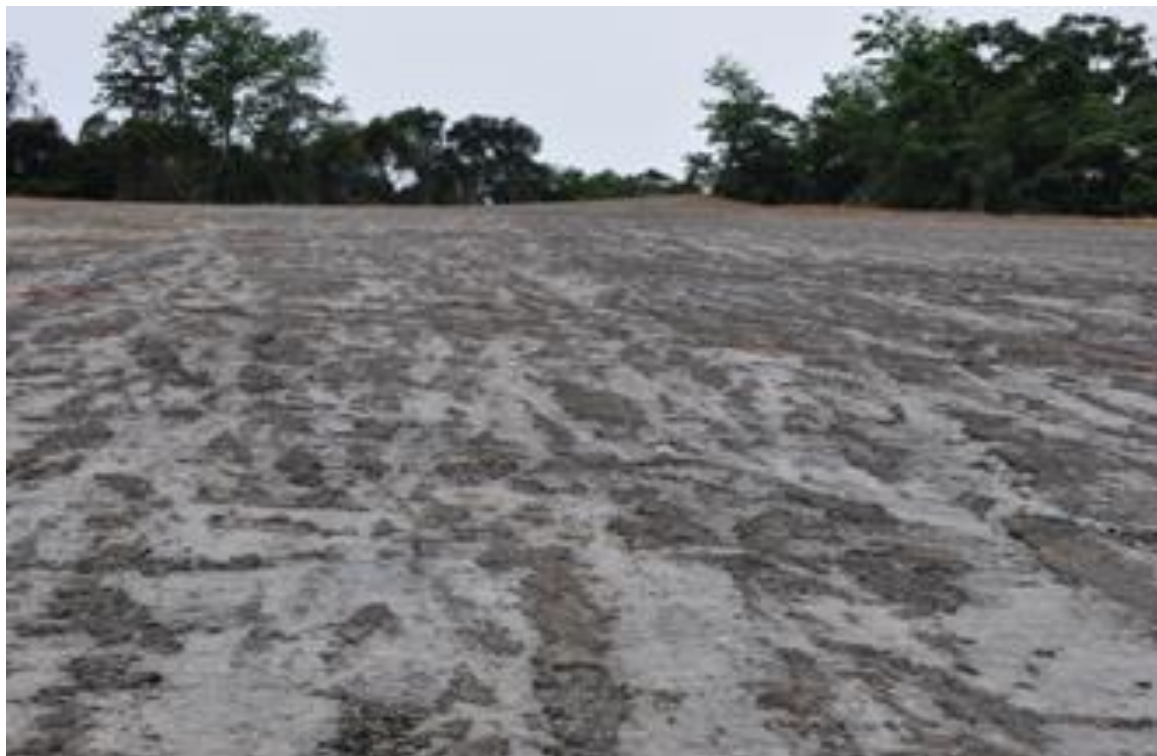
(a) Schematic drawing (Lambe and Whitman, 1972)

(b) Field condition

Figure 6.7. Partial contact between two adjacent blocks.

Slip at a Very Slow Velocity. When the block slips at a very slow velocity, *i.e.*, the yellow silty sandstone slips very slowly on the grey to black shale surface, the interface has transformed from full contact to partial contact as shown in Figure 6.7.

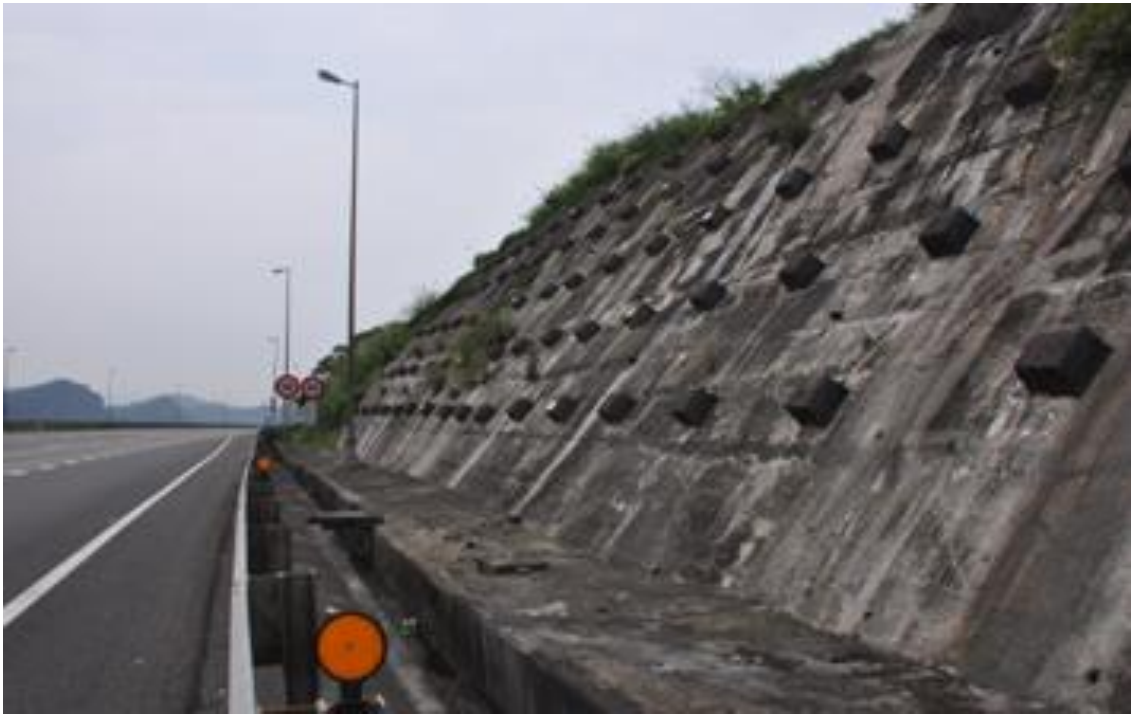
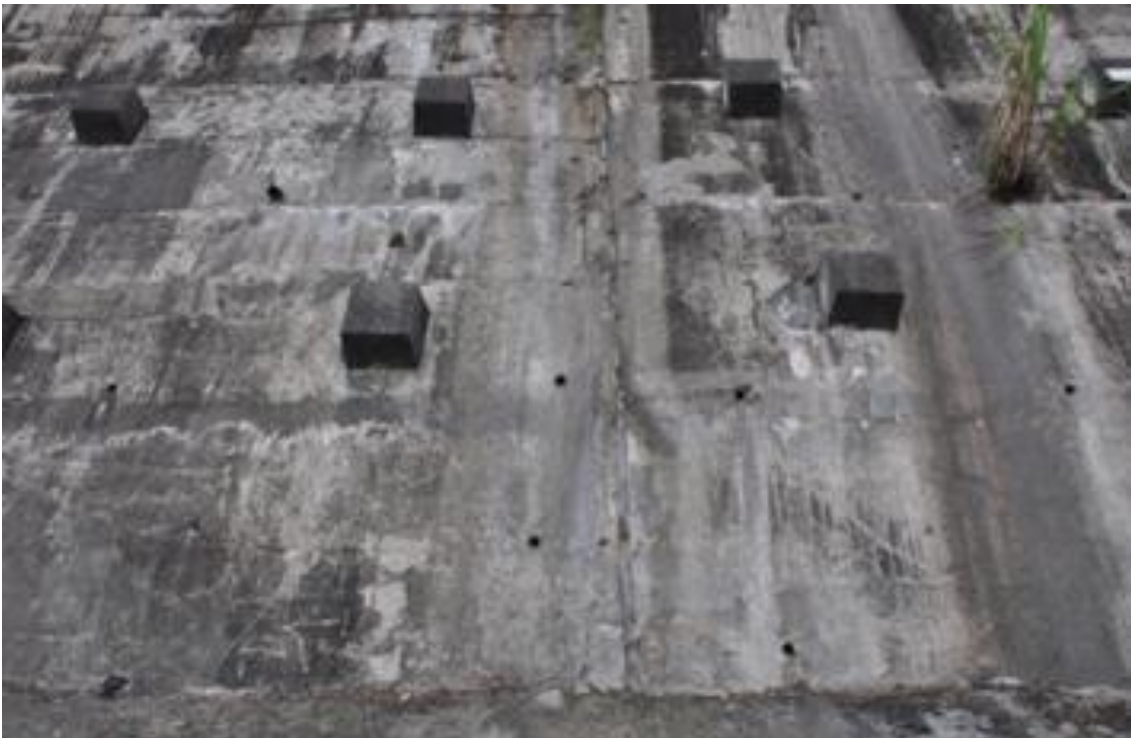
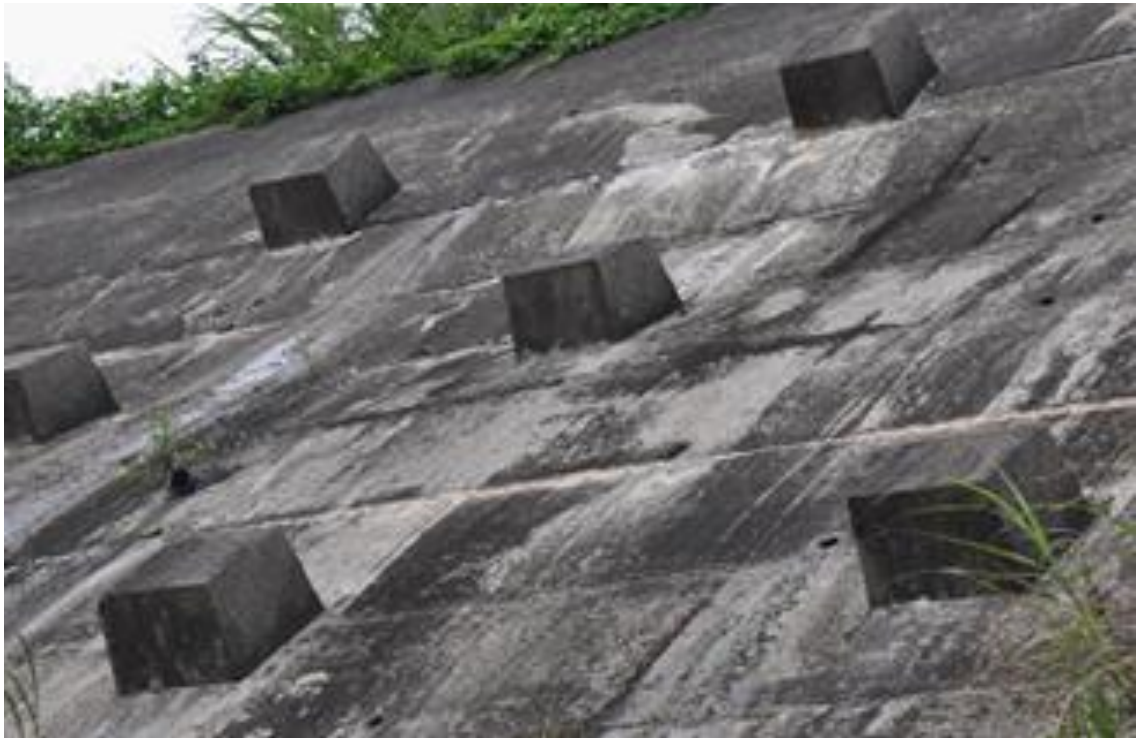
Figure 6.9. Current slope instabilities at 3.2K of National Freeway No. 3.

(a) Severe leaking out of the cemented substances

(b) Cracking of the retaining wall

(c) Warping of the retaining wall

5. After the investigation report was issued by Taiwan Geotechnical Society in 2011, the host organization immediately re-constructed the existing anchored slope with a grid pattern at 3.2K of the National Freeway No. 3 to anchored retaining walls. However, only five years after the reconstruction, the retaining wall has shown severe deformation (see Figure 6.9). This resembles the instability of the retaining wall on the left bank of the southbound lane at 3.1K of National Freeway No. 3 prior to the landslide (see Figure 6.10). The host organization should have the proper understanding with regard to the design and safety maintenance of anchored slopes. It should not treat the secondary factor as the primary factor of the landslide and ignore the primary factor, thus undermining the stability of freeway slopes.

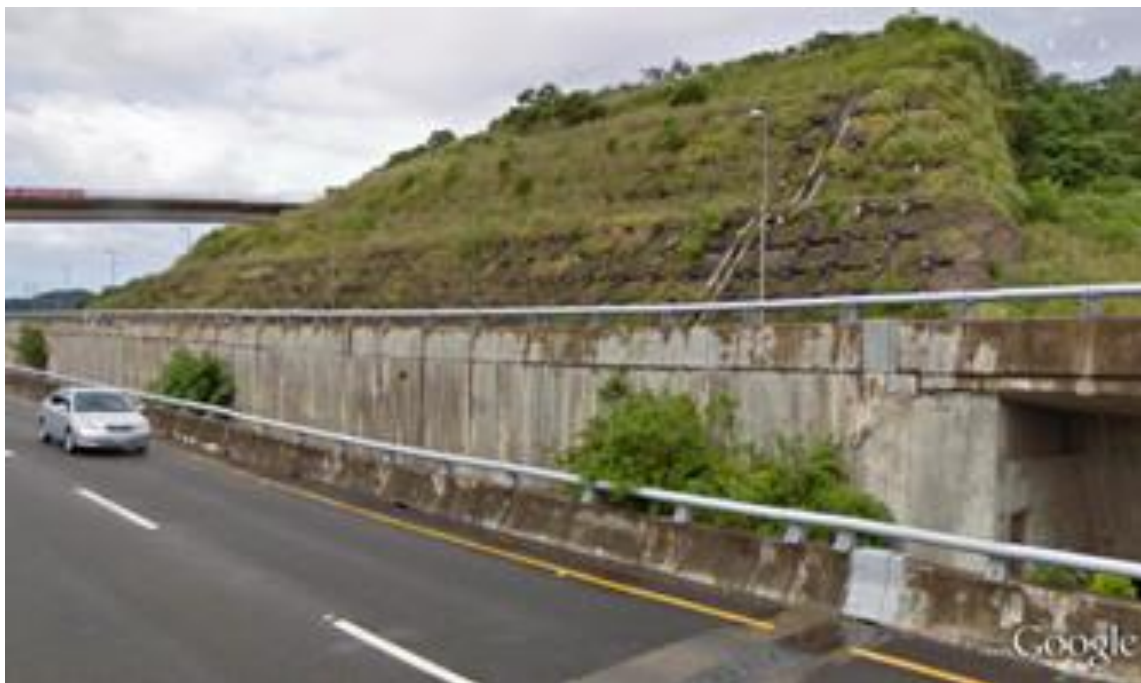
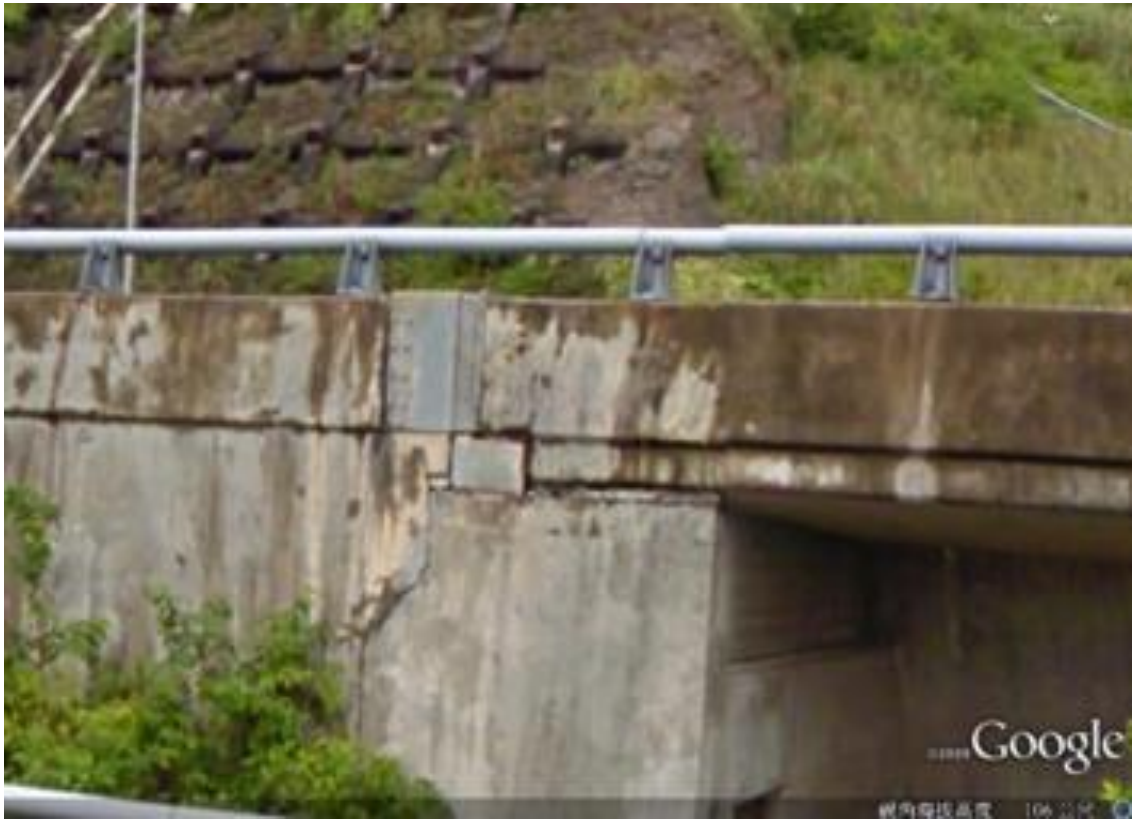
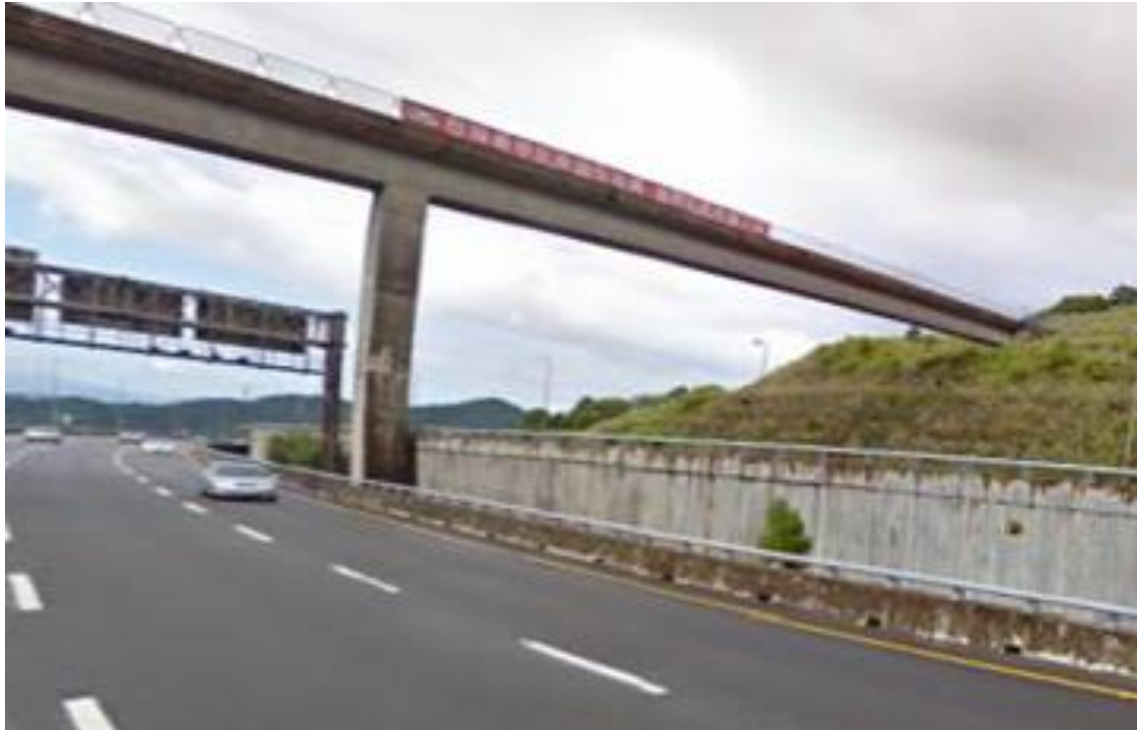
Figure 6.10. Slope instabilities at 3.1K of National Freeway No. 3 prior to the landslide (Google Earth, 2017).

(a) Severe leaking out of the cemented substances

(b) Cracking of the bridge abutment

(c) Bending of the bridge

4. For the anchored slope at 3.1K of National Freeway No. 3, more than 77.5% of the slip resistance is from the friction between the bottom of the sliding blocks and the shale surface, and the resistance by the anchors accounts for less than 9.3%. Under this circumstance, anchor corrosion is not in fact the main reason for the slope failure. The main reason is that, as the cumulative amount of shear banding increases, the adhesion of the slip plane c_a reduces to zero, the friction coefficient reduces and the tensile strength of the anchors reduces significant as well.

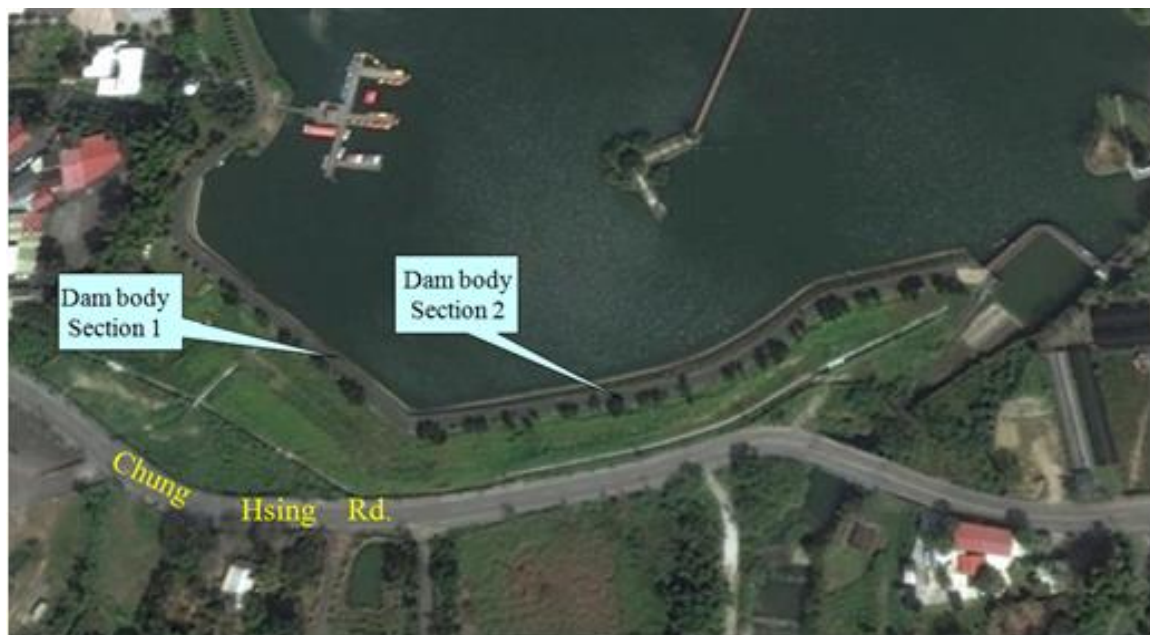
Figure 7.1. The dam for the Hutoupi Reservoir
(Taiwan Chia-Nan Irrigation Association, 2010).

Hutoupi Reservoir is an old dam. It was often destroyed by floodwaters during the period from 1841 to 1867 and it was also destroyed in the earthquake of 1906. After the 1935 Guan-Dao-Shan Earthquake, the embankment of the Hutoupi Reservoir dam collapsed following heavy rainfall and gushing due to piping damage emerged at the corner between dam body section 1 and section 2, as illustrated in Figure 7.1.

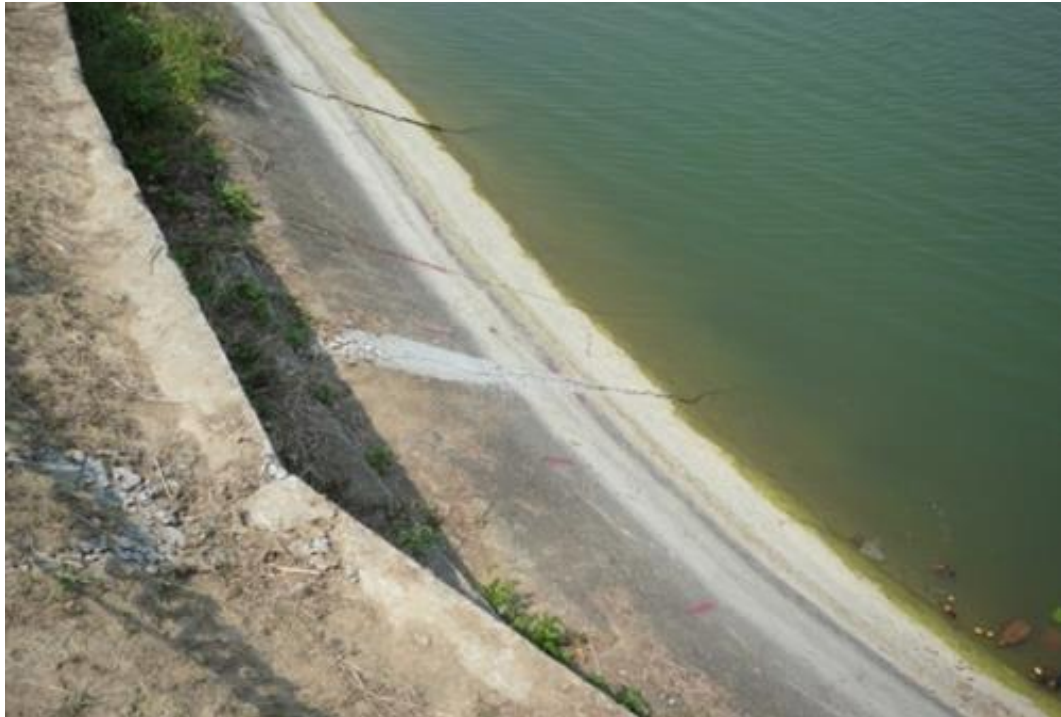
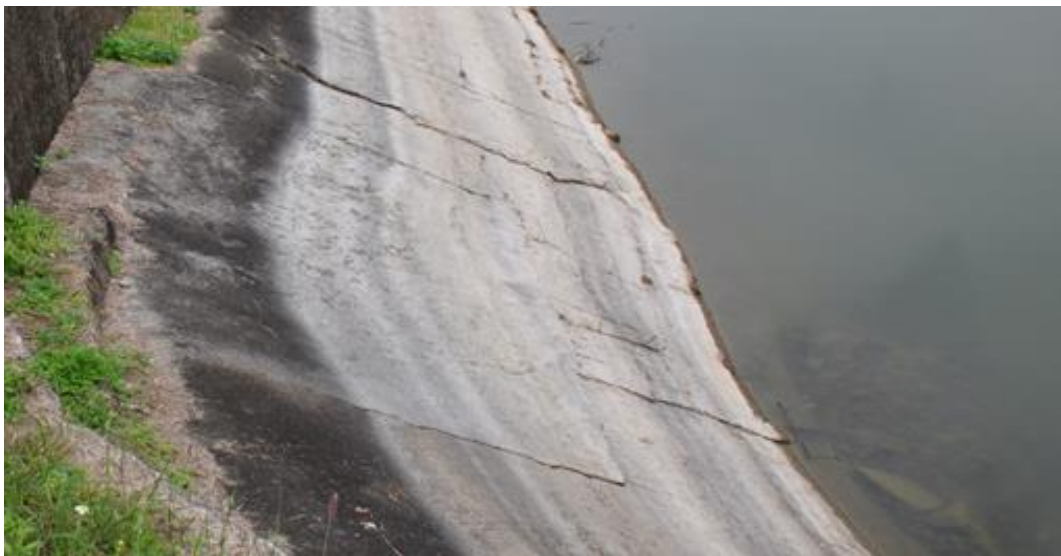
Figure 7.3. Comparison of degrees of earthquake damage for the two earthquakes in succession.

(a) After the 2010 Jiaxian Earthquake

(b) After the 2016 Meinong Earthquake

Then, during the 2016 Meinong Earthquake, the original emergency repair site once again exhibited earthquake damage. As shown in Figure 7.3, the extent of earthquake damage after the 2016 Meinong Earthquake was higher than that after the 2010 Jiaxian Earthquake. Shocked and not wanting further earthquake damage to occur in the future, the organizing body requested the authors to provide a high-quality and effective emergency repair method, as required for homogeneous dams, thereby ensuring that the dam body will not exhibit earthquake damage again after an earthquake of similar magnitude in the future.

After the completion of work on the Jiaxian Earthquake emergency repair project, the dam body exhibited water leakage on the downstream slope in 2013, as shown in Figure 2. During the 2016 Meinong Earthquake, the dam body exhibited more severe earthquake damage, as shown in Figure 3(b). The in-situ entity test results after the completion of these works directly shows that the quality of the Jiaxian Earthquake emergency repair project was poor.

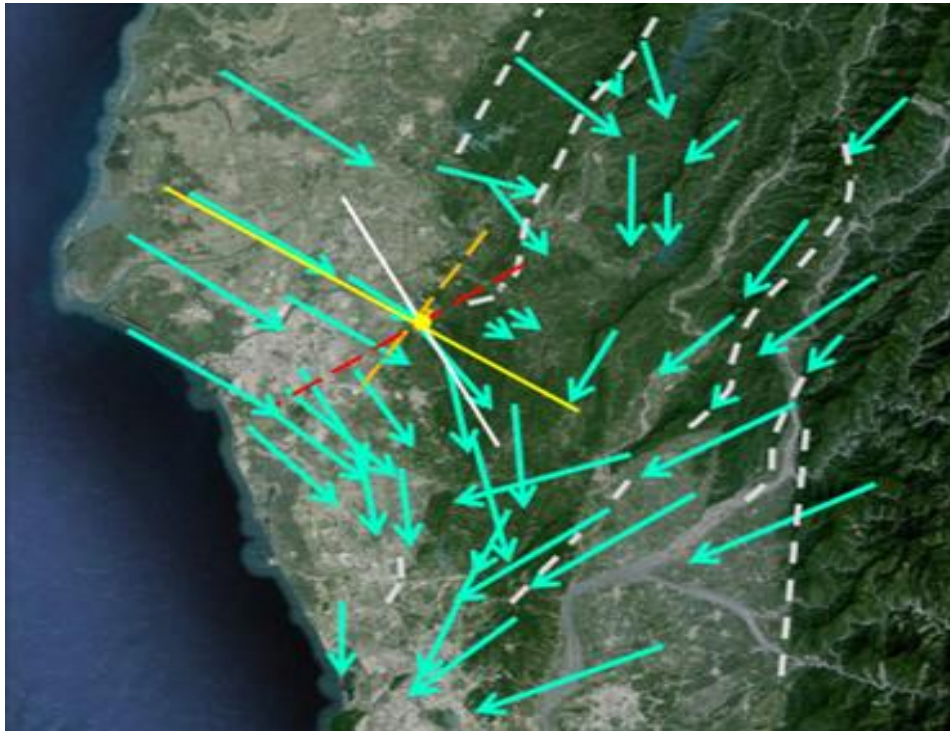
Figure 7.8. Shear bands identified from the distribution of displacement velocity vectors (background figure and vectors taken from Google Earth (2017) and GPS LAB (2017), respectively).

Identifying Shear Bands From a Map of the Distribution of Displacement Velocity Vectors. From a map of the distribution of displacement velocity vectors shown in Figure 7.8, the mechanism of shear band formation can be identified. There are four groups of shear bands with different strikes in the vicinity of Hutoupi Reservoir: (1) a twinning-type shear band indicated by the white solid line with a strike of $N26^{\circ}W$; (2) a conjugate twinning-type shear band denoted by the red dotted line with a strike of $N54^{\circ}E$; (3) a slip-type shear band indicated by the yellow solid line with a strike of $N56^{\circ}W$; and (4) a conjugate slip-type shear band indicated by the orange dotted line with a direction of $N34^{\circ}E$.

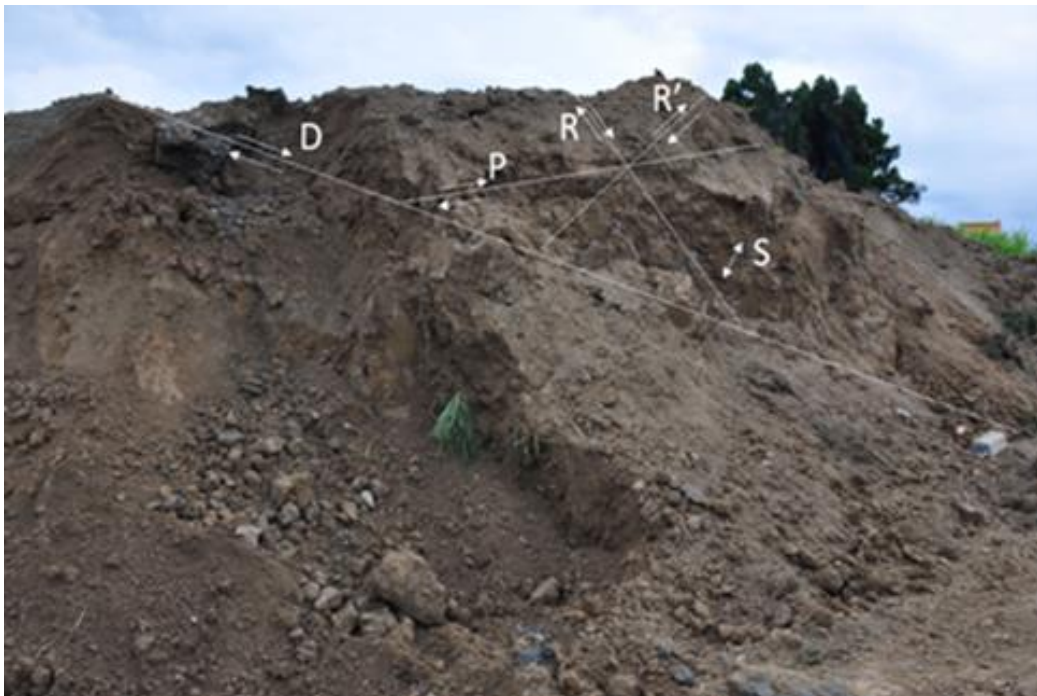
Figure 7.10. Identified shear bands and shear textures occurring in the dam body of Hutoupi Reservoir.

(a) Schematic diagram for the shear band occurring in the upper dam body.

(b) In-situ shear bands caused by the 2010 Jiaxian Earthquake.

(c) In-situ shear bands caused by the 2016 Meinong Earthquake.

Identifying the Shear Bands and Shear Textures From a Cross-sectional View of the Dam. Figure 7.10(a) shows a cross-section of the Hutoupi Reservoir dam. The Hutoupi Reservoir dam zone is divided into an upper dam body and a lower dam body. Since the cross-section of the upper dam body is aberrant, it will exhibit shear banding relative to the lower dam body in all previous tectonic earthquakes. The aforementioned shear banding will induce various shear textures within the total shear band width (see Figures 7.10(b) and 7.10(c) for detail).

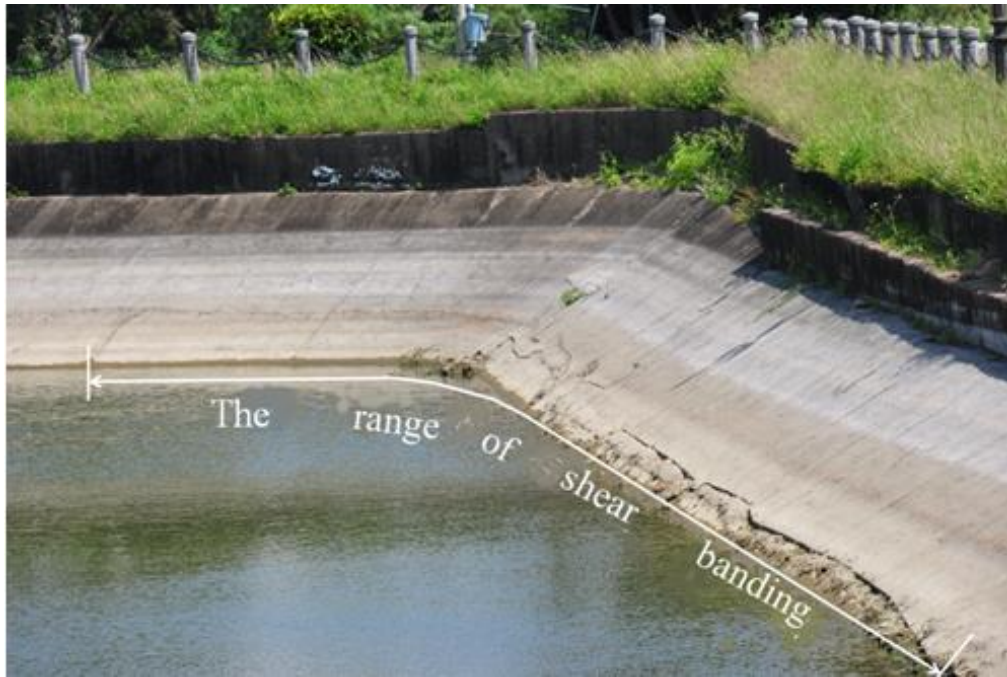
Figure 7.11. The area of shear banding that needs to be repaired after the 2016 Meinong Earthquake.

(a) Cross-section of the area that needs to be repaired.

(b) The dam perimeter needs to be repaired.

With the shear bands and shear textures clearly identified, the cross-section of the dam that requires repair is the whole upper dam body above the red line depicted in Figure 7.11(a), while the dam perimeter that requires repair is the extent of shear banding illustrated in Figure 7.11(b).

Based on the study results above, the authors consider that the Hutoupi Reservoir dam emergency repair project for the 2016 Meinong Earthquake must excavate the area indicated in Figure 11 and then conduct stratified backfilling with more earthquake-resistant clayey gravels (GC), which has a relative desirability index of 1 (Wagner, 1957). During the backfilling process, systematic compaction quality counseling and management are introduced in anticipation that the compacted soil quality of the whole repair zone will comply with the contracted requirements.

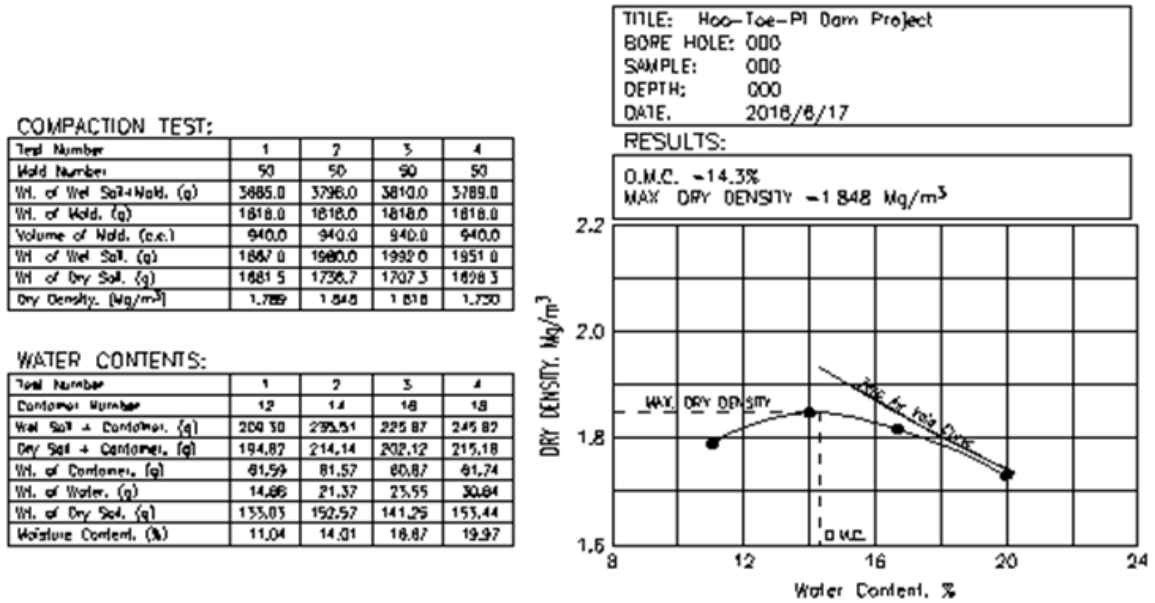
Figure 7.14. Results of the standard Proctor compaction test for a gravel content of P=0%.

Before using the modified formula, it is necessary to first conduct a test of the soil sample passing through the US standard sieve #4. It shows that, for a soil sample with a gravel content of $P=0\%$, the resulting specific gravity is $G_s=2.672$, the maximum dry unit weight is $\gamma_{d,\max} = 1.848\text{Tf/m}^3$, and the optimum moisture content is $\text{OMC}_0 = 14.3\%$ (see Figure 7.14 for details).

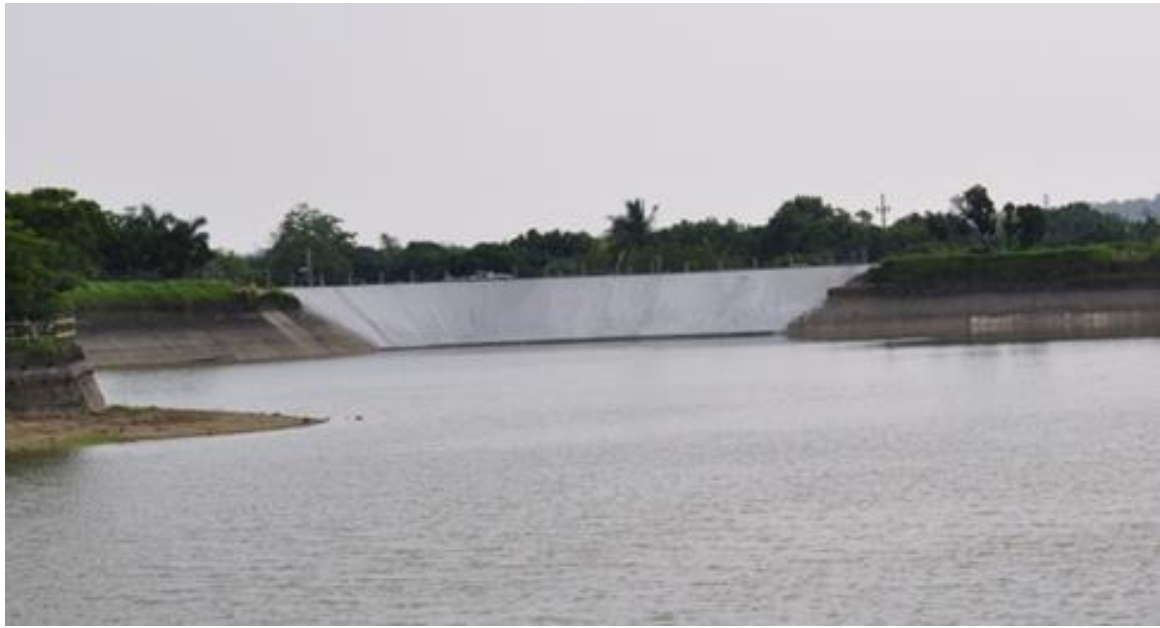
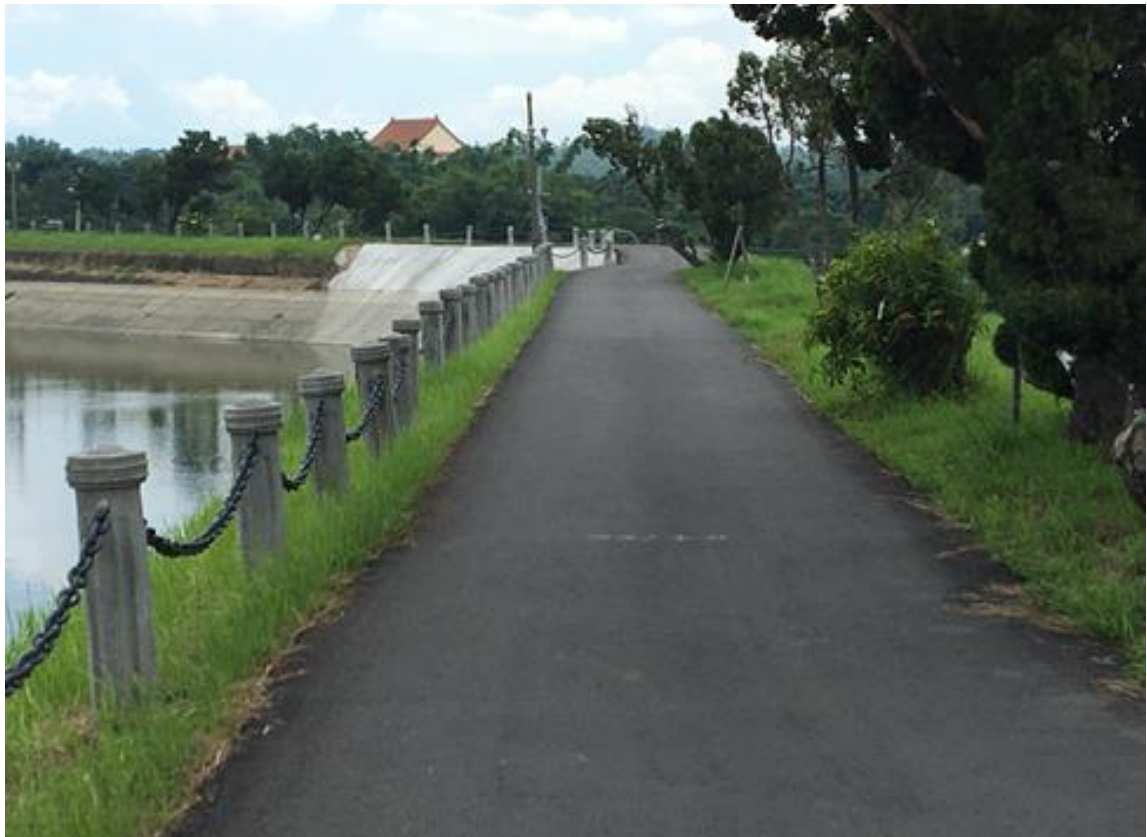
Figure 7.17. Entity test results for the emergency repair project of the Hutoupi Reservoir dam after the 2017 Tainan Earthquake.

(a) Dam body after emergency repair

(b) AC road surface on the crest of the dam after emergency repair

After the completion of work on the Meinong Earthquake emergency repair project, the dam body and the AC road surface on the crest of dam, as illustrated in Figure 7.17, both did not display any earthquake damage after the 2017 Tainan Earthquake. This shows that the quality of the Meinong Earthquake emergency repair project is excellent. The in-situ entity test results also demonstrate that earthquake damage to a homogenous dam or gushing due to piping damage can be eliminated by using the high-quality and effective emergency repair method proposed in this work.

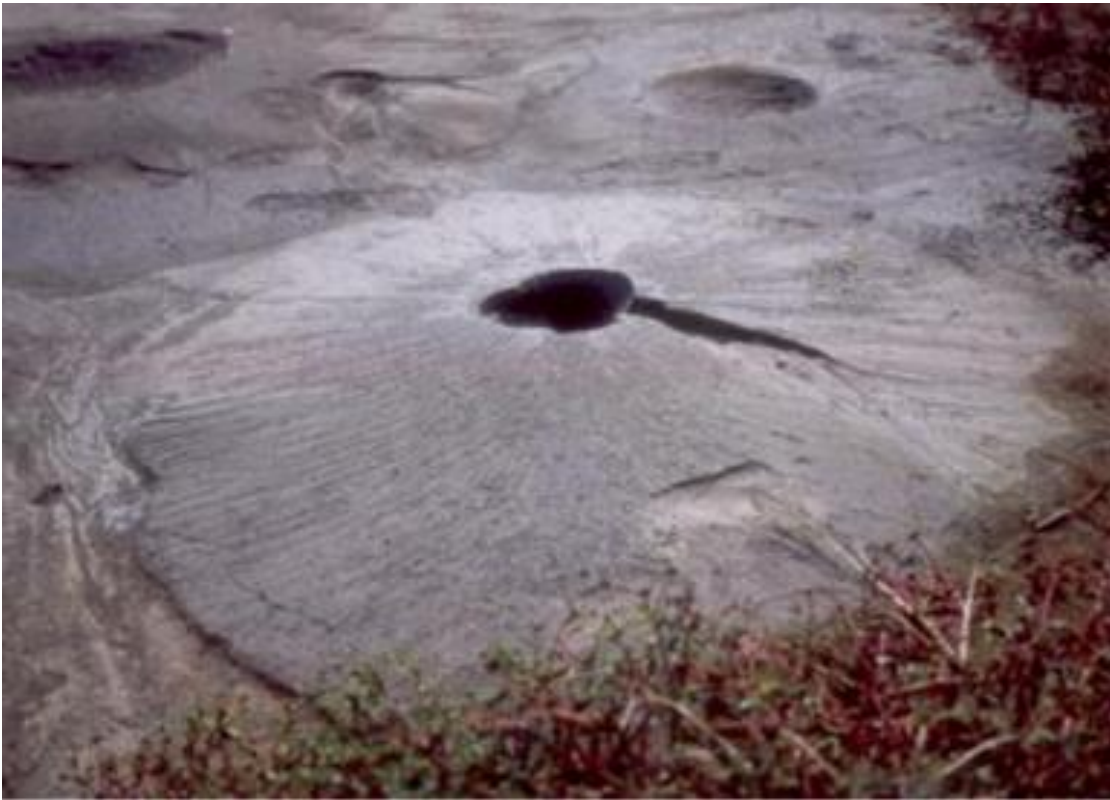
Figure 8.6. Tubular soil liquefaction took place during Chi Chi Earthquake (EOU Education Market, 2014)

Localizations of soil liquefactions can be divided into tubular soil liquefaction (as shown in Figure 8.6) and striped soil liquefaction (as shown in Figure 8.7). The tubular soil liquefaction is resulted from the tectonic plate equipped with tubular water channel similar to piping (Terzaghi and Peck, 1967). Hsu and Chiu (2016) believed that this tubular water channel is formed by intersection of shear textures of different strikes; the striped soil liquefaction is resulted from the tectonic plate equipped with striped water channel, which is the shear band under plane strain conditions (as shown in Figure 8.4).

Comparison among various causes of conventional and localizations of soil liquefactions is as shown in Table 8.1. It appears that the cause of conventional soil liquefaction is totally different from the cause of localizations of soil liquefactions. Obviously the cause of localizations of soil liquefactions can better meet the requirement of actual soil liquefaction as shown in Figure 8.6 and Figure 8.7.

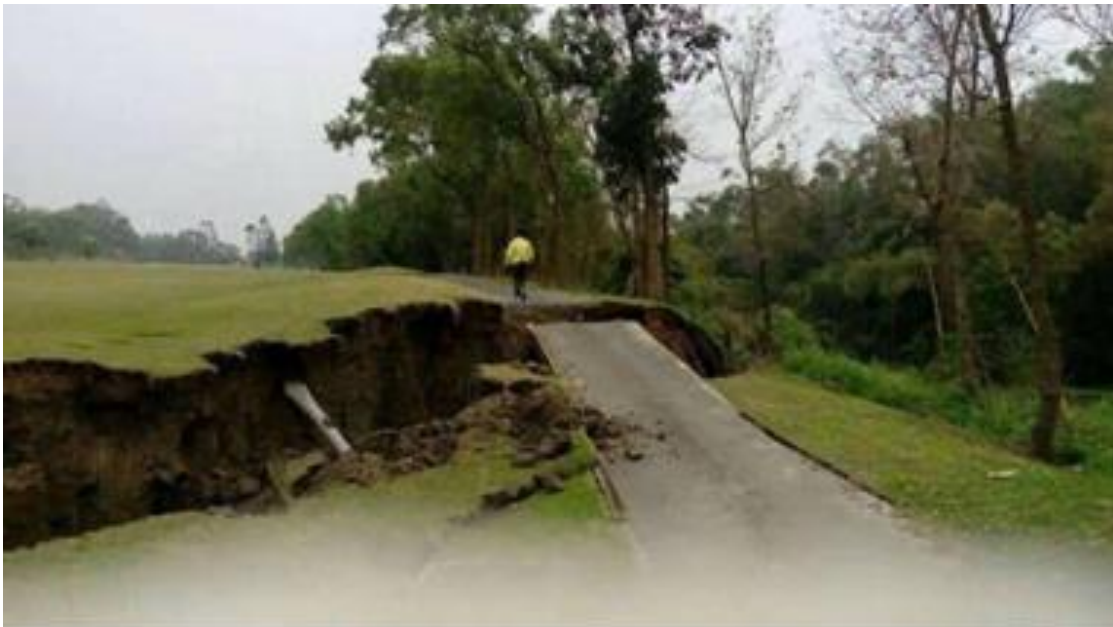
Figure 8.7. Striped soil liquefaction took place during Meinong Earthquake (Liberty Time Net, 2016)

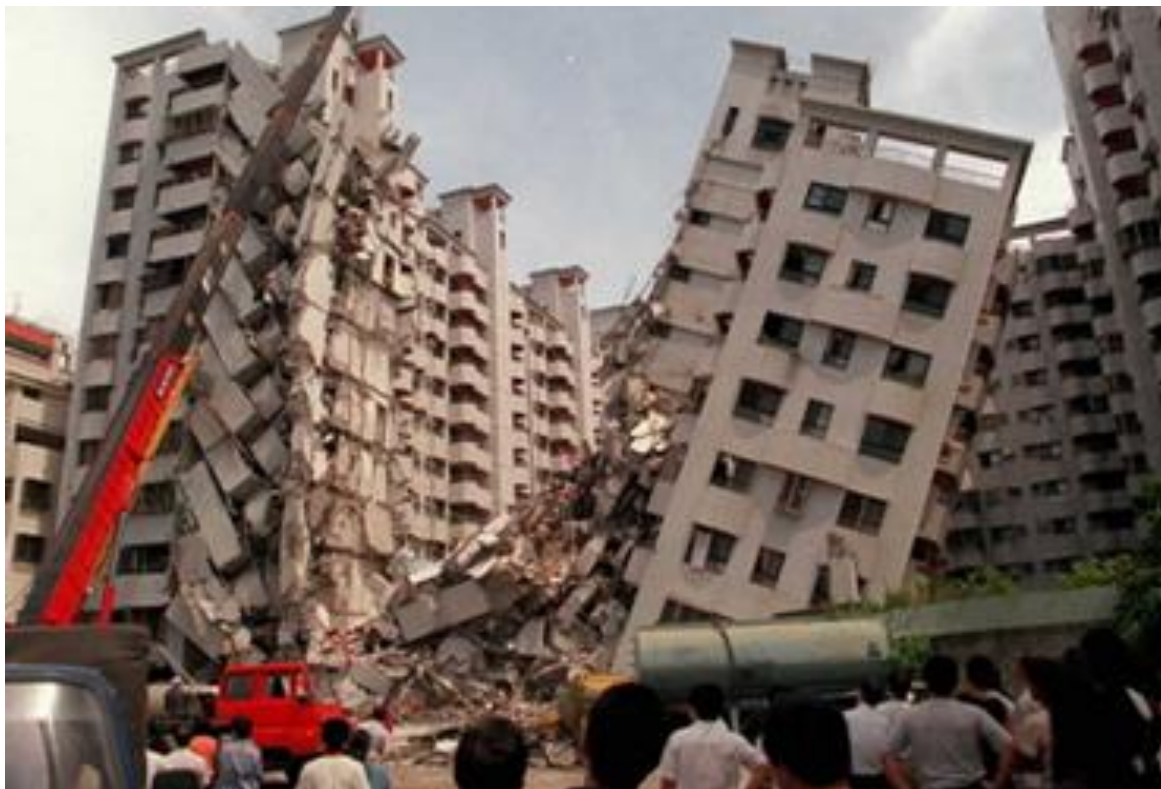
(a) Illustration of building damage pattern

(b) Actual building damage pattern (Pixnet, 2010)

Figure 8.8. Building damage induced by localizations of soil liquefactions during a tectonic earthquake

The building damage pattern induced by localizations of soil liquefactions during a tectonic earthquake is as shown in Figure 8.8. This kind of damage pattern is totally different from the damage pattern described by Hsu and Ho (2016) where the building was collapsed due to punching shear failure or tilted due to local shear failure.

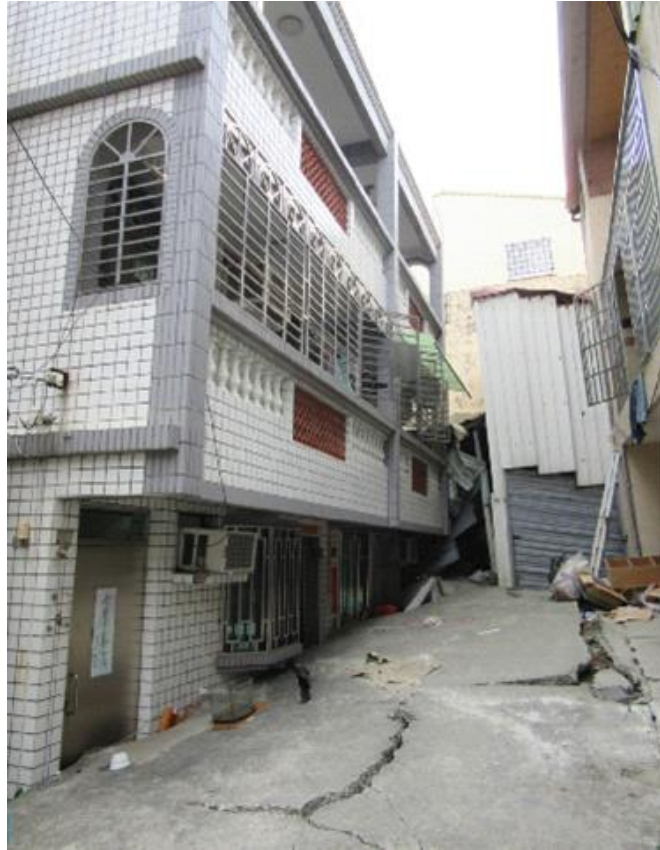
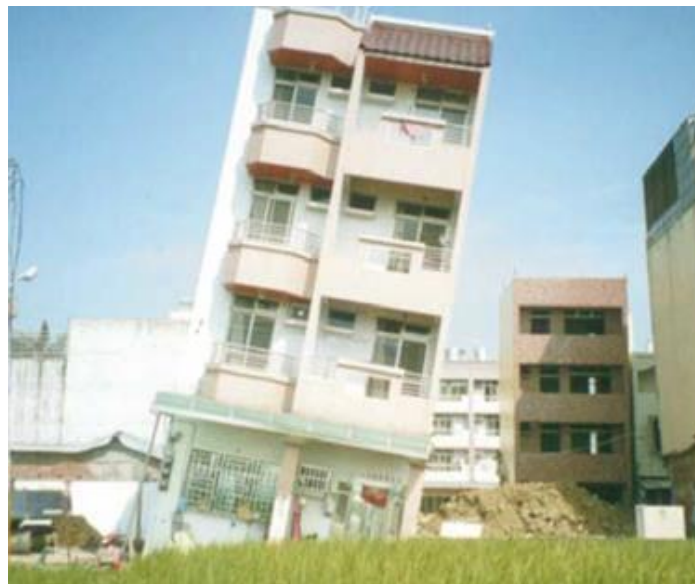
(a) The case of misidentifying the punching shear failure of foundation as soil liquefaction (Lee, Der-Ho, 2016)

(b) The case of misidentifying the local shear failure of foundation as soil liquefaction (Moh et al., 2000)

Figure 8.9. Cases of building damages during earthquake misidentified as to be induced by soil liquefaction

Different damage patterns will require different disaster mitigation methods related to earthquake, so the building damage induced by foundation punching shear failure (as shown in Figure 8.9a) or local shear failure (as shown in Figure 8.9b) must not be misidentified as to be induced by soil liquefaction.

In the past, scholars and specialists focused on the conventional constituting elements of soil liquefactions. They believed the cause of soil liquefaction was all-around vibrations, so the lecturing mould of soil liquefaction was as simple as a box of saturated loose sand and different models of buildings. When consistent horizontal vibration was applied, the building model settled down gradually (Figure 8.10); the ultimate cause of this kind of settlement was the punching shear failure induced by the lack of foundation bearing capacity (McCarthy, 2014). However, this kind of lecturing mould misled students to believe that the punching shear failure of the foundation was soil liquefaction. Under the guidance of such lecturing moulds, for people who became scholars or specialists in the future, it would be very natural for them to misidentify that, during tectonic plate vibration, building settlement (Figure 8.9a) induced by punching shear failure was instead induced by soil liquefaction.

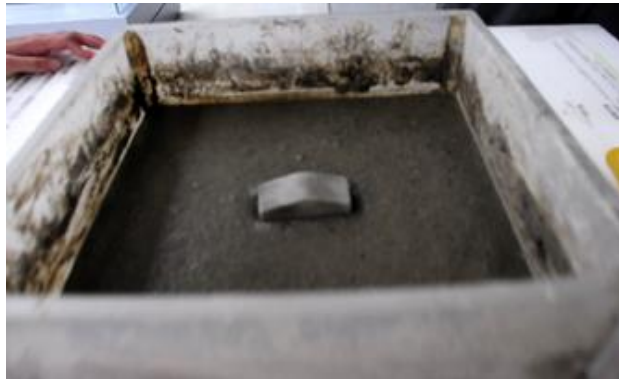
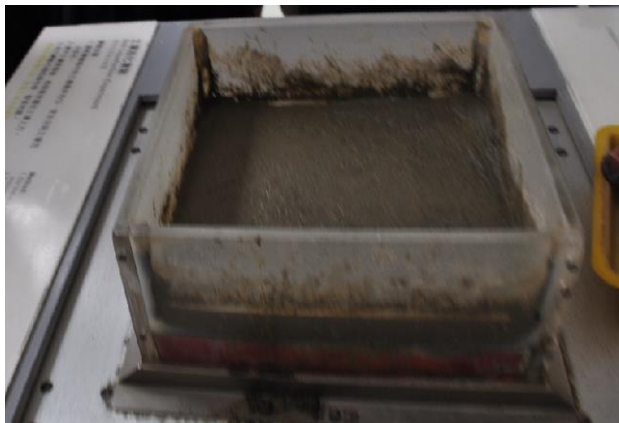
(a) No punching shear failure before vibrating

(b) Only punching shear failure produced after vibrating

(c) No shear banding and no ground water flow upward with sediment entrainment after vibrating

Figure 8.10. The lecturing mould used in teaching soil liquefaction today
