THE MAJOR CAUSE OF EARTHQUAKE DISASTERS : SHEAR BANDINGS

**THE MAJOR CAUSE OF
EARTHQUAKE DISASTERS:
SHEAR BANDINGS**

Institute of Mitigation for Earthquake
Shear Banding Disasters

Capturing Shear Bandings

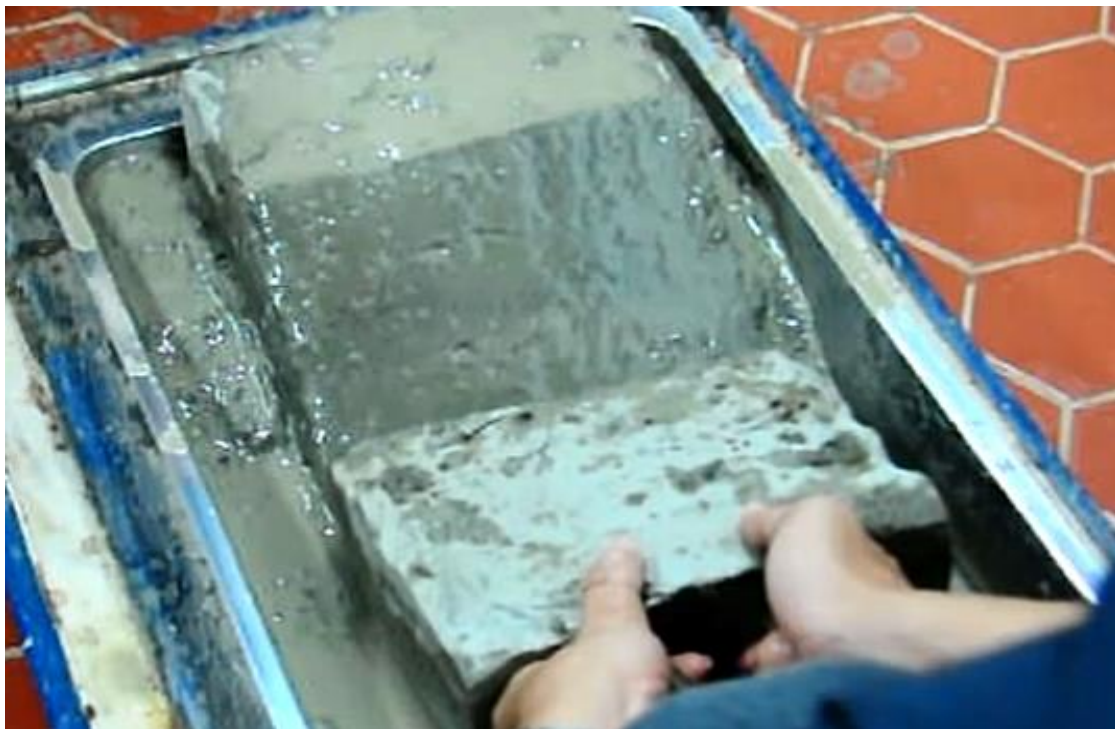
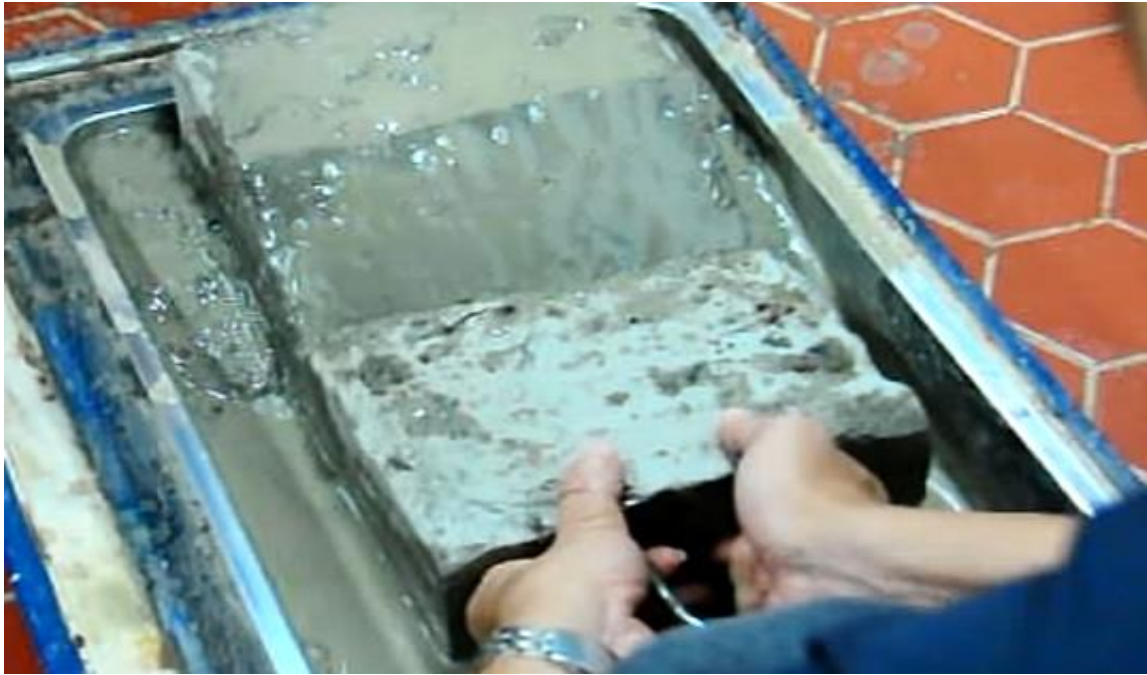
(a) Before ground water flow upward with sediment entrainment

(b) After ground water flow upward with sediment entrainment

Figure 8.13. A lecturing mould for localizations of soil liquefactions

8. A new lecturing mould for localizations of soil liquefactions is presented in Figure 8.13. It can be seen from Figure 8.13 that shear banding between hanging wall and foot wall has led to highly concentrated excess pore water pressure and forming the channel for upward ground water flow with sediment entrainment.
